# Report On the Archaeological Site Examination of the Entrance Drive, Carriage House, Greenhouse, Vegetable Garden, Flower Garden and Grapery at Gore Place, Waltham, Massachusetts

**CULTURAL RESOURCES MANAGEMENT STUDY NO. 17**

**2006**

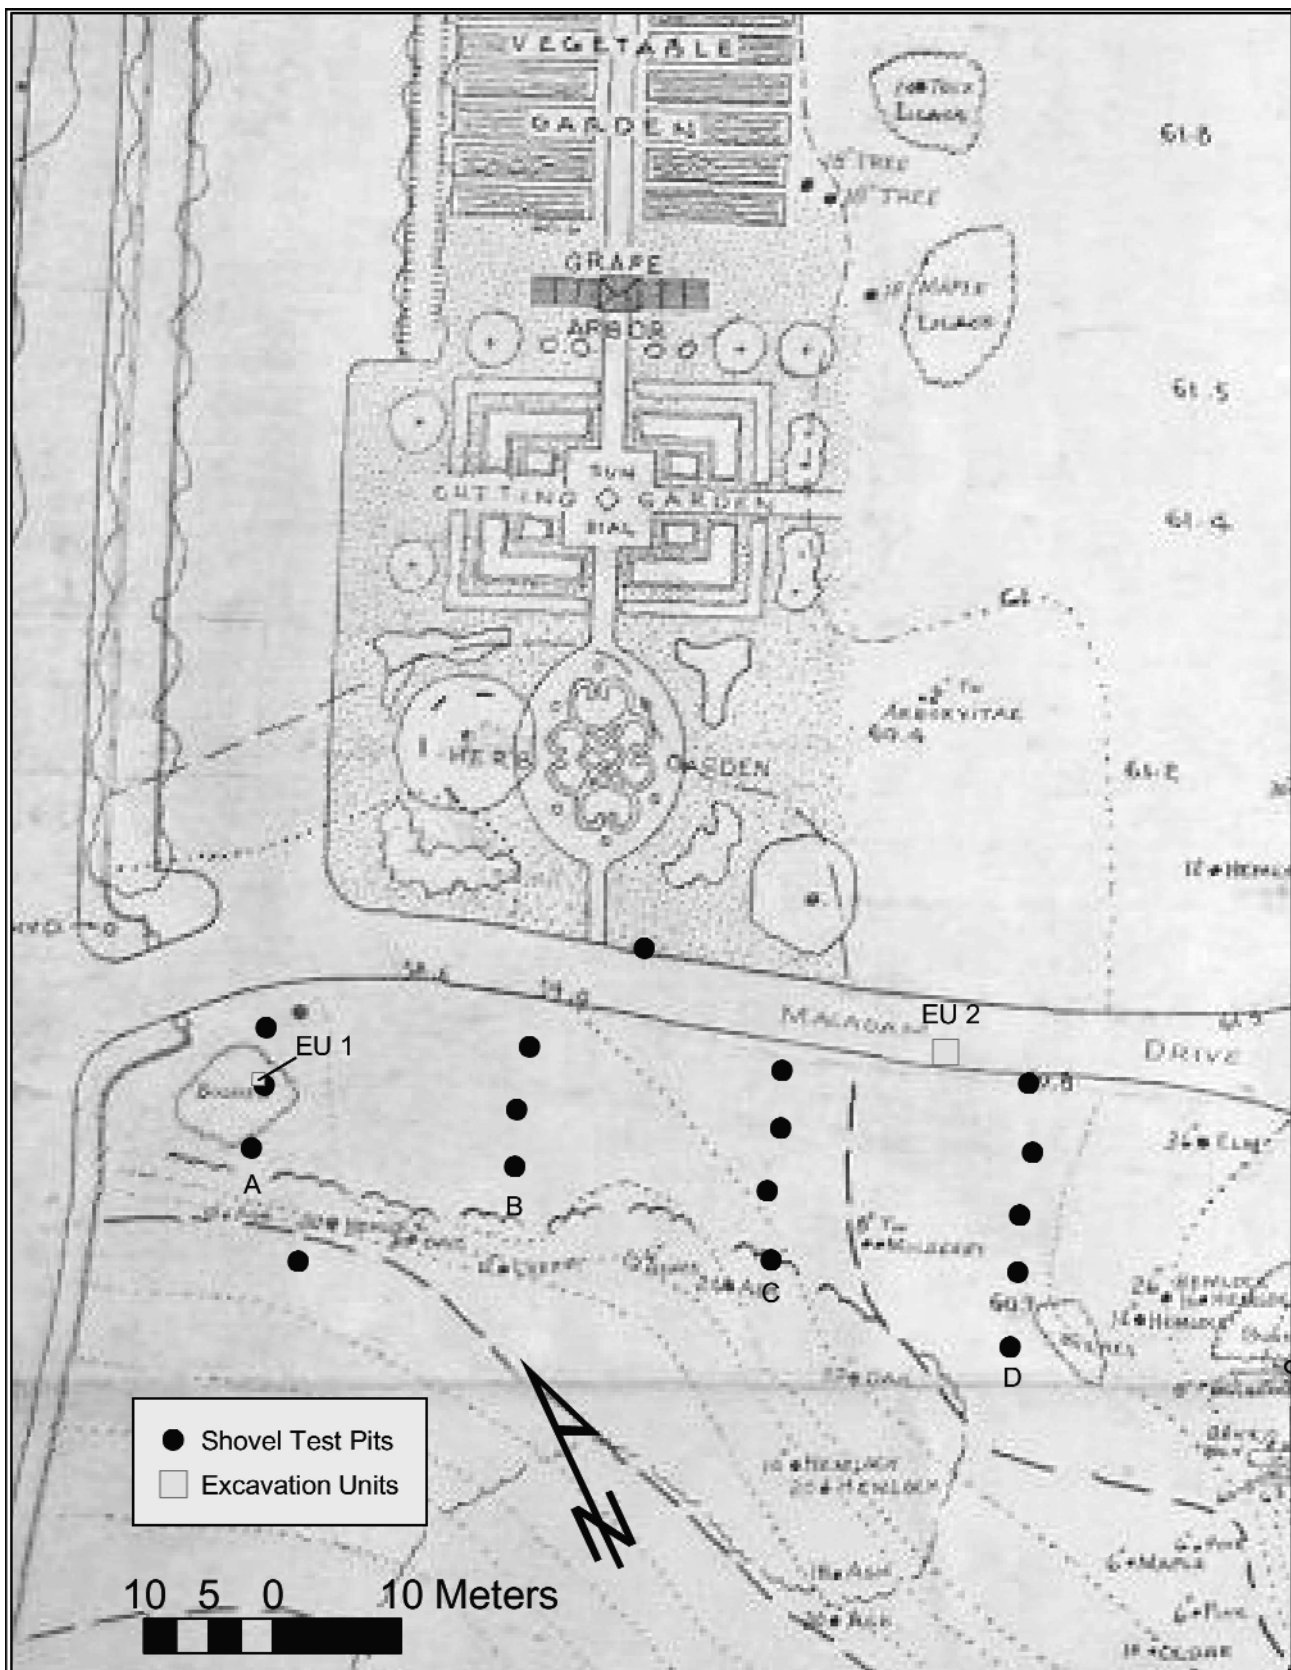
Figure IV.2. Archaeological Testing Plan in the Entrance Drive Area.

graphic depictions, suggested that early entrance drives may be present below and/or adjacent to the present drive. Archaeological investigations in this area, therefore, focused on identifying the location and composition of historic entrance drives between Gore Street and the mansion house. This search was accomplished by the excavation of a series of 50 cm x 50 cm (20 in x 20 in) shovel test pits (STPs) arranged in five transects that extended perpendicular to and south of the existing asphalt drive. The transects were 20 m (65.6 ft) apart and consisted of three, four or five tests spaced at 5 m (16.4 ft) intervals (Fig. IV.2). The westernmost transect was located 5 m (16.4 ft) east of the western stone property wall adjacent to Gore Street. Two additional tests were completed on the edge of the paved asphalt drive; STP G1a located 3 m (9.8 ft) east of the knot garden walk, and STP E5 located 5 m (16.4 ft) east of D5 to search for the possible presence of early drive surfaces. An additional test was performed in the entrance drive itself to make sure that early roadbeds did not exist beneath the present drive. A small area of loose asphalt was removed with mechanical assistance so that a 1 m x 2 m (6.5 ft) test trench could be completed. This test was located between 7 m and 8 m (22.9 ft and 26.2 ft) west of STP D5 and extended 2 m (6.5 ft) northward from the south edge of the asphalt drive. The grassy drive circle was also slated for testing, but the observation of historic photographs that revealed extensive disturbance resulted in the decision to avoid this area. Although additional STPs and excavation units (EUs) were planned to clarify expected drive edges, only two extra STPs and two EUs were needed due to the consistent stratigraphic profile across the area and due to the absence of buried drives.

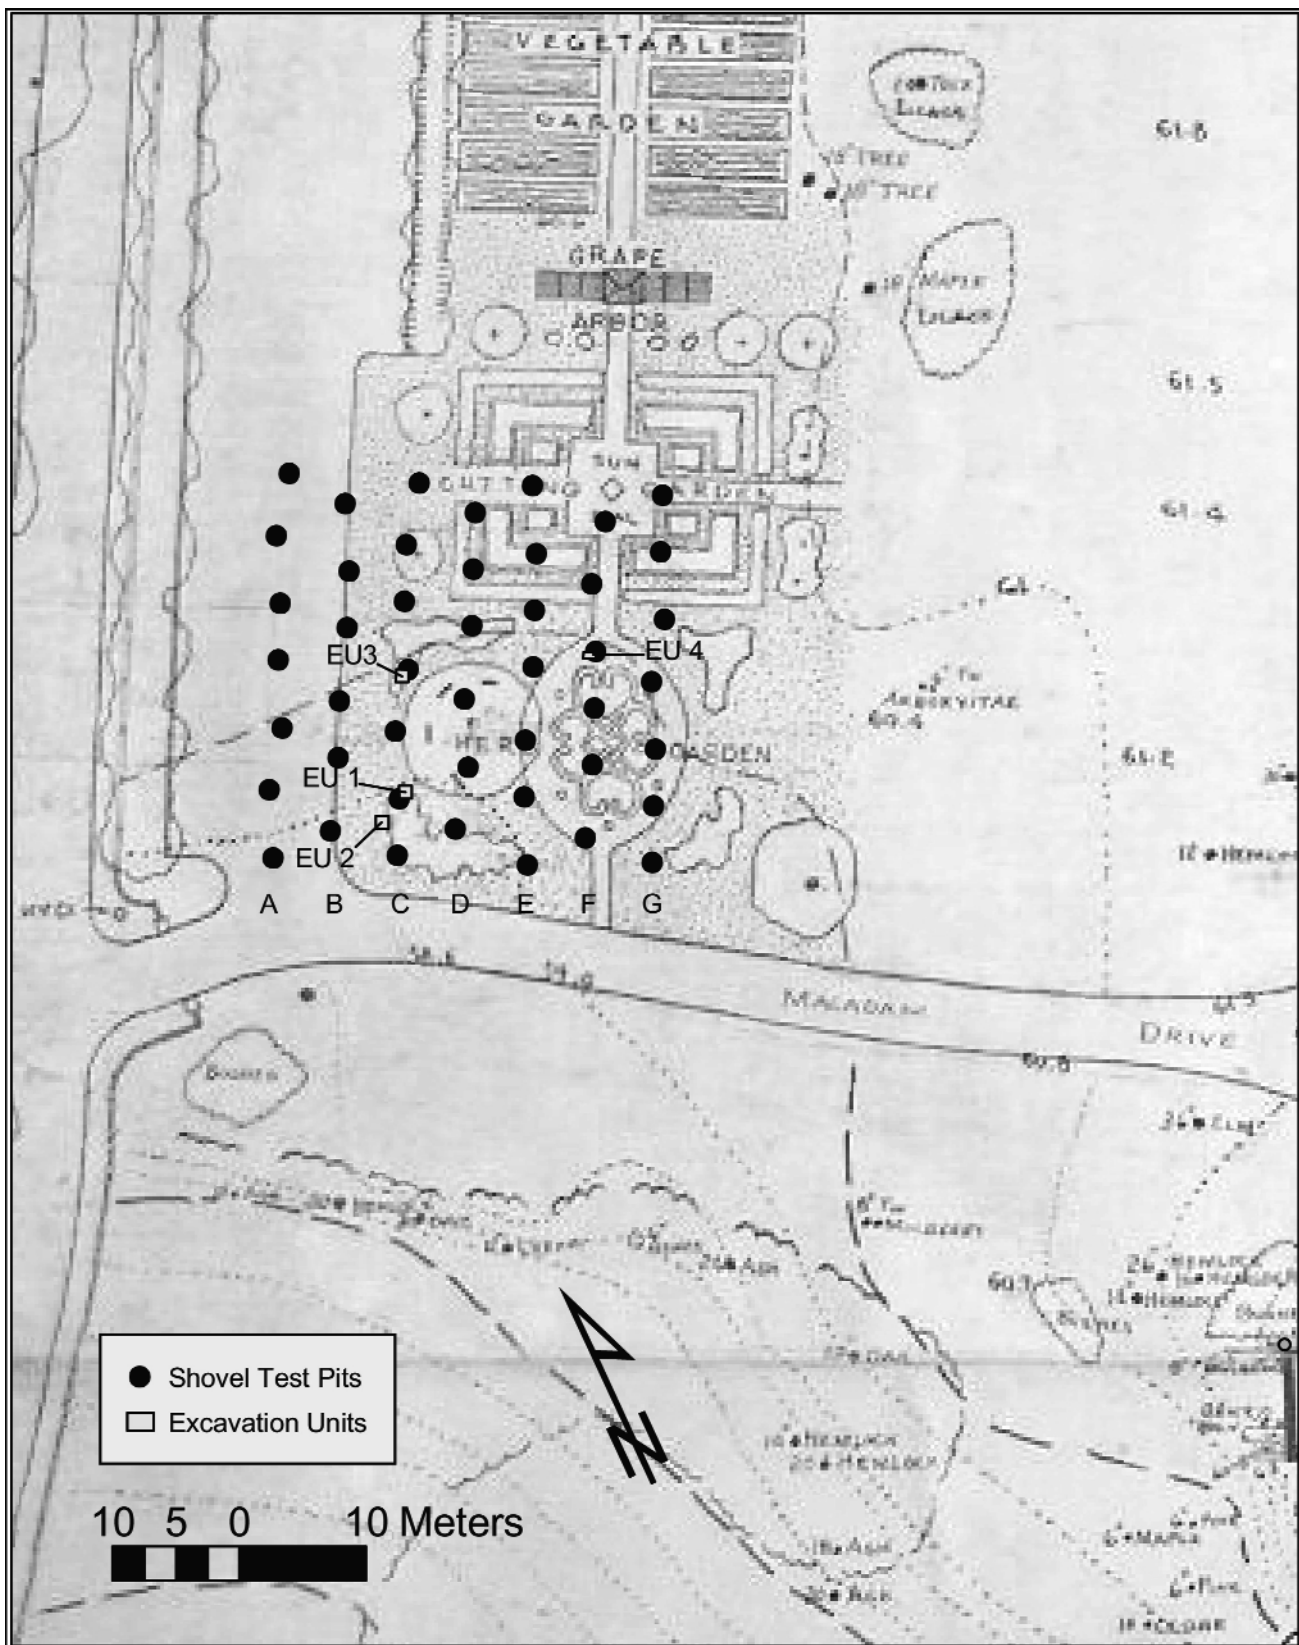
Figure IV.5. Archaeological Testing Plan in the Greenhouse Area.

Greenhouse investigations commenced with a determination of approximate location from study of the 1834-38 Lyman and 1841 Green estate maps. Subsurface testing was performed by the excavation of a 30 m x 30 m block of shovel tests spaced and staggered at 5 m intervals. The block was located immediately east of the original carriage house foundation. This strategy allowed for coverage of the entire greenhouse area including the central structure, the surrounding yard, and the south edge of the historic vegetable garden that was situated north of the greenhouse and carriage house (Fig. IV.5). The block consisted of 7 transects labeled A-G from west to east, and 1-7 from south to north. Although 46 STPs were planned, transect A was eliminated due to its location in a portion of the parking lot that appears to have been disturbed during removal of the carriage house.

C, D, E and F revealed foundation stones and brick and mortar rubble between the A-horizon and underlying sand and gravel (see Fig. IV.5). This rubble area underlies the present oak tree, west bench and west and north edges of the present knot garden and a portion of the yew hedge north of the knot garden. Soils to the south and immediate east of the structure rubble are characterized by a thick A-horizon over a B-horizon, while tests further east contained sand and gravel below the A-horizon. The western portion of the area (Transect B) adjacent to the present gravel parking lot revealed a variety of soil types as well as a possible cobble surface.

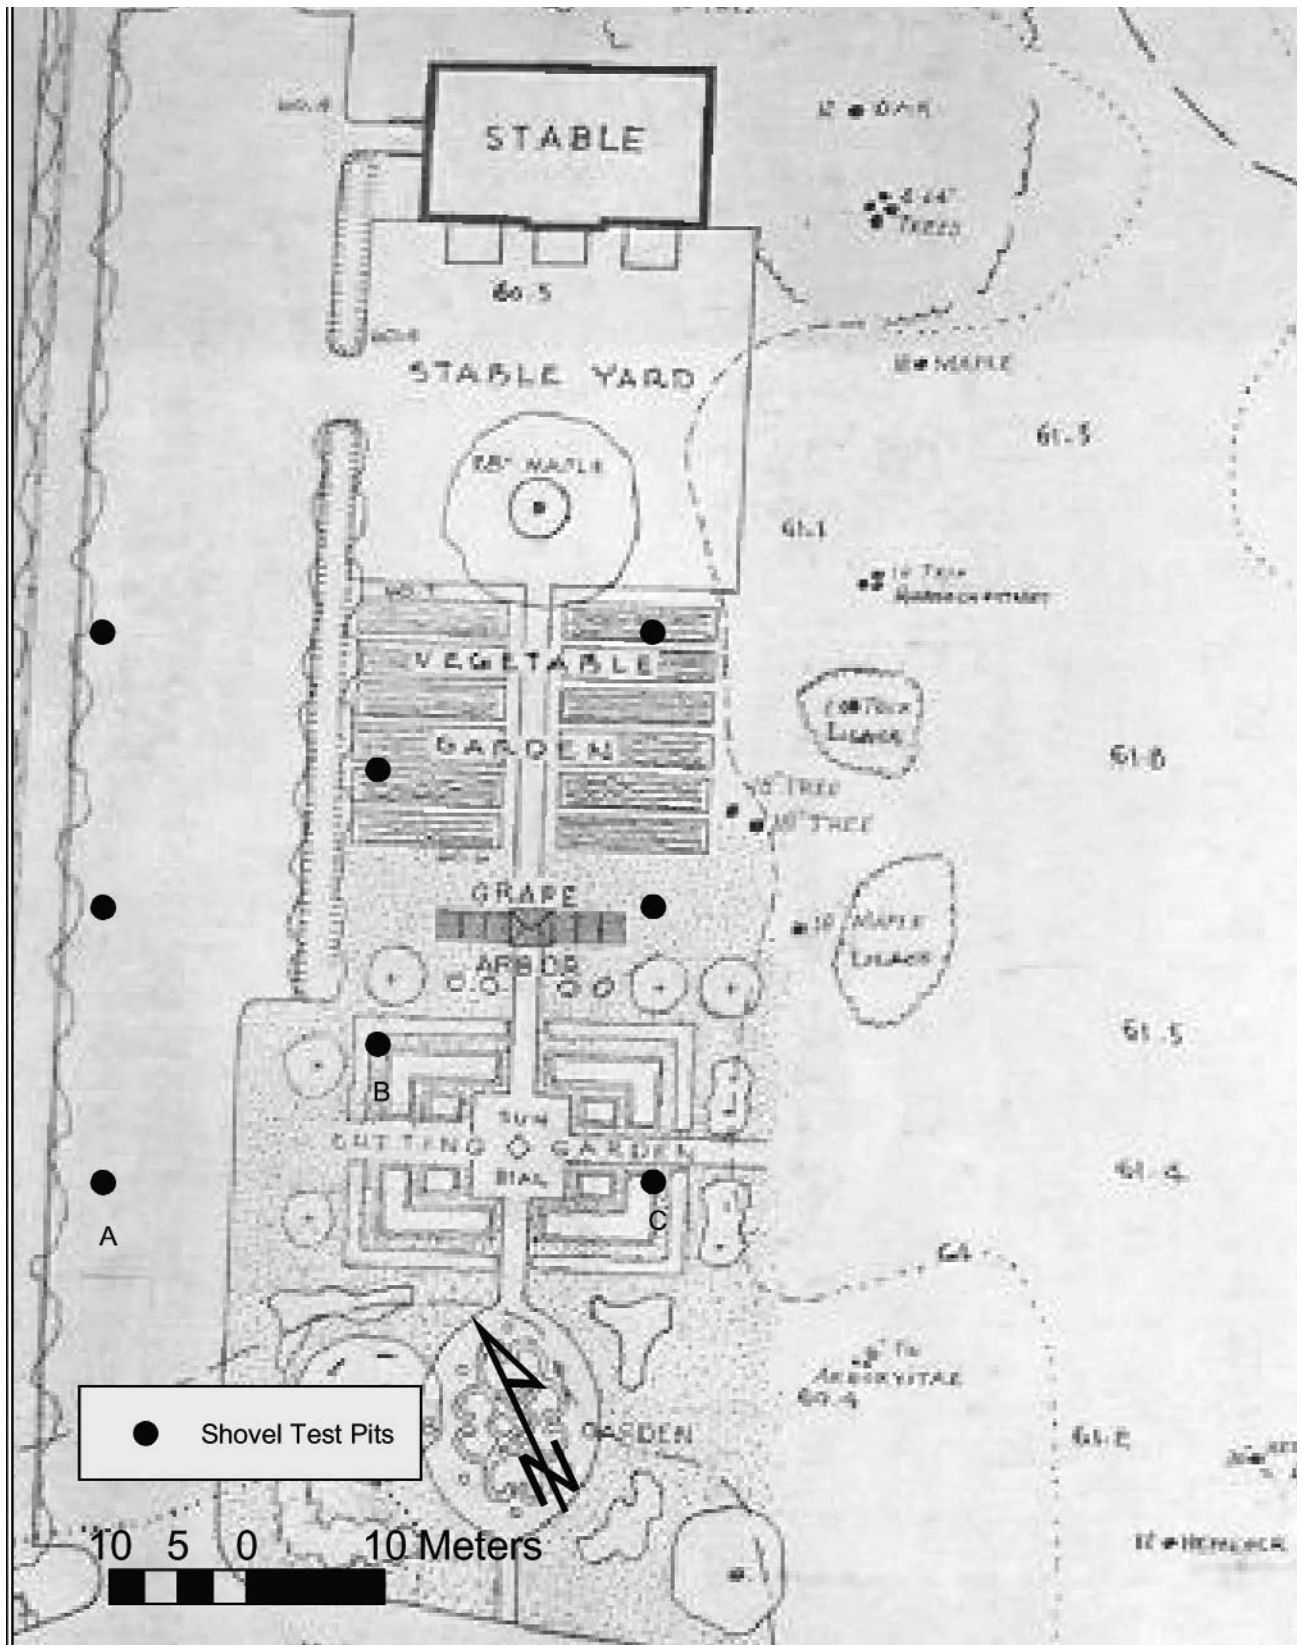
Figure IV.6. Archaeological Testing Plan for the Vegetable Garden

The three tests located in the parking area (STPs A1-A3 in Fig. IV.6) revealed between 25 cm (9.8 in) and 40 cm (15.7 in) of a yellow, medium sand bedding below 10 cm (3.9 in) of gravel. A1 revealed gray-brown coarse sand and gravel fill to a depth of 60 cm (23.6 in), while A2 and A3 revealed dark brown clay loam that extended to

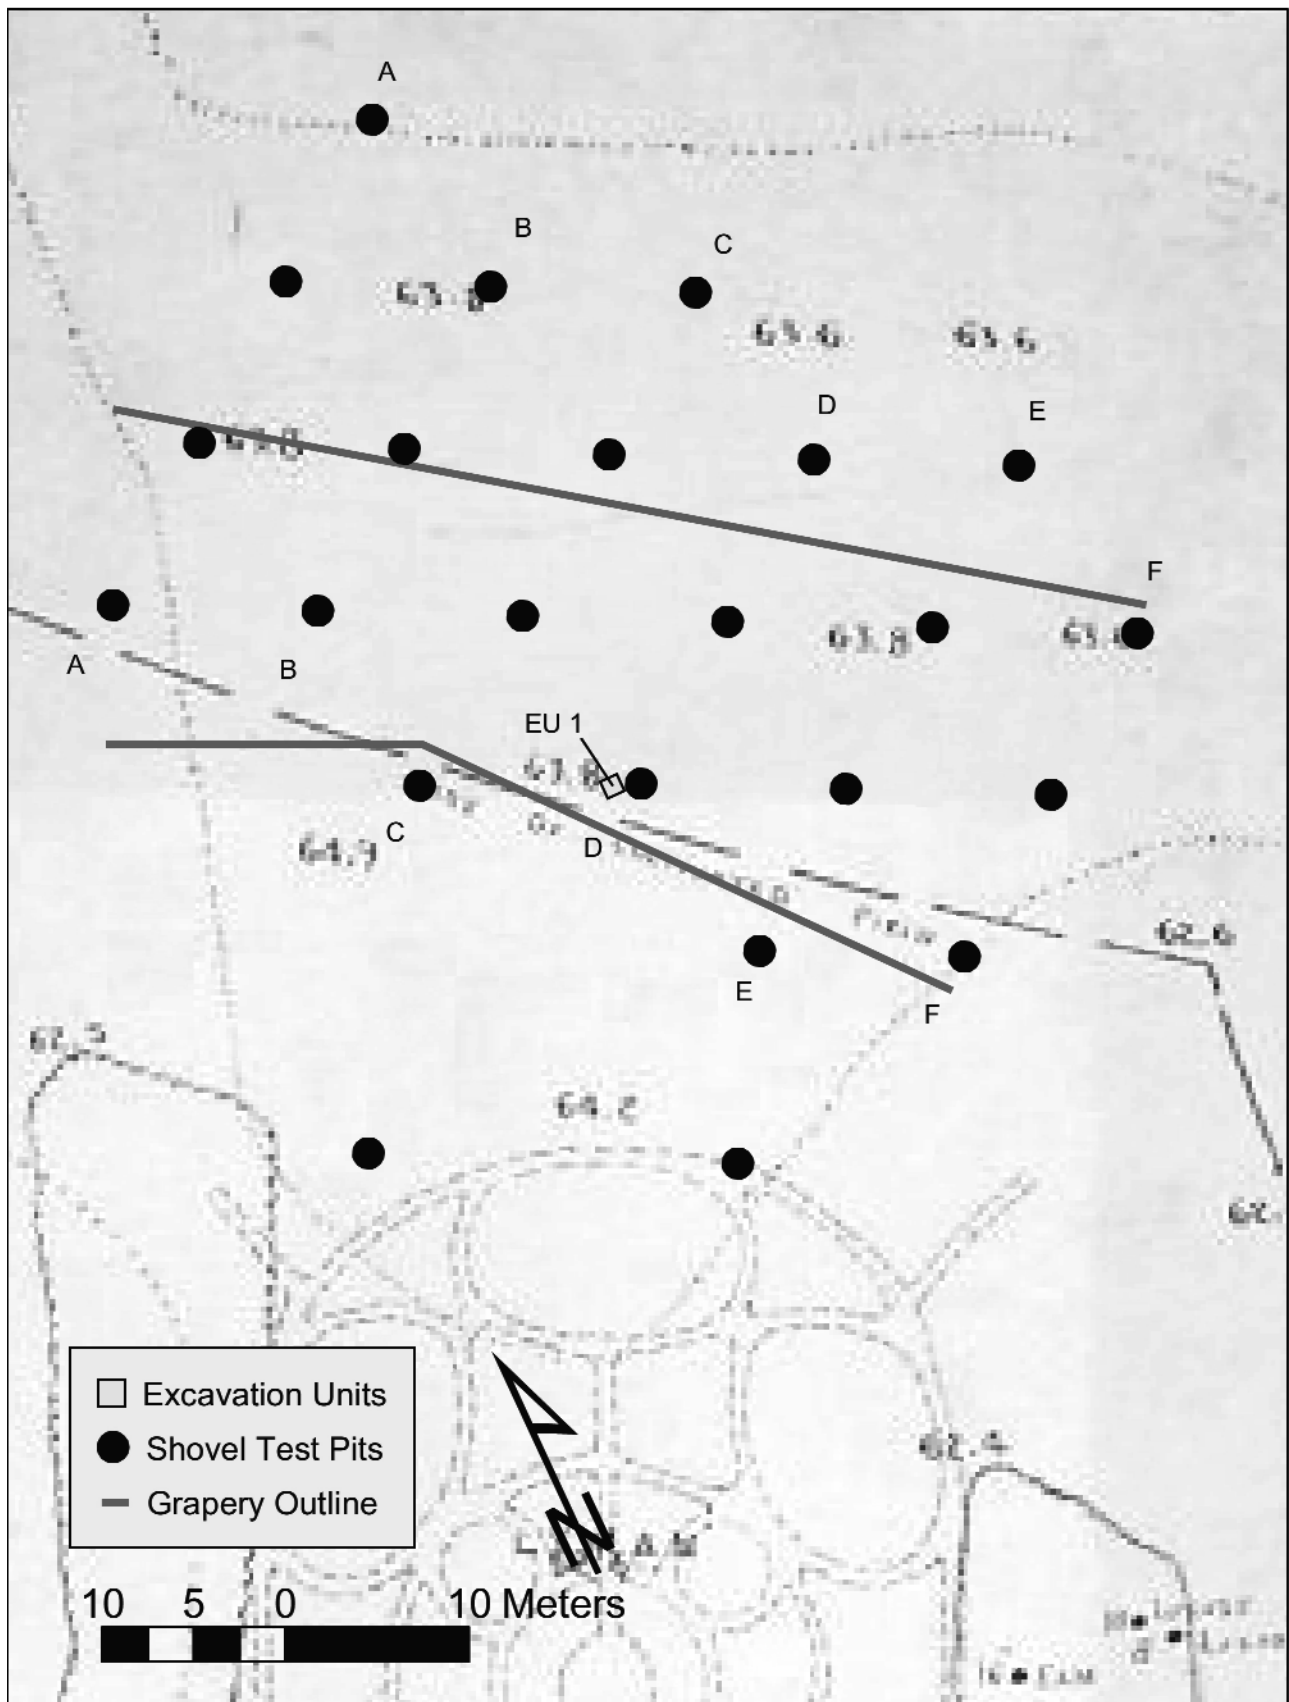
Figure IV.8. Archaeological Testing Plan in the Grapery/Fruitwall Area. Tests Between Lines Revealed Deep Grapery Greenhouse Soils.

Archaeological investigations in the grastery area revealed remnants of brick foundation in three of the shovel tests (C2, D1 and D2) and demolition debris in a number of others. Soil profiles also provided a general indication of areas that lay within and outside of the greenhouse structure (see Fig. IV.8). Tests believed to be located outside revealed a sandy loam A-horizon between 35 and 42 cm in depth. Below this was 10 cm (4 in) to 20 cm (7 in) of mixed transition sandy loam subsoil that overlay a sterile sand. These units were located across the north and northwest portion of the block. Shovel tests across much of the south and southeast portion of the block revealed deeper stratigraphic profiles and are believed to be located within the west wing of the greenhouse. Tests A1, A2 and B1 revealed a 70 cm (27.5 in) deep A-horizon that overlay mottled sandy loam. Tests immediately east (C2, D1 and D2) revealed foundation remains consisting of intact brick piers and possibly a stone foundation, while EU1 adjacent to D1 revealed a brick wall. These tests are believed to be located within the grastery greenhouse's central block. Tests E2, E3 and F1-F3 further east revealed an A-horizon between 50 cm (20 in) and 75 cm (29.5 in) in depth overlying a loamy sand subsoil. These tests may be inside the central block and/or east wing. Two of the southernmost tests, C1 and E1, revealed shallower stratigraphy amounting to an A-horizon 38-40 cm (14.9-15.7 in) in depth and these are believed to lie outside of the structure. A low density of historic artifacts was fairly evenly spread across the block of tests. Fragmented planting pots and window glass were present in all 21 tests. Creamware and/or pearlware was present in just under half of the tests, while whiteware was present in 17, amounting to 81% of the tests. Also present was a low density of burned glass and ceramic, as well as bottle glass, nails, and fragments of coal, oyster shell and bone (Fig. IV.20).

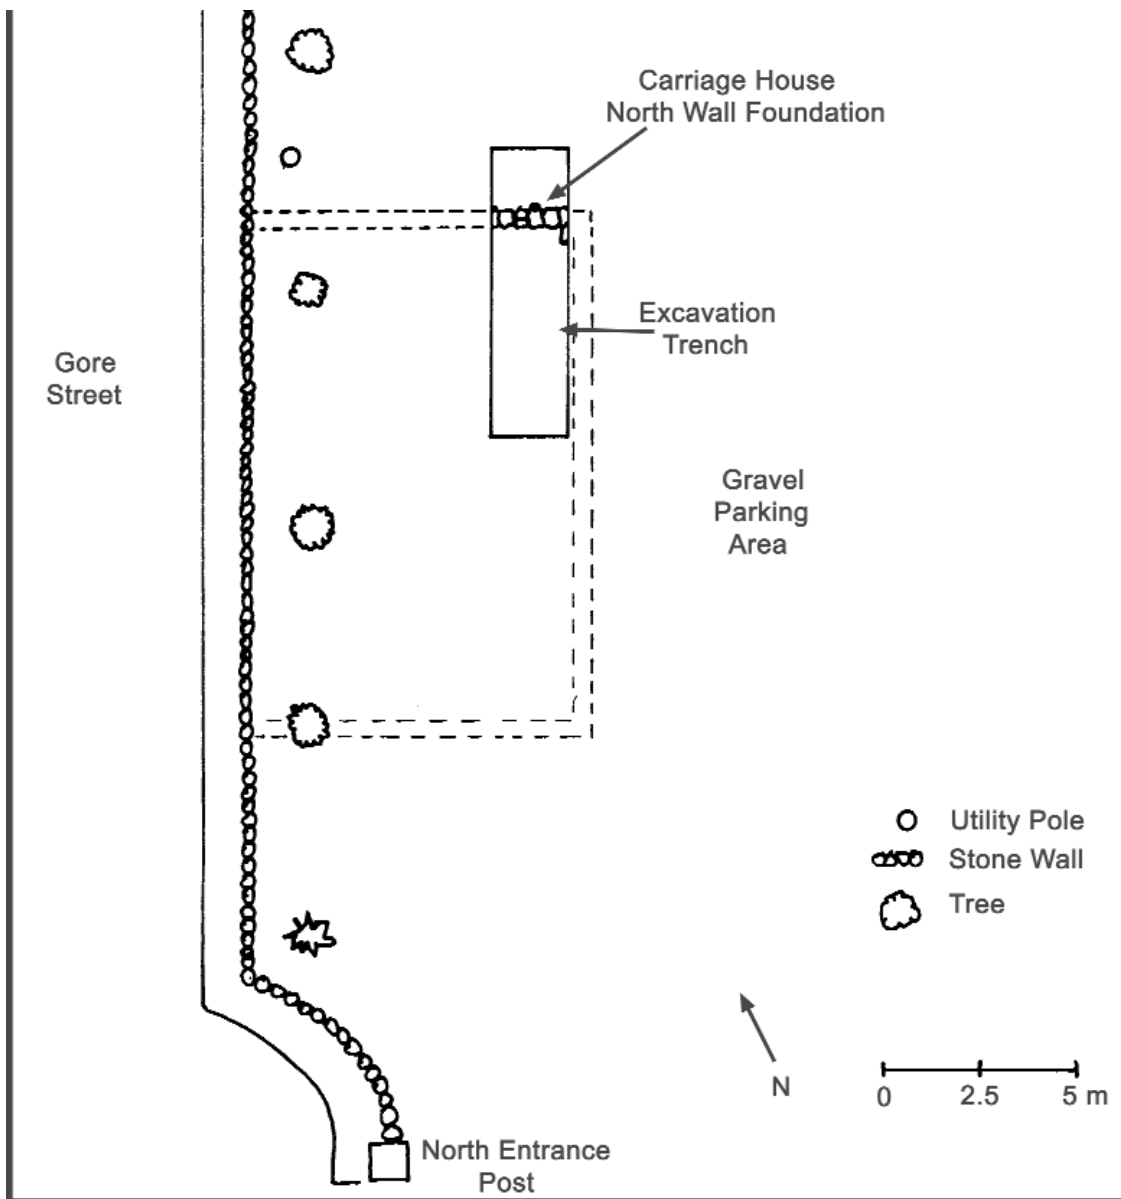
Figure IV.12. Location of Excavation Trench and Foundation Wall in the Carriage House Area.

The carriage house north foundation wall lies approximately 23.75 m (77.92 ft) north of the north entrance post and 1.25 m (4.10 ft) south of an electric utility pole (Fig. IV.12). The surface of the partially demolished wall lies between 1 m (3.28 ft) and 1.20 m (3.93 ft) below surface. Measurements suggested the cellar entrance in the east wall was just outside of the test trench that was located approximately 9 m (29.5 ft) east of the present western stone boundary wall. The foundation wall is constructed of large rounded boulders and angular foundation stones held together with mortar. Excavation revealed upper foundation stones to lie out of place on either side of the wall, with most having fallen or been pushed into the cellar's interior (Fig. IV.13). A small section of collapsed brick wall was also present in this area. Cellar fill consisted of a loose, medium brown sandy loam that also con-

tained stones and a few pieces of asphalt pavement. A small deposit of artifacts consisting of later nineteenth-century bottle and some window glass was encountered on the north side of the foundation wall at an elevation between 70 cm (27.5 in) and 100 cm (39 in) below the parking lot surface. After the foundation wall's location was recorded the excavation trench was back-filled.

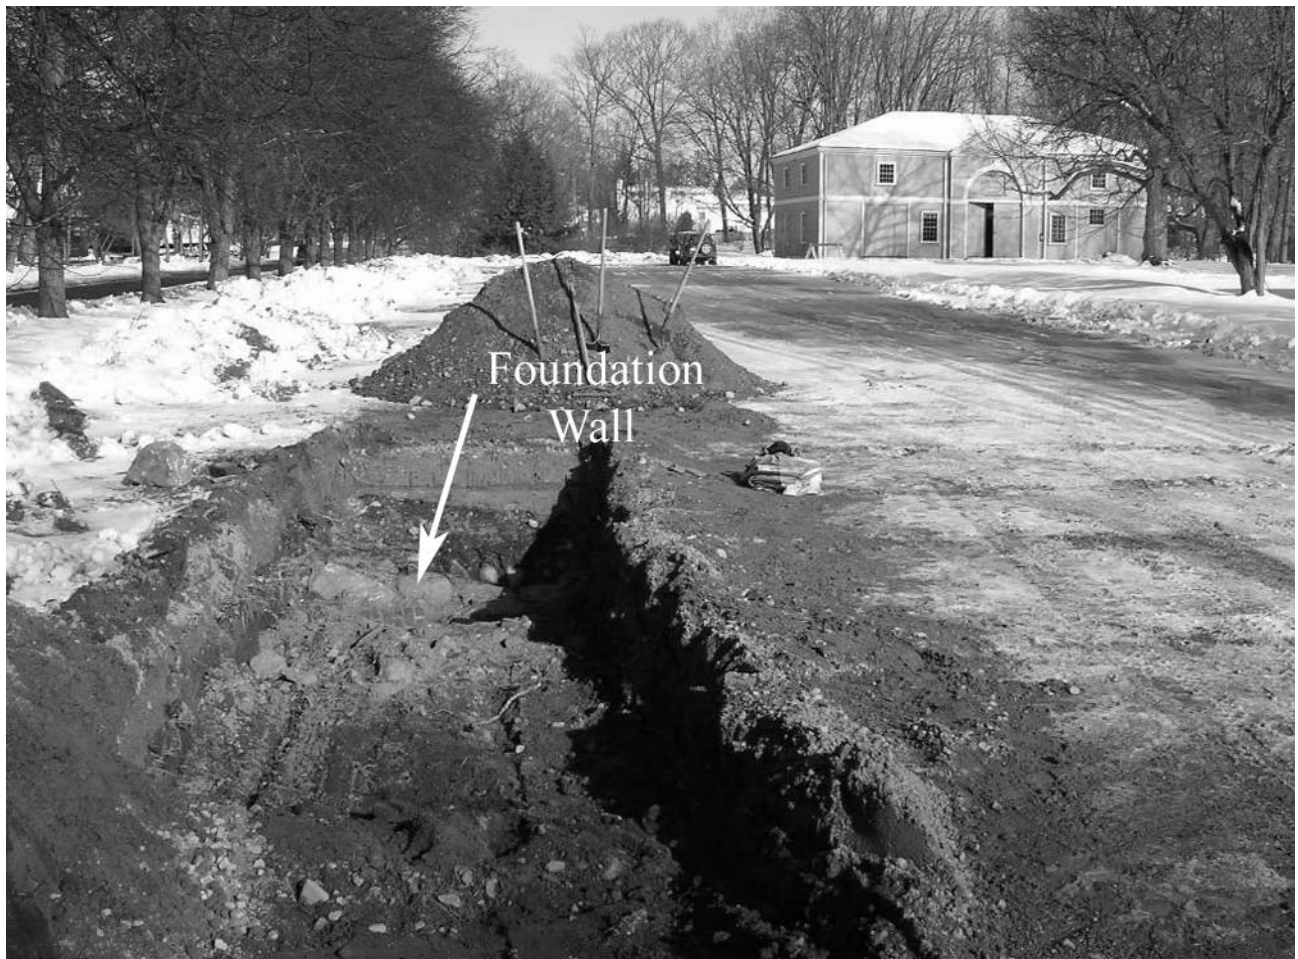
Figure IV.13. Carriage House Area Trench and Foundation Wall (facing north). Note post 1967 Carriage House location in background.

deposits. Loose foundation stones and a few brick fragments were encountered at a depth of approximately 90 cm (35.4 in) below the parking lot surface. An additional pass with the tractor followed by hand excavation revealed the carriage house north foundation wall right where it was supposed to be.

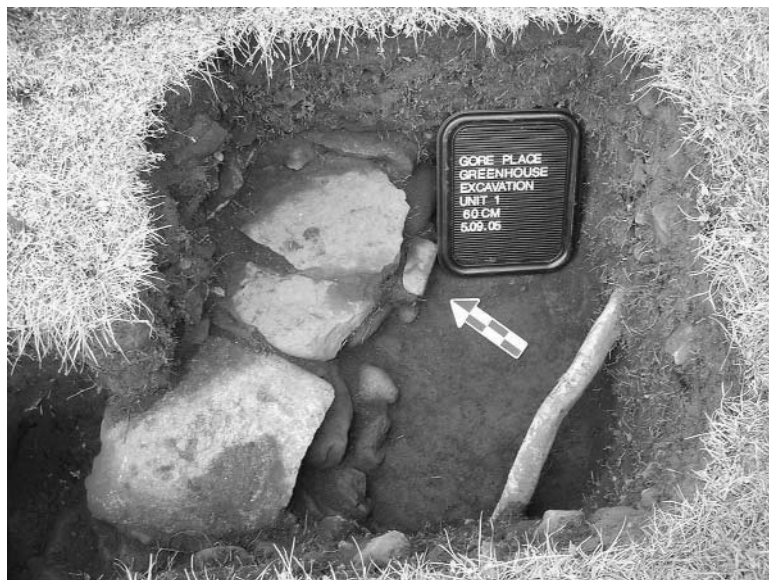
Figure IV.15. Stone-lined Drain Revealed in Excavation Unit 1 in the Greenhouse Area.

Stones interpreted to be possible structure foundations were encountered in STP C2 and F4. Unit 1, measuring 1 m x 1 m, was excavated immediately east of C2 to further explore this anomaly. The upper 40 cm of dark brown medi-

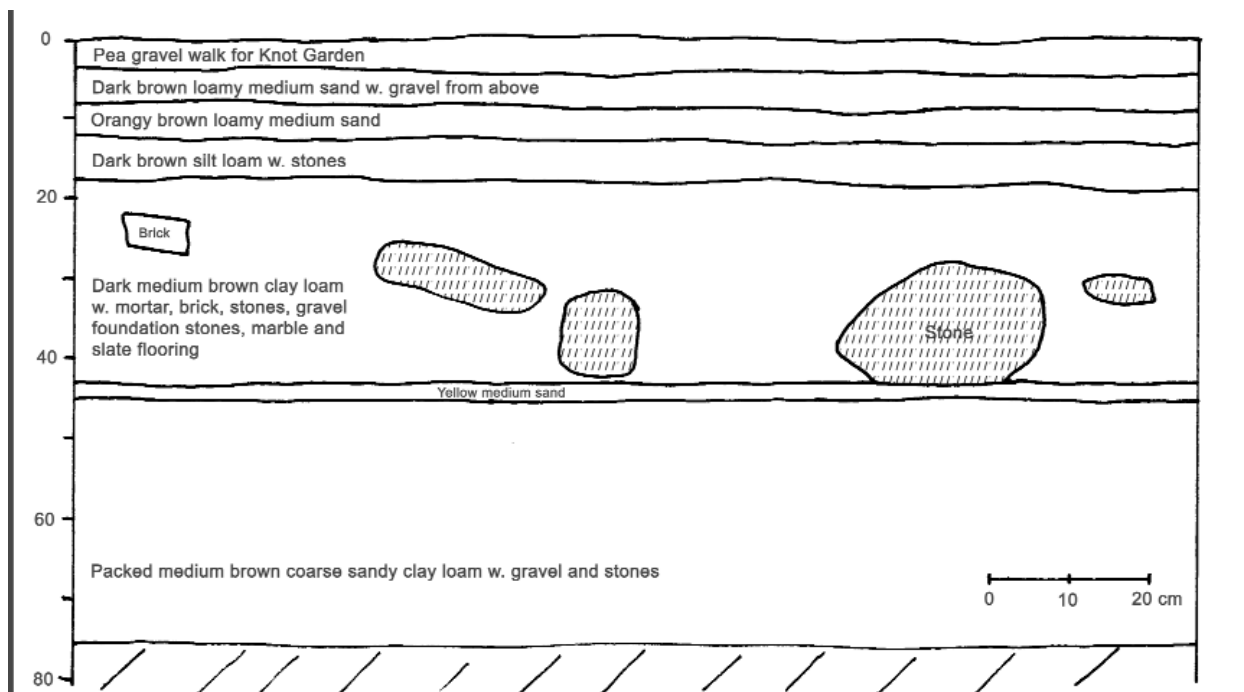
Figure IV.17. North Wall Profile of STP F4 Extension in the Greenhouse Area.

and possible foundation stones were first encountered in F4 at a depth of 18 cm (7 in) below surface. Work on the STP was halted until the unit could be expanded for further investigation. The completion of F4 and its extension revealed 25 cm (9.8 in) of medium brown clay loam containing demolition rubble consisting of fragmented plaster, mortar, brick, stones, gravel, possible large foundation stones and fragments of marble and slate floor tiles (Fig. IV.17). Also present was a low density of artifacts including planting pot and bottle fragments, nails, window glass, bone and coal. This was underlain by 2 cm (.8 in) of yellow sand that covered hard packed, brown coarse sandy clay loam with gravel and

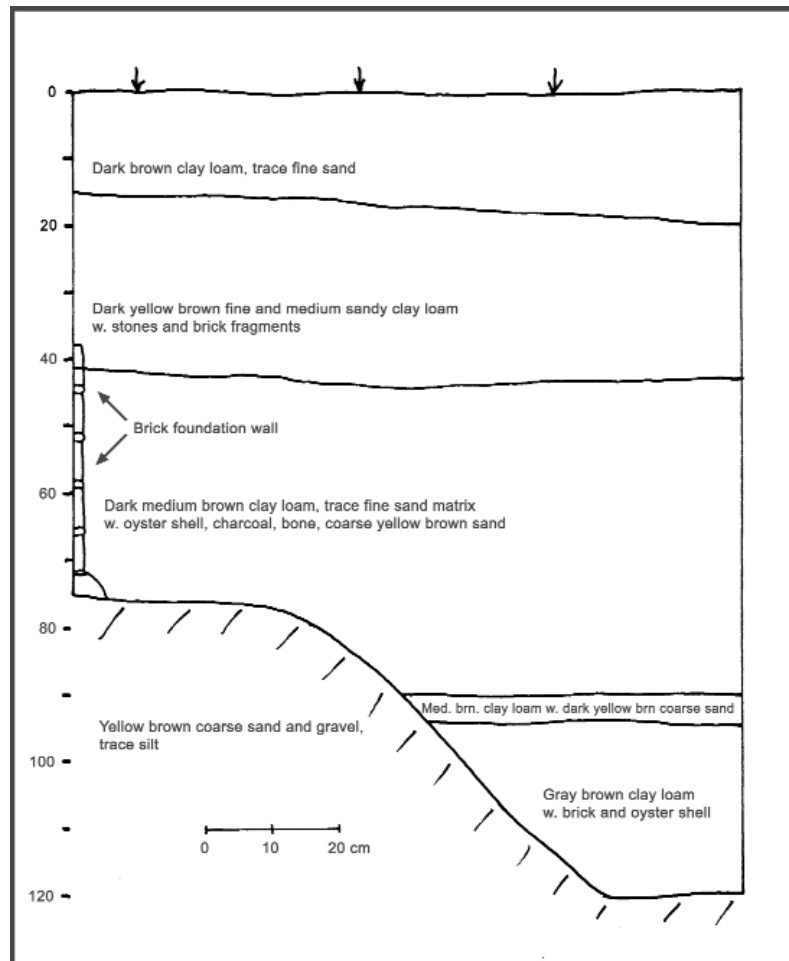
Figure IV.20. West Wall Profile of Excavation Unit 1 in the Grapery Area.

nents (Fig IV.21). The upper two strata consisted of 15 cm (5.9 in) of dark brown landscaping loam overlying 25 cm (9.8 in) of dark yellow-brown fine and medium sandy clay loam with stones and a small amount of demolition rubble. Below this was additional rubble and the surface of a brick wall and pier situated along the south unit wall. Excavation of the soil within (north of) the greenhouse foundation revealed 45 cm (17.7 in) of dark medium brown clay loam with a trace of fine sand. This matrix was mixed with oyster shell, charcoal, coarse yellow-brown sand and bone. Also present were a few brick fragments, roofing slate, window glass, stones and a few fragments of 4-5 in (10-12 cm) -diameter cast iron pipe. Below this was 4-5 cm (1.6-1.9 in) of medium brown clay loam with dark yellow brown coarse sand. The lowest soil deposit commencing at approximately 55 cm (21.6 in) was a dark medium brown loam slightly lighter in color than the main deposit above and contained fragments of brick, oyster and a few artifacts including a pipe stem and fragment of gray stoneware. This soil extends beyond a depth of 80 cm (31.5 in) from the top of the foundation wall and beyond 120 cm (47.2 in) from the present ground surface. All of the above soils are underlain by a dark yellow-brown, silty, coarse sand and gravel that extended as a flat surface northward from the base of the foundation wall and then dropped sharply downward (see Fig. IV.21).

The brick wall follows an east-west orientation and appears to represent the south foundation wall of the greenhouse's central block. The wall is two brick courses in thickness and is five courses in height, with the top course approximately 40 cm below the present ground surface. The wall was constructed on a stone sill topped with mortar. An interior brick pier extends approximately 46 cm. (18 in) northward from the wall, and what appears to be a separate brick pier is situated nearly 15 cm (5.9 in) to the northeast. The orientation of this second pier is slightly offset from the wall and pier immediately south, suggesting that it may have been constructed

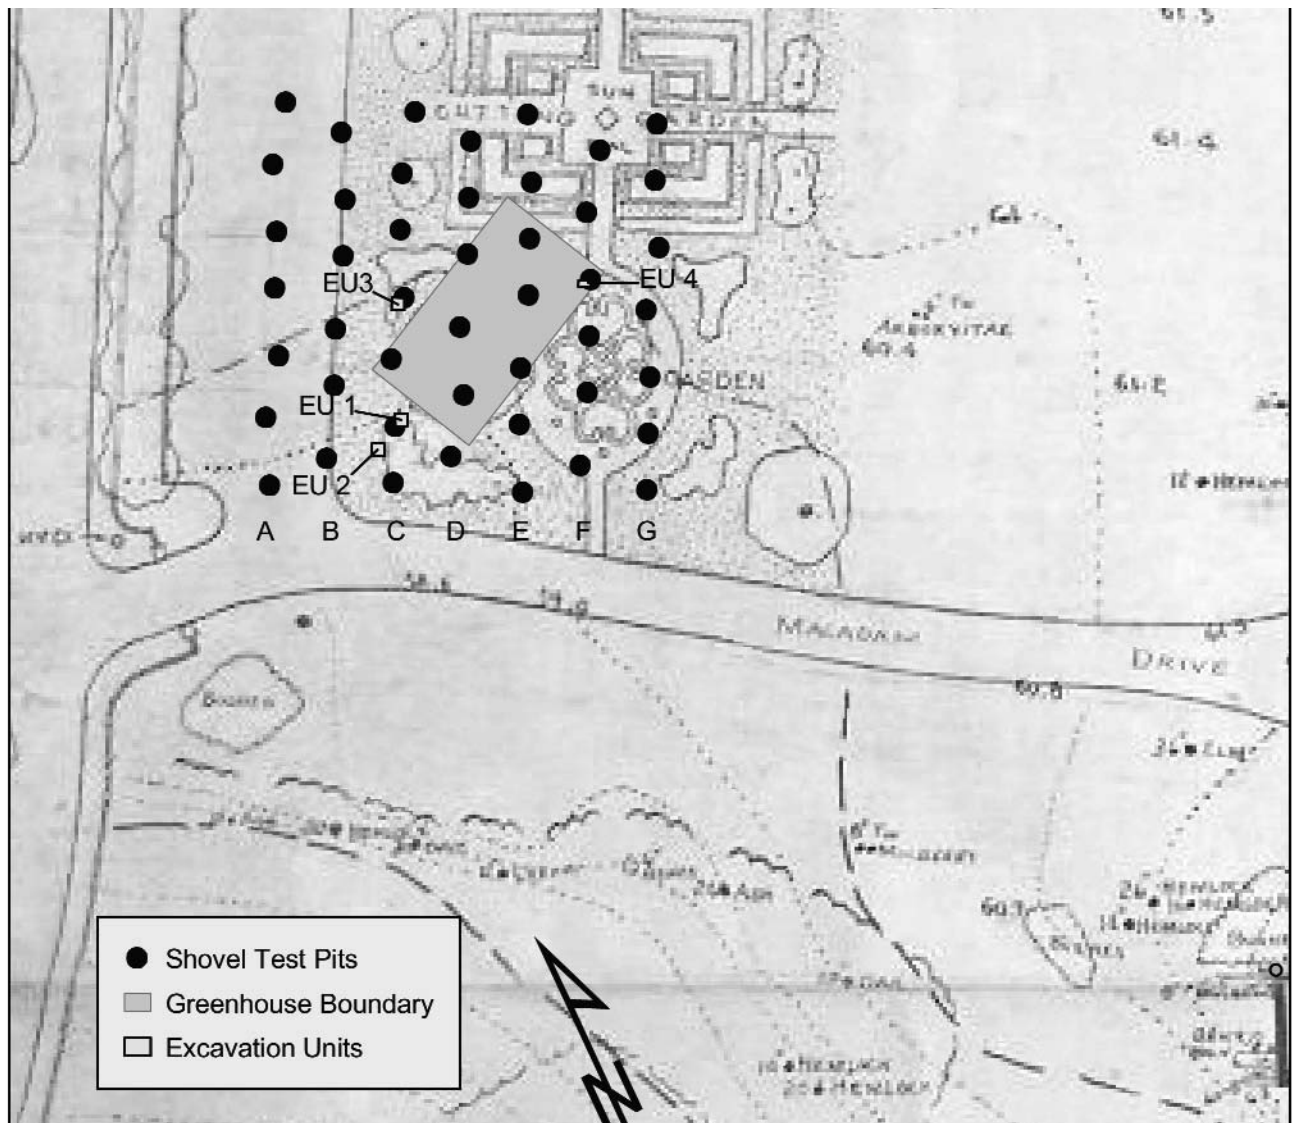
Figure V.3. Approximate Location of Greenhouse based upon Archaeological Findings.

Also discovered at the site was a stone-lined drain that appears to have extended beneath the long axis of the greenhouse (see Fig. V.3). Its presence is logical given the constant use of water in such a facility and given Gore's interest in designing adequate ventilation and drainage systems for the mansion house and grounds. Questions regarding access to this drain within the structure will need to be addressed by future investigations. The eastern extent of the drain is unknown. It is possible the drain also serviced the small structure northeast of the greenhouse that has been suggested to be a cold frame. The western extent of the drain is also enigmatic since it appears to terminate just outside of the greenhouse with no clear evidence for a catch or drainage basin other than a shallow depression. Soil staining that continued beyond the depression will need to be investigated further and may indicate that the drain structure was removed from this area.

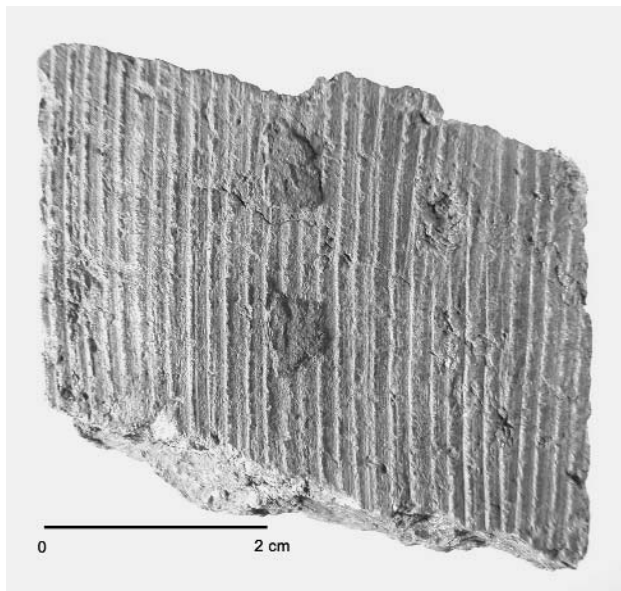
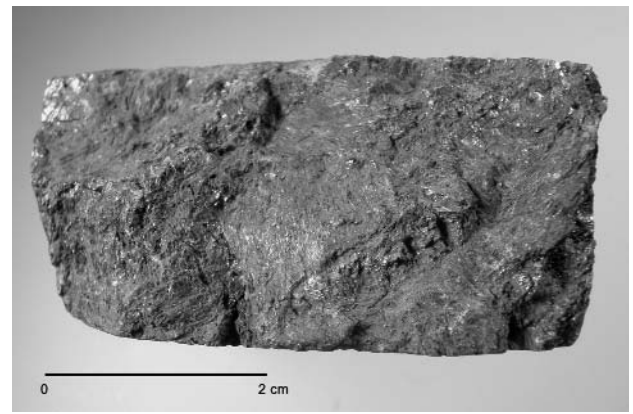
Figure V.6. Soapstone Brick Fragment Recovered from the Greenhouse Area. Striated surface (left) and brick profile (above).

While the heating design remains a question, the excavation revealed potentially important evidence of moisture creation within the greenhouse. Found within the structure's demolition rubble was the fragment of what appears to be a small or miniature brick made of cut soapstone

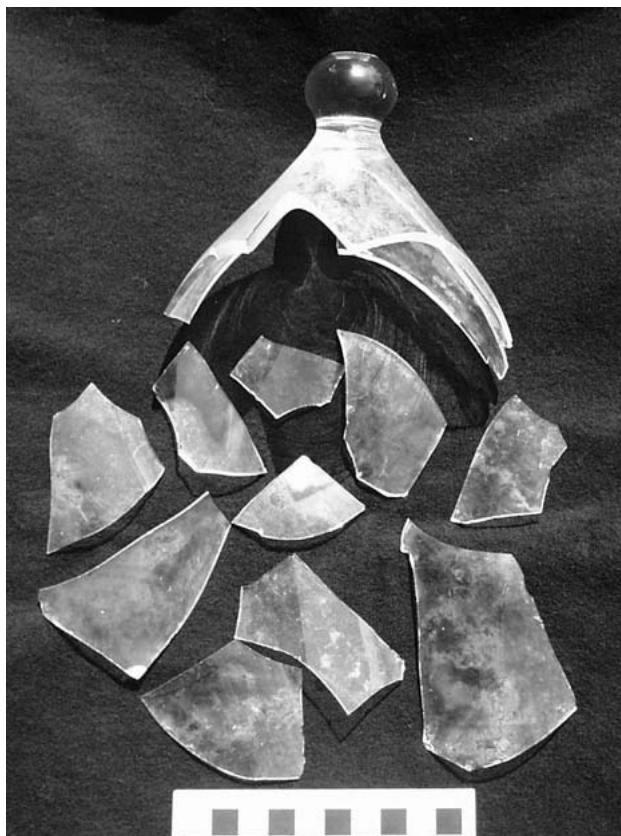
Figure V.7. Glass Bell Jar Fragments Recovered from the Greenhouse Area Drain.

Fragments of a glass bell jar that would have been used to cover moisture sensitive plants were found at the western end of the drain (Fig. V.7). The jar is of typical cylindrical form with a thin, sheared rim and thickened top or upper end that has a solid, oblong knob measuring 4.5 cm (1.25 in) in diameter. The jar's height is presently unknown. A cracked-off pontil scar is present at the top of the knob. The reason for the jar fragments at the end of the drain is unclear, but may have been placed there to help with drainage. The presence of the bell jar reveals the efforts to which the Gores and/or their gardener went to protect and propagate plants. It is not known if this jar was imported or produced locally, but such vessels were likely available
