An Emptying Village: Transformations in Architecture and Spatial Organization at Streamstown Village, Co. Galway

AN EMPTYING VILLAGE:
TRANSFORMATIONS IN ARCHITECTURE AND SPATIAL ORGANIZATION AT
STREAMSTOWN VILLAGE, CO. GALWAY

Historical Archaeology Program

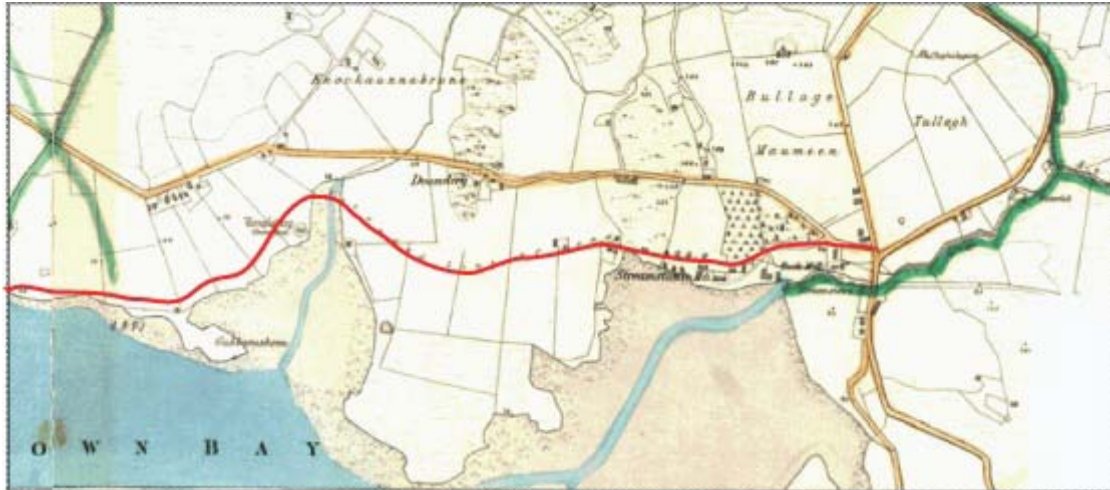
Figure 6.7: 1842 OS Map, Modern Road in Red, Pre-1850 Road in Yellow

When the government decided to shift the road closer to the bay and onto the other side of the hills at the southern end of the settlement, it cut off the interior village even further (Fig.6.6). The village is not visible from the southern road, and vice versa. The main house, schoolhouse, reverend's house, and orphanage were all directly off the road. These organized ventures into the community caused an institutionalization of the landscape which transformed the local built environment and the way people interacted with it. It additionally brought new people into the townland to run the school and orphanage, and with these people came new ideas about expectations of the materialization of daily life. The children in the townland were exposed to the teachings of the ICM, and brought those lessons back home to their parents. It brought a new element to daily life and changed community dynamics after 1850.

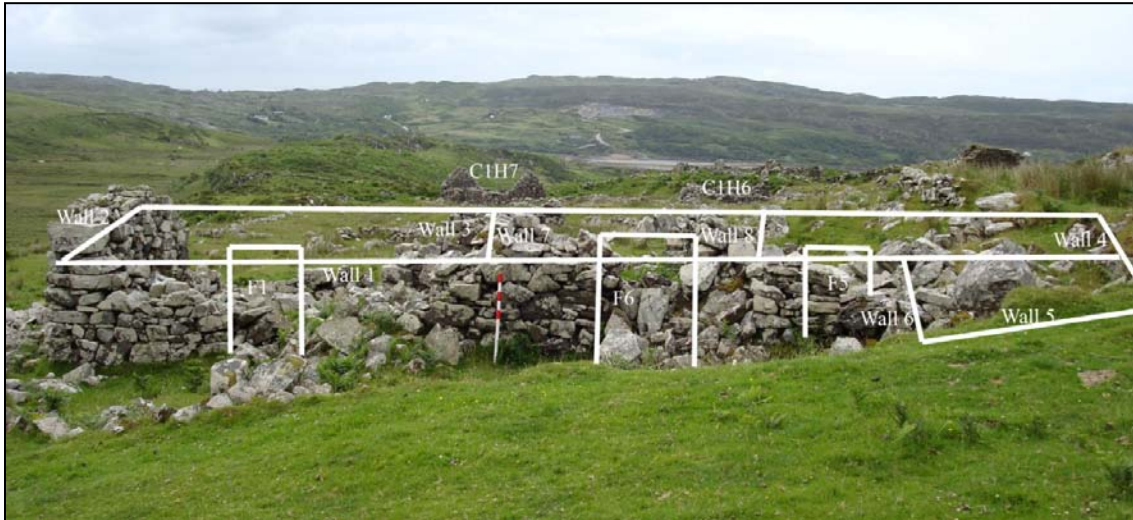
Figure 7.1: House 1, Carmacullev, Facing South, Scale Bar = 1 meter, 2007

The two interior walls consist of smaller stones. Walls 4 and 6 come directly into the side of the slope, with the ground level higher on the exterior of these walls, although it is not clear if this is a result of taphonomic forces (slumping earth) or was deliberately built directly into the side of the slope. There is no evidence of a chimney or hearth, and no windows are preserved in the walls.

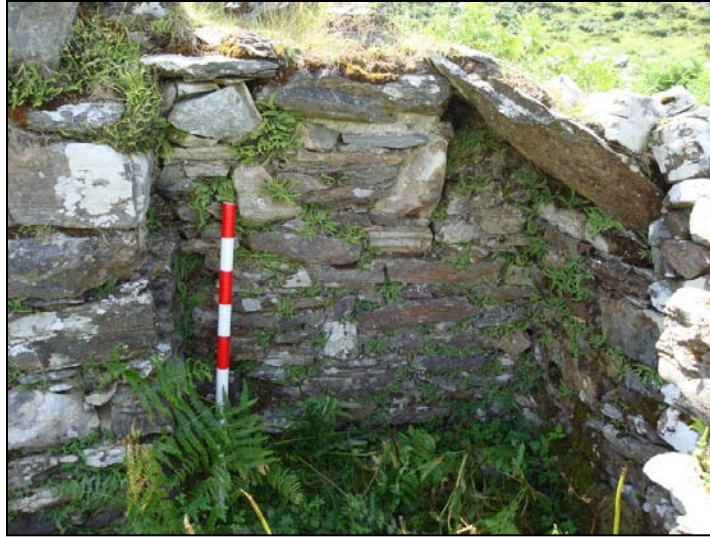
There are two unaligned exterior doors (which is uncommon), neither with lintels preserved. A large niche, with mortar lining the interior, is on the same wall as the blocked fireplace. In the bed outshot (Walls 5, 6, and 7), thick mortar bonds the stones, which are smaller than those in the rest of the structure (Fig. 7.4). The house also has large blocked-in large fireplace and chimney. This is characterized by two large lintel-like stones on either side with a narrow gap in the middle where another lintel perhaps lay at one time, before it collapsed and subsequently refilled. The walls on either side abut the fill in, and the filled in area gets narrower as it gets higher.

Figure 7.4: House 8 Outshot, Carmacullev, Facing West, Scale Bar = 1meter, 2008

There is a window in the outshot with a stone lintel (not pictured). Each side of the window does not line up with Wall 6 or Wall 1 like the lower part of Wall 7.

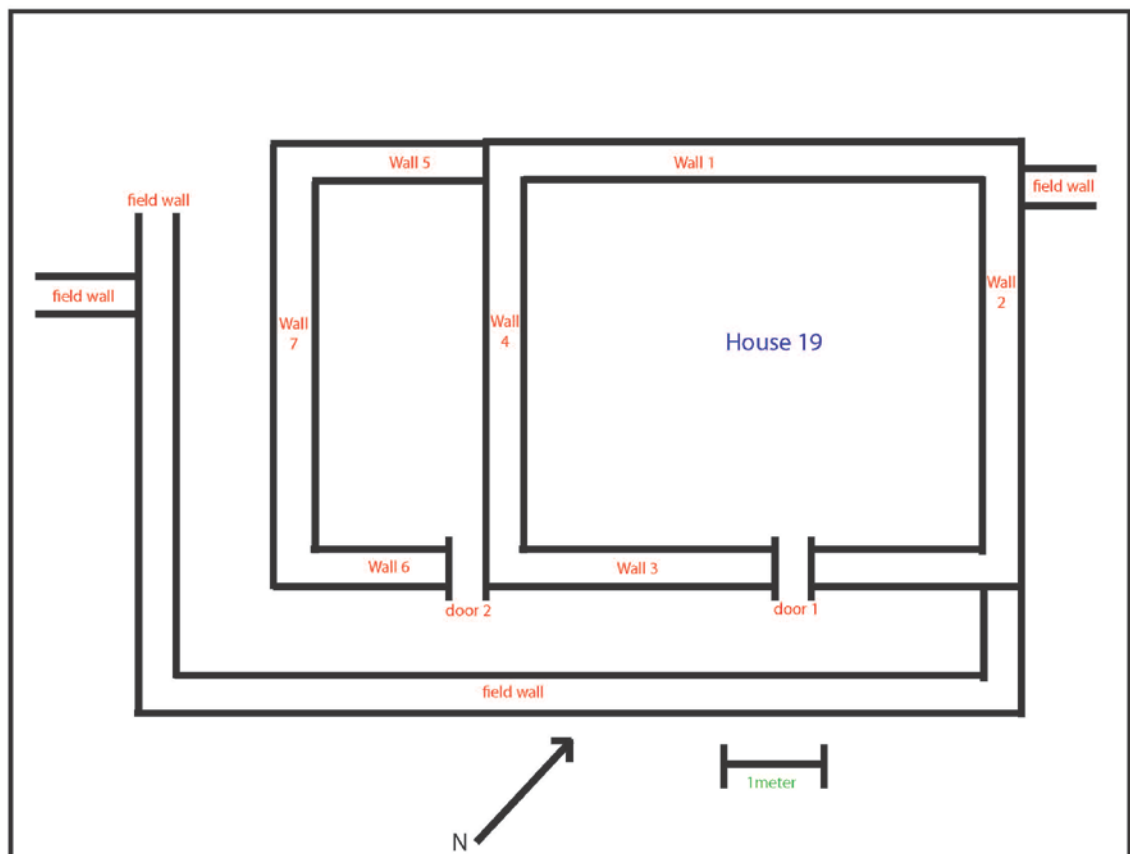
House 19 is two-roomed structure in Drumgarve. It has a total area of 33.95m². Many field walls run close to the structure – one field wall abuts Wall 2, and another abuts Wall 3. A field wall runs parallel to Wall 7 and another runs parallel to Walls 3 and 6. The roof is an A-frame with slotted gables, which could indicate the roof was originally thatched. The stones of the walls have dry stone construction with some mortar fill. There are two exterior doors, neither with a lintel preserved, each opening into a single room.

Figure 7.5: House 19 Floor Plan, Drumgarve

The first phase of this house is the construction of the original one room structure. The second phase is the construction of the addition created by Walls 5, 6, and 7. This addition, as per Aalen and Whelan's house typology (1997), would have been for agricultural storage or livestock holding. It is uncertain when in the phasing the construction of the field walls occurred, although it was clearly after the original one-roomed structure since the field walls abut the exterior of the structure. Griffith's Valuation lists the house as unoccupied as of 1855.

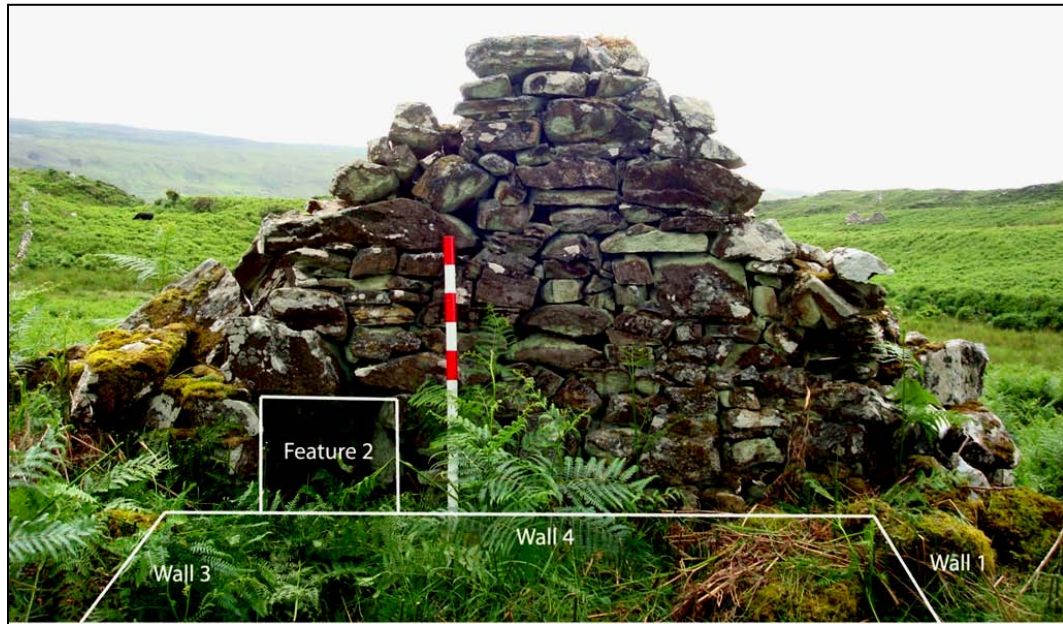
although these both contributed to its present state of breakdown. The house is significantly robbed out and poorly preserved, and barely anything remains of Walls 1 and 3. Additionally there is a large tree growing out of the hill into Wall 2.

Figure 7.6: House 22 Wall 4, Drumgarve, Facing West, Scale Bar = 1 meter, 2008

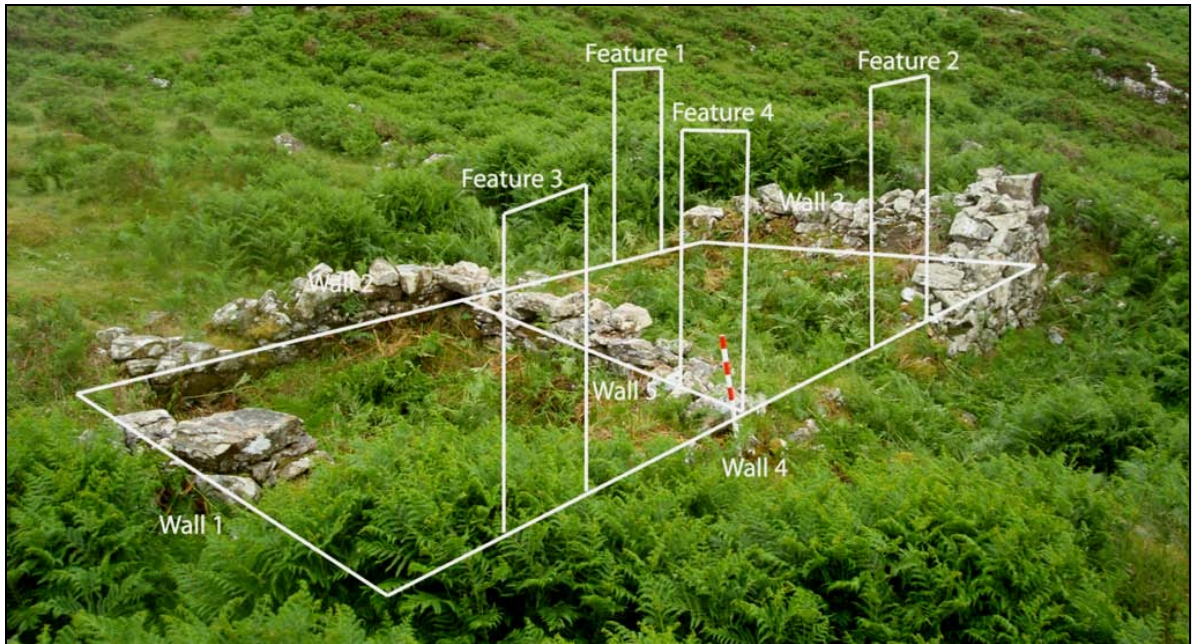
House 34 is a two-room structure in Drumgarve with a total area of 43.70m^2 . The location of the house is on the top of the main ridge and it is somewhat isolated from the other structures. Its position is in an area where land sloping creates protection for the structure. There are also some nearby field walls, one which abuts Wall 1. Others run parallel to Walls 1, 3, and 4. The roof is not preserved. It had no occupants listed in 1855 and had a 'T'-shape on the corresponding map, indicating someone dismantled those extensions after this time.

Figure 7.7: House 34, Drumgarve, Facing Southeast, Scale Bar = 1 meter, 2008

The walls have dry stone masonry. There are no chimneys or windows present since the remaining walls are too low to detect. There are three exterior doorways, one set parallel to one another. All doors are largely destroyed, and none have lintels intact. Feature 4 is also a mostly destroyed feature in Wall 5, possibly a door. The first phase of the house is the construction of the exterior walls, and the second phase is the construction of the interior abutting wall. The structure is mostly robbed out (Fig. 11) with only very low walls remaining and very few loose stones remaining in the immediate vicinity.

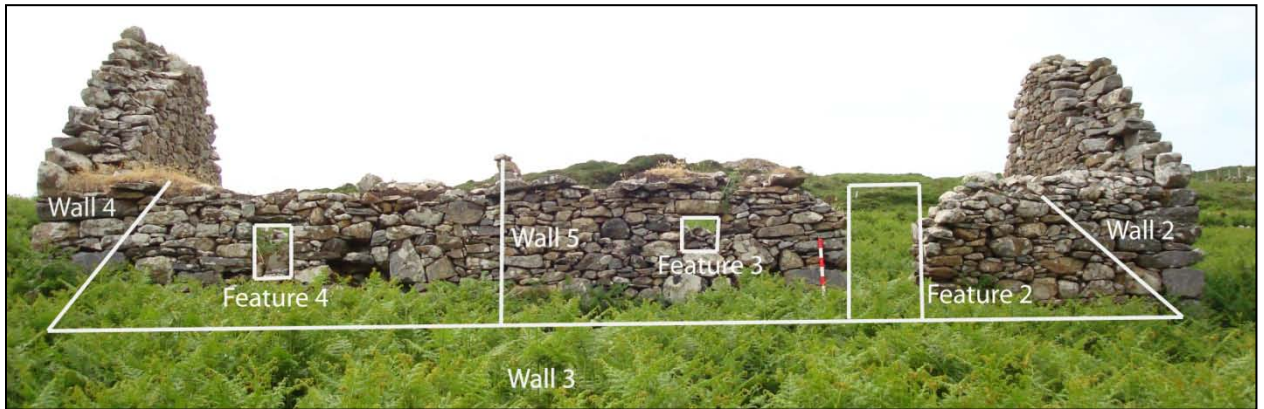
his house at 5 shillings. The Valuation lists no outbuildings. Additionally, the map shows the house oriented north-south, and not east-west like the modern remains.

Figure 7.9: House 17, Knockannabrone, Facing North, Scale Bar = 1 meter, 2008

The house superstructure misaligns with the foundation at the western end. There are grooves for a loft on the western wall. The interior wall is partially collapsed, but signs of a large fireplace remain on both sides. The fireplace in the unlofted room possibly had a flue, but access was blocked by collapse. The house has two exterior doors, running parallel to one another. Neither has a preserved lintel. There is one interior door, also without a lintel. There are also two windows, both trapezoidal and facing the bay. One has a wooden lintel, and the other lintel is stone. A wooden lintel provided additional support the stone material above the opening. The poor preservation of wood, however, prevents us from knowing to what extent stone lintels may have been further supported by wooden lintels.

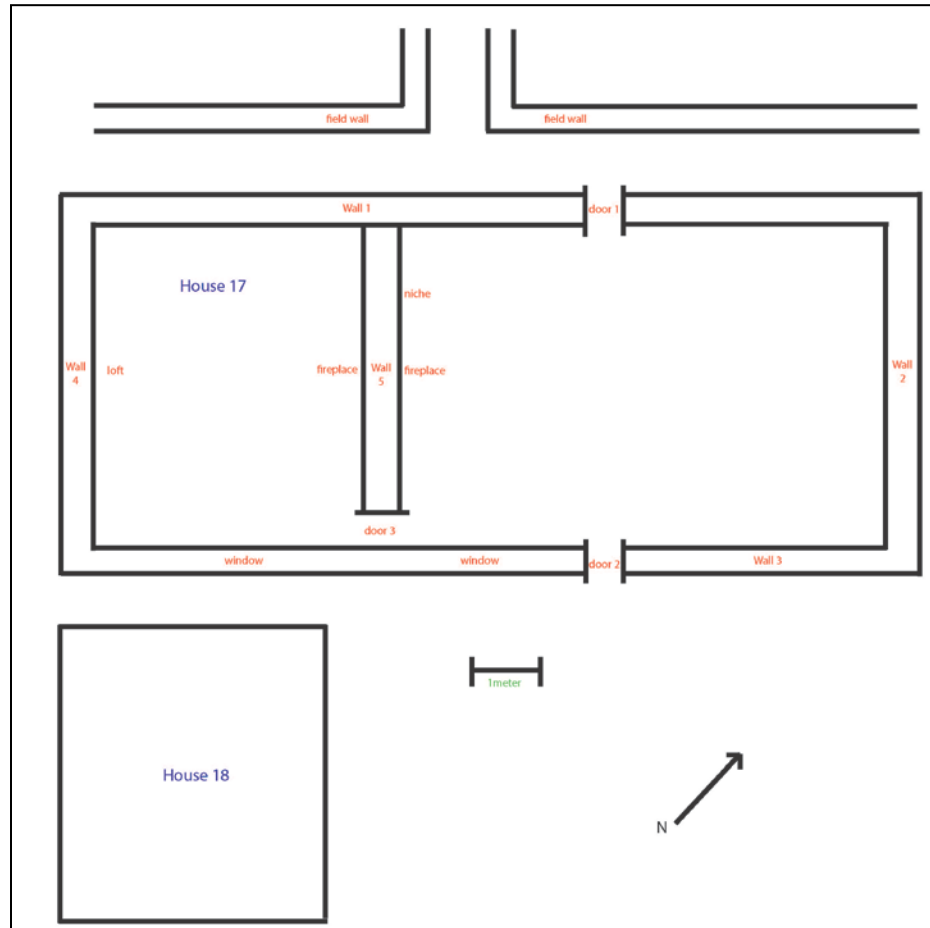
third phase is the construction of the interior wall. The preservation of this house is very good, and there is little evidence for robbing of stones.

Figure 7.10: House 17 Floor Plan, Knockannabrone

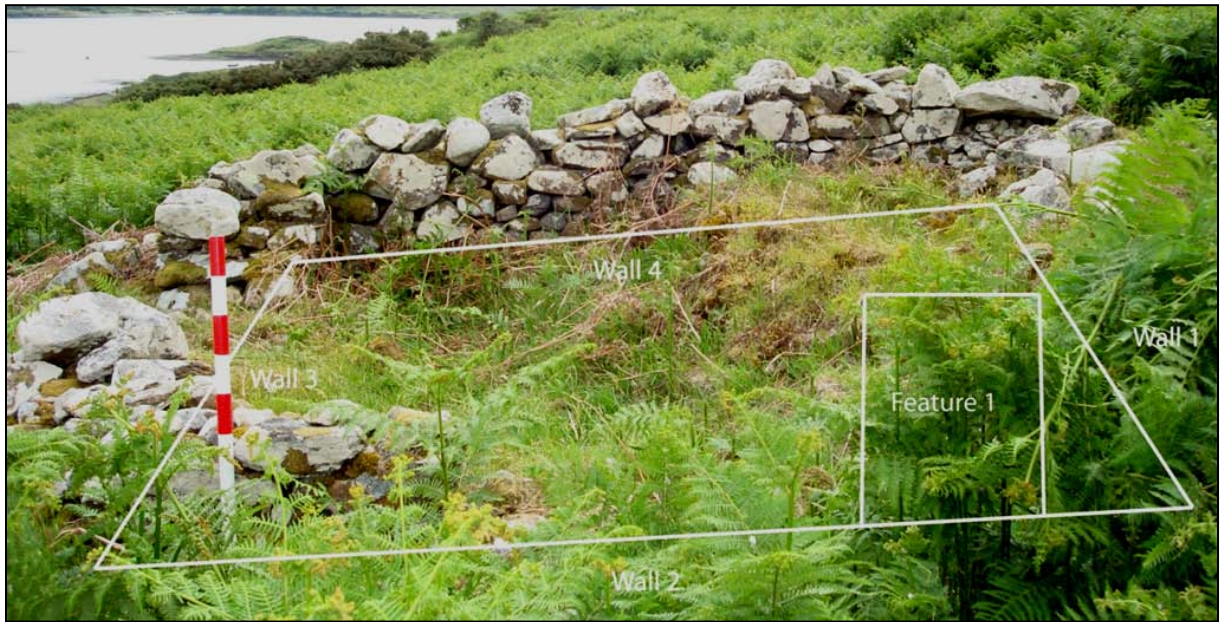
potential exterior door on Wall 2. The remains suggest a single phase of construction for the entire building.

Figure 7.11: House 18, Knockannabrone, Facing West, Scale Bar = 1 meter, 2008

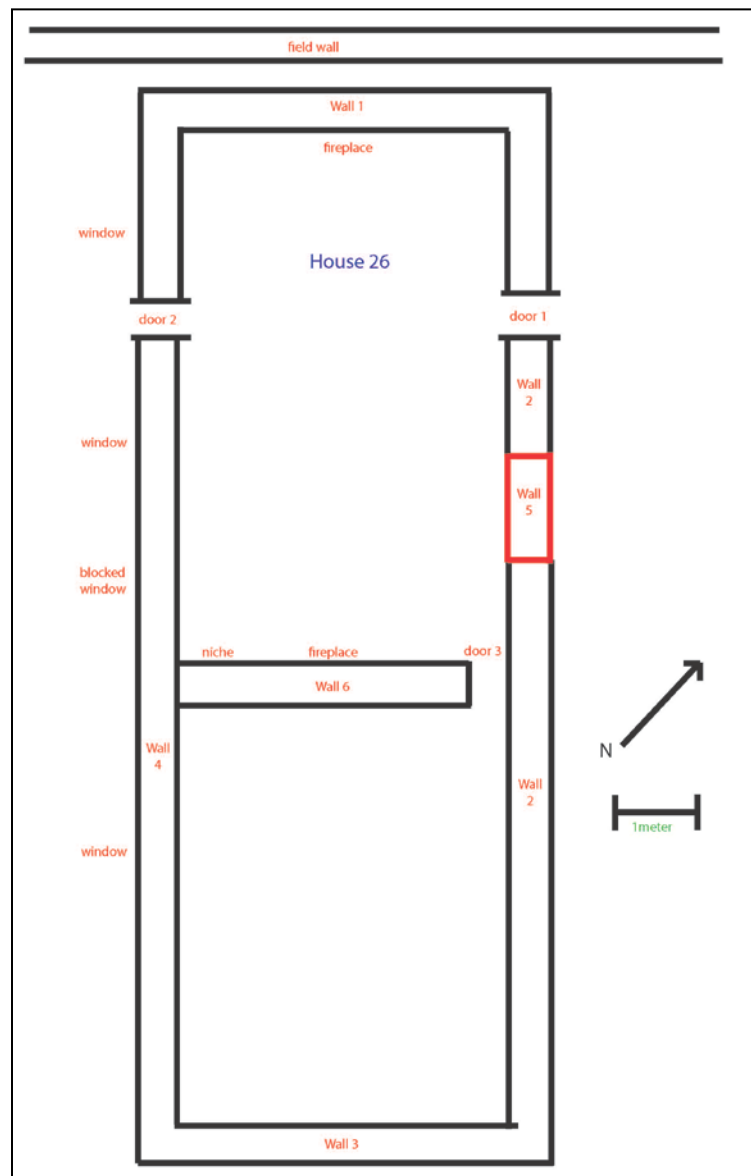
door. It also has four windows. One window is tightly blocked with a stone sill and lintel still visible. Two of the windows are trapezoidal, both with stone sills remaining. Of these windows, one has a stone lintel, and the other lintel is wood. The other window is mostly collapsed.

Figure 7.12: House 26 Floor Plan, C-Area

The house has two chimneys. The chimney structure on Wall 1 has a metal lining. There are also two corresponding fireplace features, a small one with a stone lintel on an

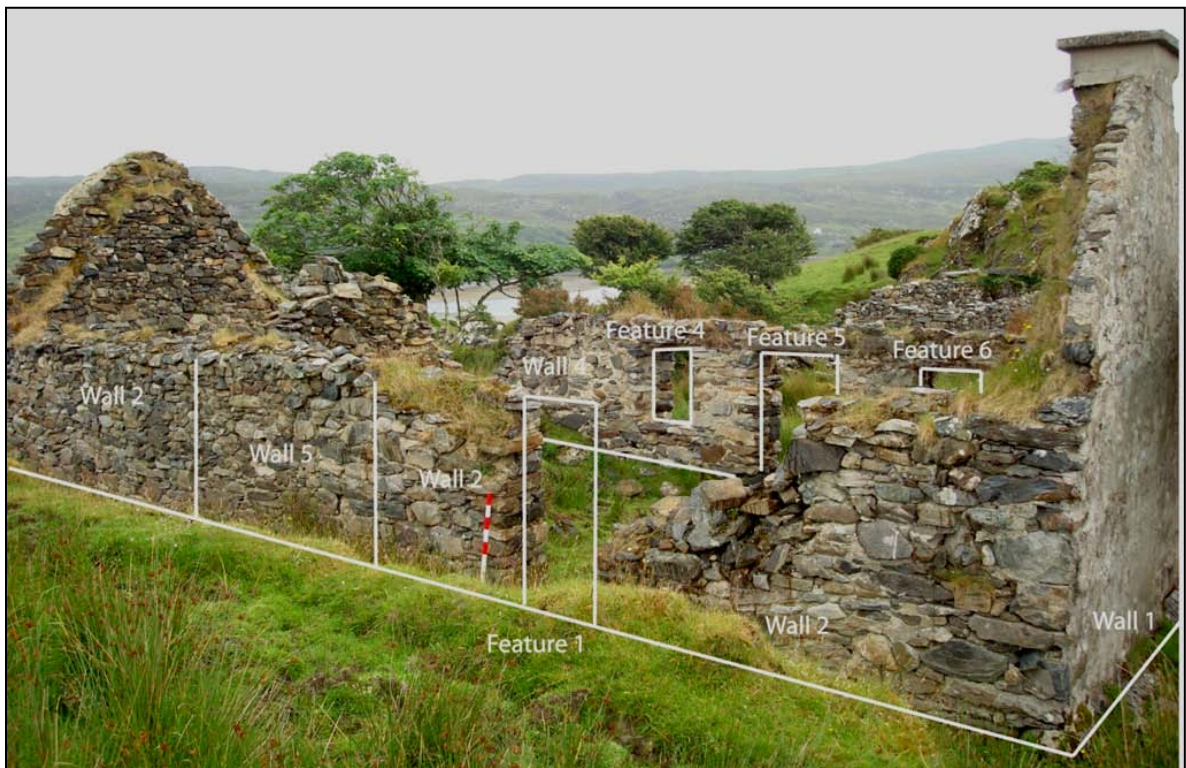
exterior wall and the other much larger, on the interior wall with some pieces of wood extending from it. Near the fireplace is a tall niche, stretching from the floor to almost the height of the fireplace. There is a horseshoe in one of the walls, as well as some barbed-wire visible and rebar surrounding the top of the chimney structure. There are also industrial-made bolts stuck in Wall 1, 2, and 4. These particular materials suggest cattle may have been kept in the house and tethered to these bolts. This is common in older structures, as demonstrated by the cow byre in late 18th and early 19th century structures (Whelan 1997), but surprising in a home constructed after 1850.

Figure 7.13: House 26, C-Area, Facing Southeast, Scale Bar = 1 meter, 2008

The first phase of the house is the construction of the exterior walls. The second phase is collapse of Wall 2 and the subsequent rebuilding of the section as Wall 5. The third phase is the construction of interior Wall 6. The fourth phase is the filling in of

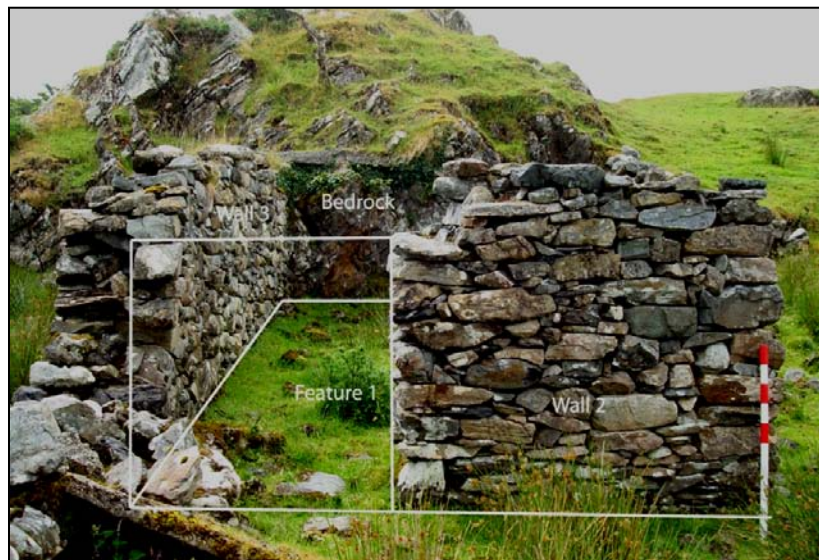
House 27 is a one-room structure with a total area of 29.25m². Proximity to House 26 and size of House 27 suggests that House 27 was an outbuilding. The roof of the structure is a straight slant and comprised of corrugated tin and cement. It is the only structure with remains of a tin roof at Streamstown. The walls have dry stone construction with mortar filling. One of the walls is bedrock and the other three walls built around it. There is an unusually wide exterior door, without a lintel. The remains suggest there was only one phase of construction. Maps show an unoccupied structure in this location in 1855, but there are no signs of it today. It was perhaps entirely deconstructed for source material to build House 26, with some portions used to reconstruct this as a shed.

Figure 7.14: House 27, C-Area, Facing West, Scale Bar = 1 meter, 2008

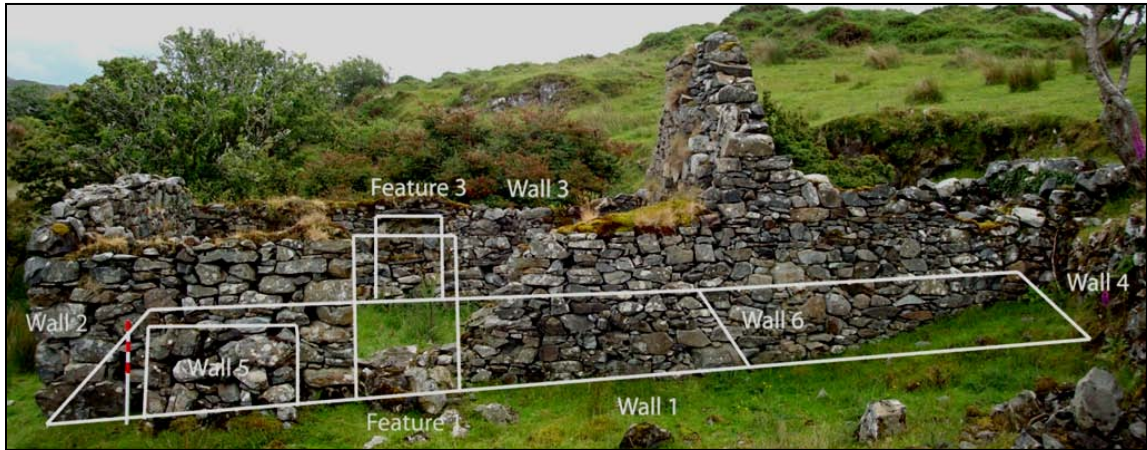
House 29 is a two-roomed structure with a total area of 57.50m². It is five meters to the south of House 30. A field wall abuts Wall 1 at the intersection with Wall 4, which also abuts House 30. There is no roof preserved. The walls were built using dry stone masonry with mortar fill. The house has one chimney connected to one fireplace.

Figure 7.15: House 29, C-Area, Facing South, Scale Bar = 1 meter, 2008

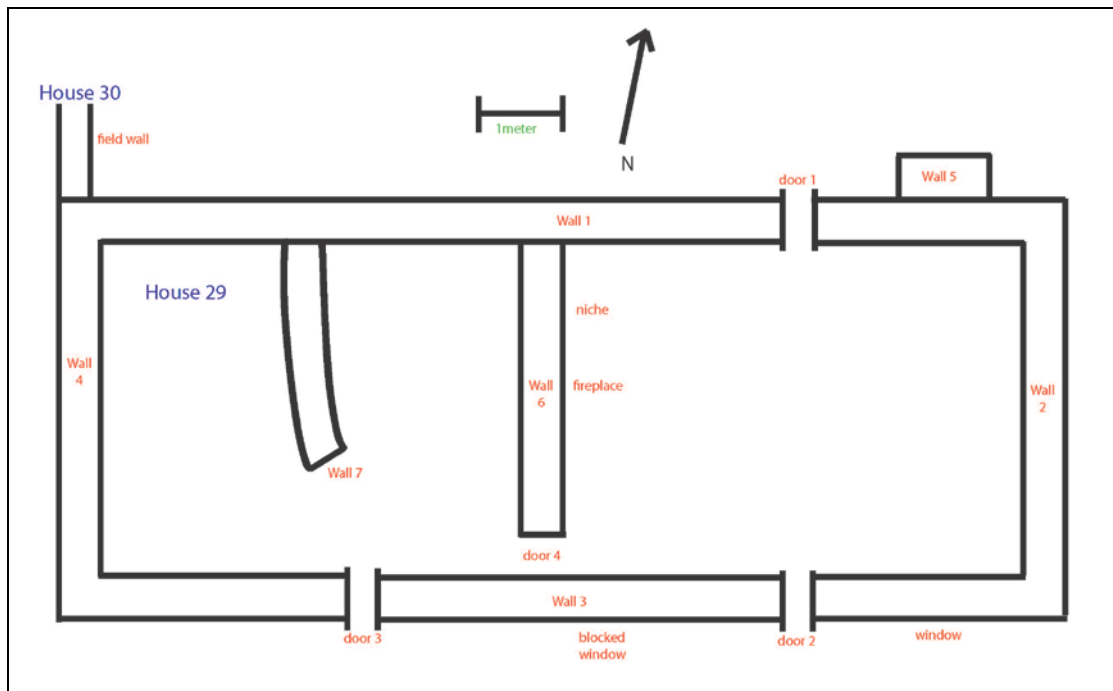
House 29 has three exterior doors. One is almost entirely collapsed, but the other two have stone lintels remaining. One is partially blocked, and the other is tightly blocked. There is also a partially blocked interior doorway. There are two windows. One is tightly blocked with a stone still, and the other is trapezoidal with a stone lintel. It also has two fireplace features. One is a fireplace with a stone mantel, and the other is a niche next to the fireplace.

Figure 7.16: House 29 Floor Plan, C-Area

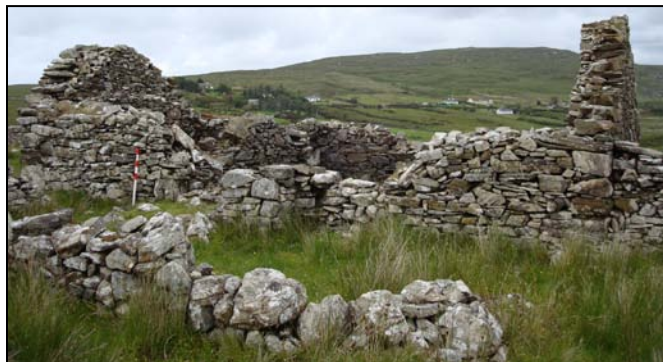
restrained, or keep out livestock from planted fields and gardens. While a part of the landscape for decades, increasing partitioning of land made them an abundant feature in the visible landscape. There are fences located in close proximity to the majority of the structures. The fences are difficult to date, but if field walls are near a robbed out structure that is one indication of a wall constructed after the abandonment of the building. Fences which coincided with habitation structures suggest increasing desire by occupants for privatization of their property. They are also a reflection of changing land use, as increased cattle and livestock in the region would have warranted protection for personal gardens. The 1855 Valuation notes personal gardens but it only lists a couple of gardens in association with structures by the main roads and not within the survey area. In some cases, such as House 19, the fences create just enough room for a pathway between the house and the fence all the way from in front of the door and around the end gable. The other sides of the house have naturally occurring features for protection – the northern wall is placed just inward of a drop-off about 2 meters deep, and the eastern wall is constructed up against a rise in the ridge. In the case of House 3, in Carmacullew, the land is much flatter and more open, and the fence separates access to two of the exterior doorways.

Figure 7.17: House 3 and Fence, Carmacullew, Facing East, Scale Bar = 1 meter, 2007

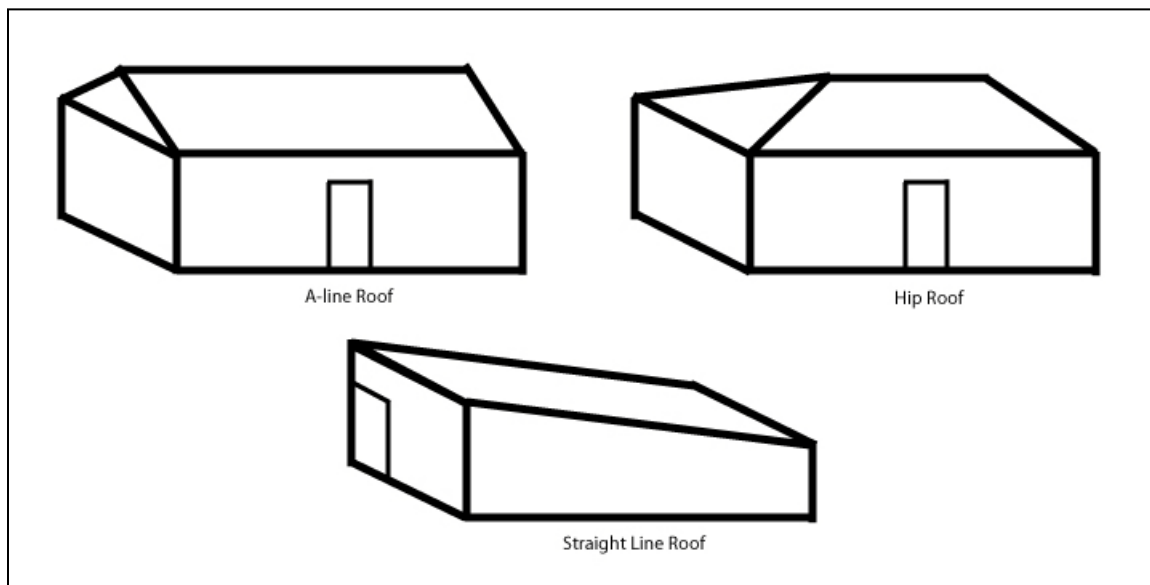
the roof slant downward to the walls). In cases where the roofline is not preserved, collapse usually indicates if there was a gable present. Hip-roof lines are not built up above the top of the wall, so there are less stones involved and therefore less collapse. There is only one structure at Streamstown with clear evidence for a straight-lined roof.

Figure 7.19: Different Roof Types
