# **Boston Harbor South Watersheds 2004 Assessment Report**

**June 30, 2004**

**Massachusetts Executive Office of Environmental Affairs**

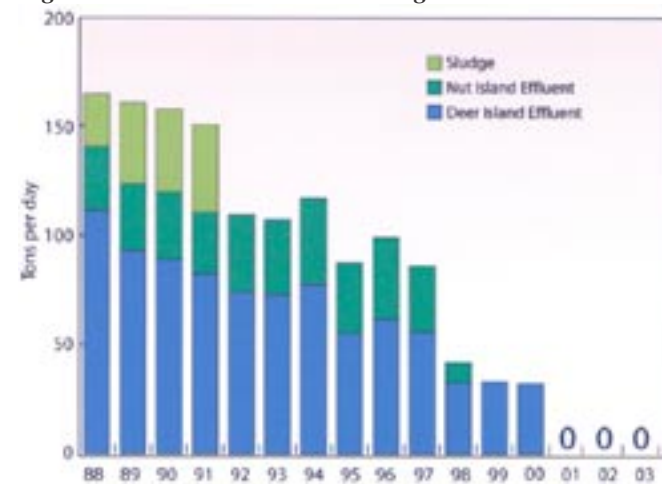
*Figure 12: Historic MWRA Discharges to Inner Harbor*

Water quality in Boston Harbor has significantly improved as a result of the Massachusetts Water Resources Authority's (MWRA) Boston Harbor Project and the Boston Water and Sewer Commission's (BWSC) ongoing efforts to address stormwater pollution. In 1988, the MWRA discharged approximately 160 tons of sludge and effluent to Boston Harbor each day. With completion of the upgraded wastewater treatment plant at Deer Island and construction of a 9 1/2-mile long outfall pipe, the MWRA's discharges of solids to the Inner Harbor were eliminated in 2001, as illustrated in Figure 14.

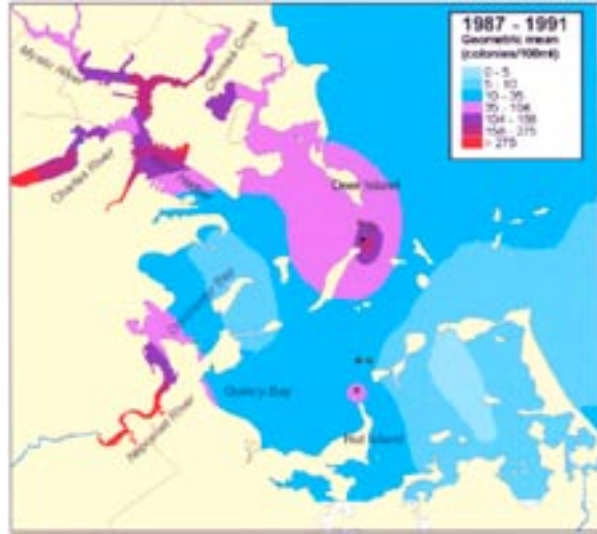
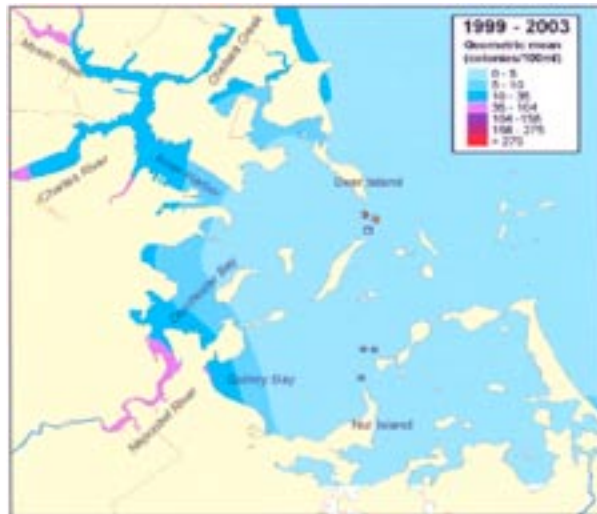
**Figure 14: Boston Harbor Enterococcus, During Wet Weather (MWRA) <35 meets EPA swimming standards.**

As shown in Figure 14, water quality in Boston Harbor was degraded before the Boston Harbor Project and CSO improvement projects began, and prior to the 1991 end of sludge discharges to Boston Harbor. In comparison, the figure shows that average bacterial counts for Enterococcus in Boston Harbor between 1999 and 2003 met the state water quality standards for swimming in most locations. Enterococcus is the sewage indicator bacteria recommended by the U.S. Environmental Protection Agency for monitoring marine waters. Water quality improvements in recent years are due to completion of the Deer Island treatment facility, cessation of sludge dumping into the Harbor, removal of effluent discharges from the Harbor (redirected into Massachusetts Bay via the new outfall), closure of 22 combined sewer overflows, minimization of CSO discharges at remaining outfalls and improved treatment at CSO facilities, and local efforts to abate stormwater pollution.

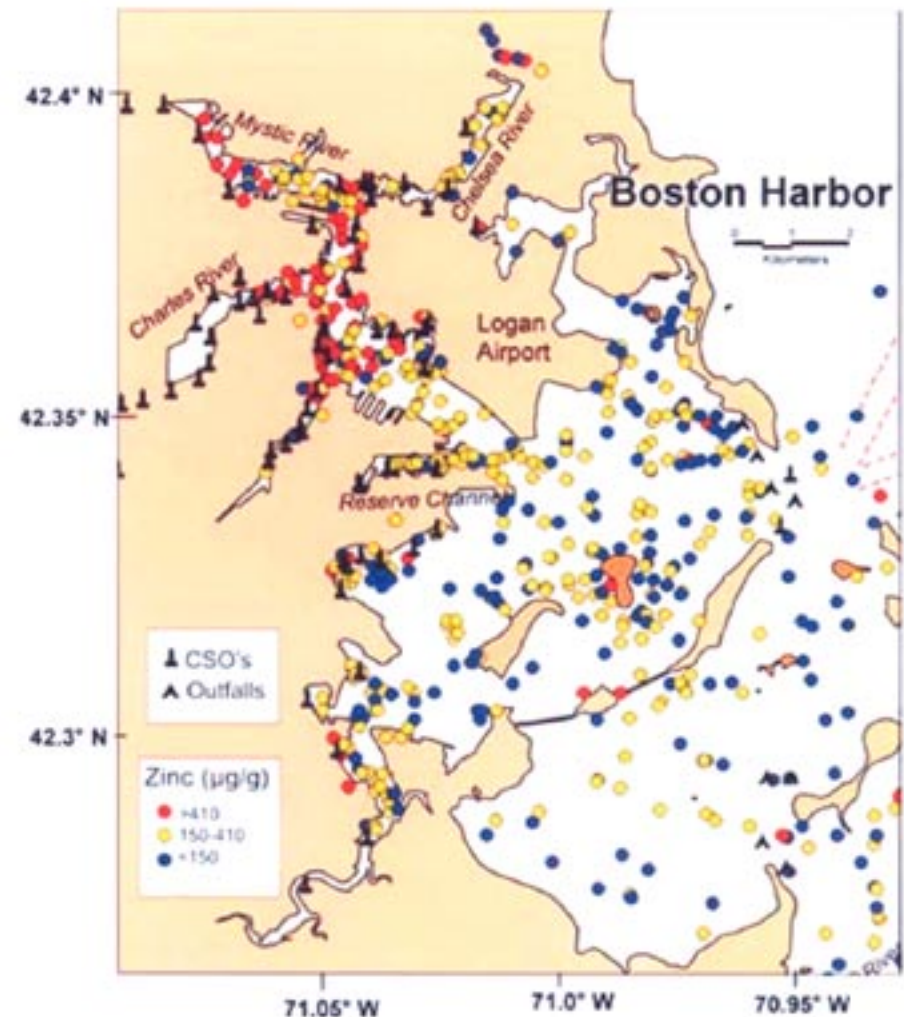
*Figure 15: Sediment Zinc Levels in Boston Harbor (USGS)*

decrease with distance from Boston, focusing the highest levels of lead (shown with red and orange dots) in the innermost harbor. Similar patterns arise for a variety of metals, which are documented in the USGS

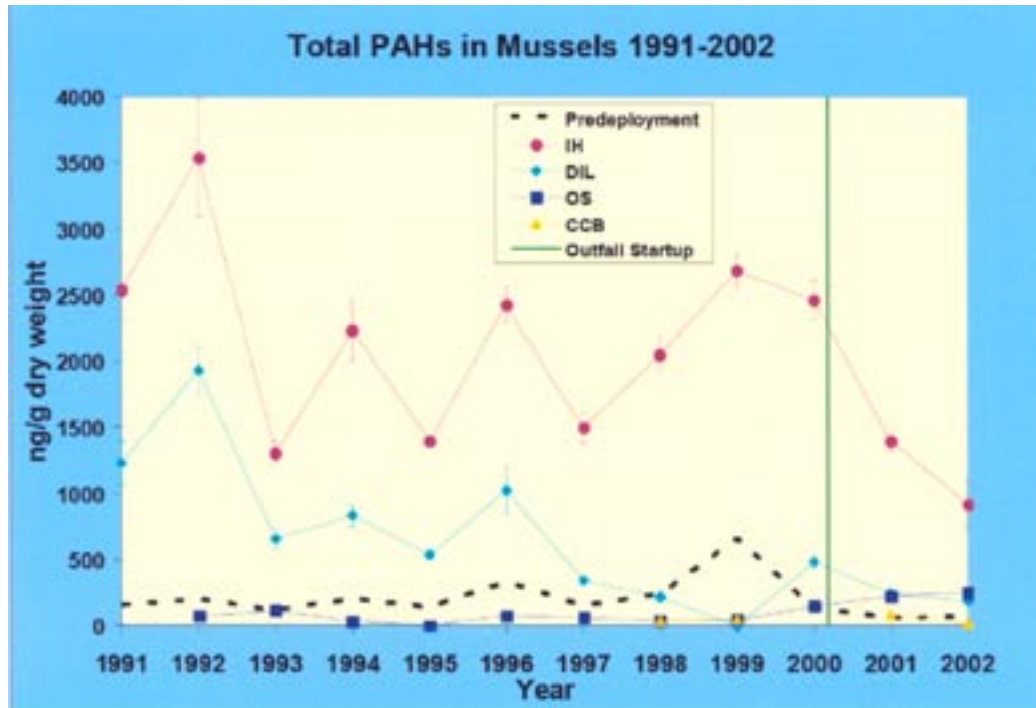
Figure 17: PAHs in Boston Harbor Mussels (MWRA)

As part of the MWRA’s ongoing fish and shellfish monitoring program, caged blue mussels from Rockport were deployed in several locations around Boston Harbor to evaluate bioaccumulation potential. The mussels were suspended in cages for 60 days at sites near the New England Aquarium, the former Deer Island outfalls, the offshore outfall site, and Cape Cod Bay. Once retrieved, the mussels were analyzed for toxic contamination. As shown in Figure 7, results indicated that PAHs found in mussels left in the Inner Harbor (IH) were higher than other locations such as Deer Island Light (DIL), the Outfall Site (OS) and Cape Cod Bay (CCB).

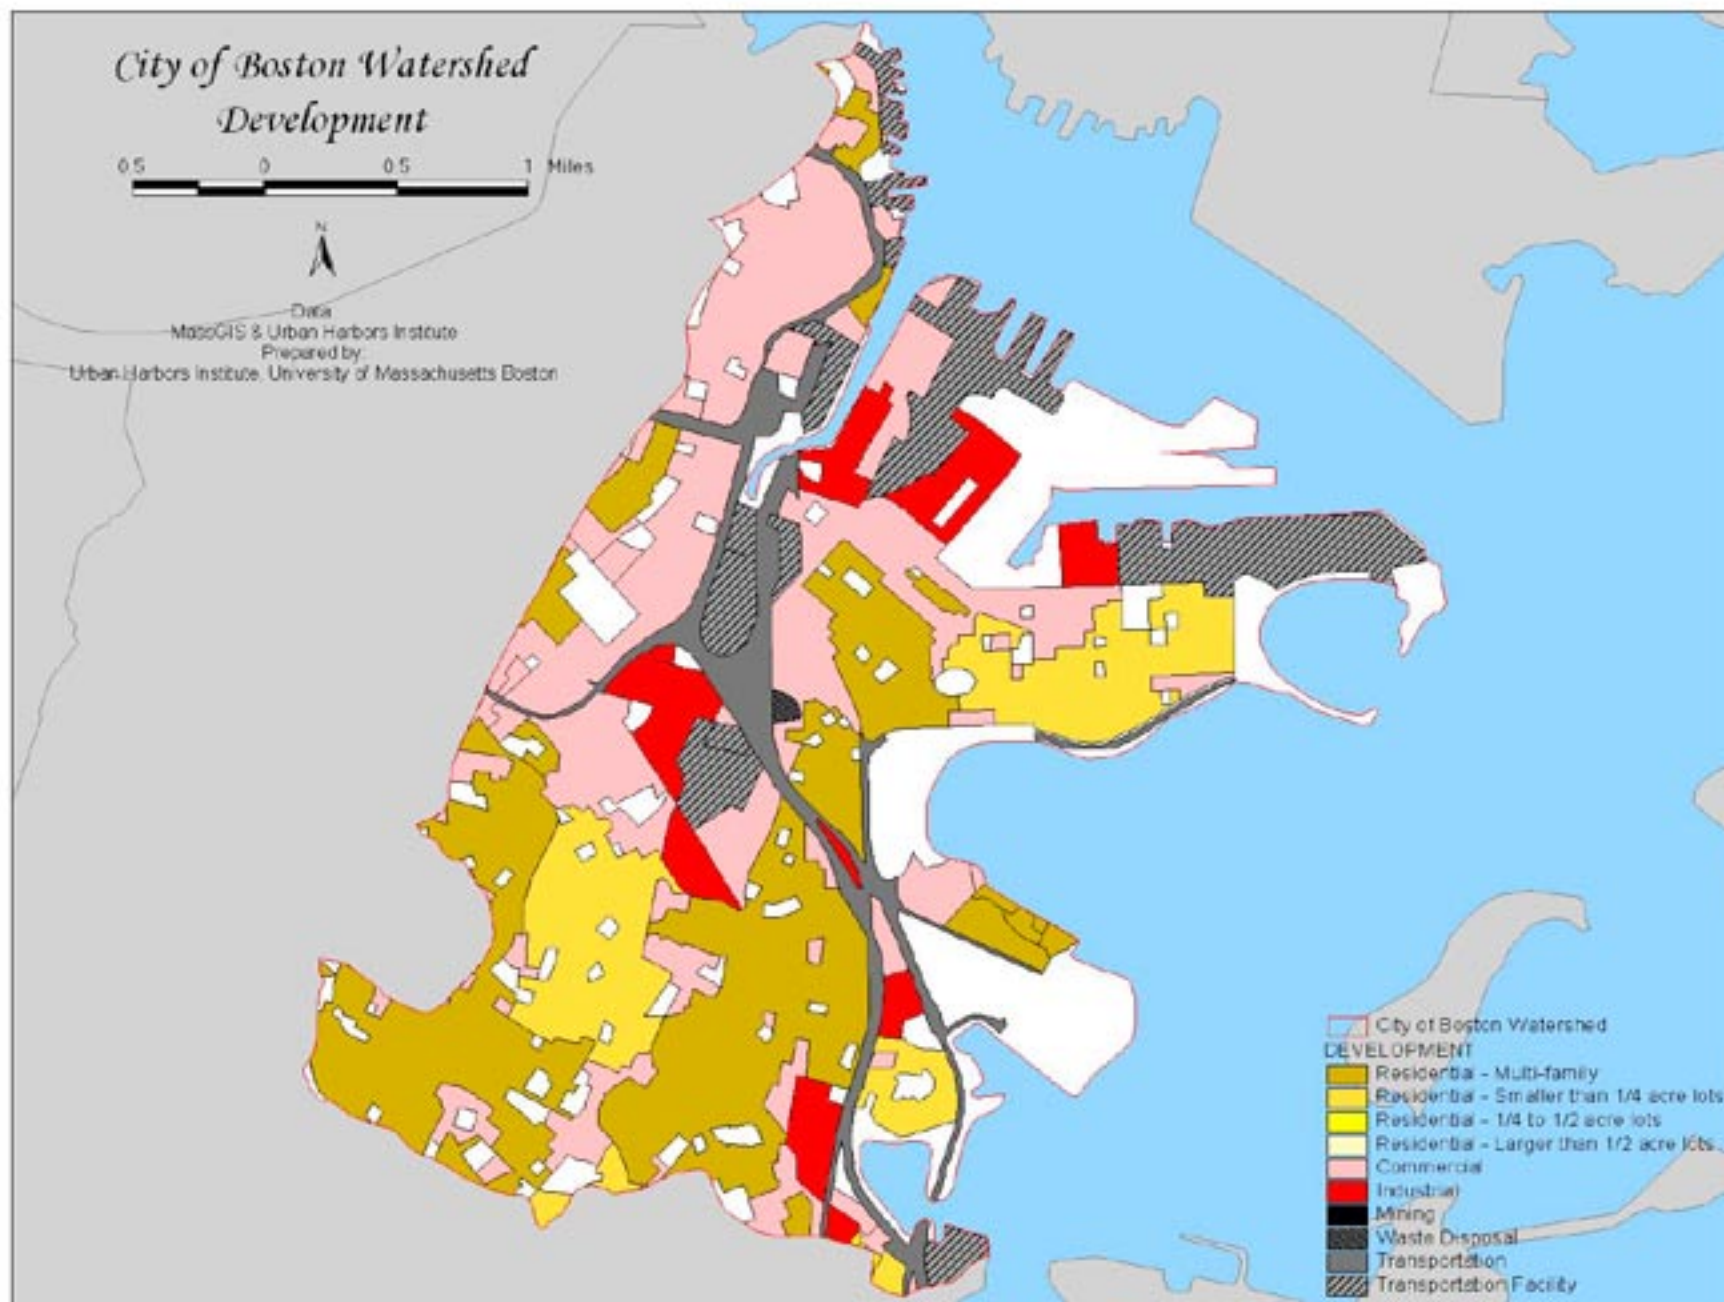
Figure 18: Bosotn Watershed Development

is impervious. See Table 3 and Figure 18 for a detailed breakdown of impervious land uses.

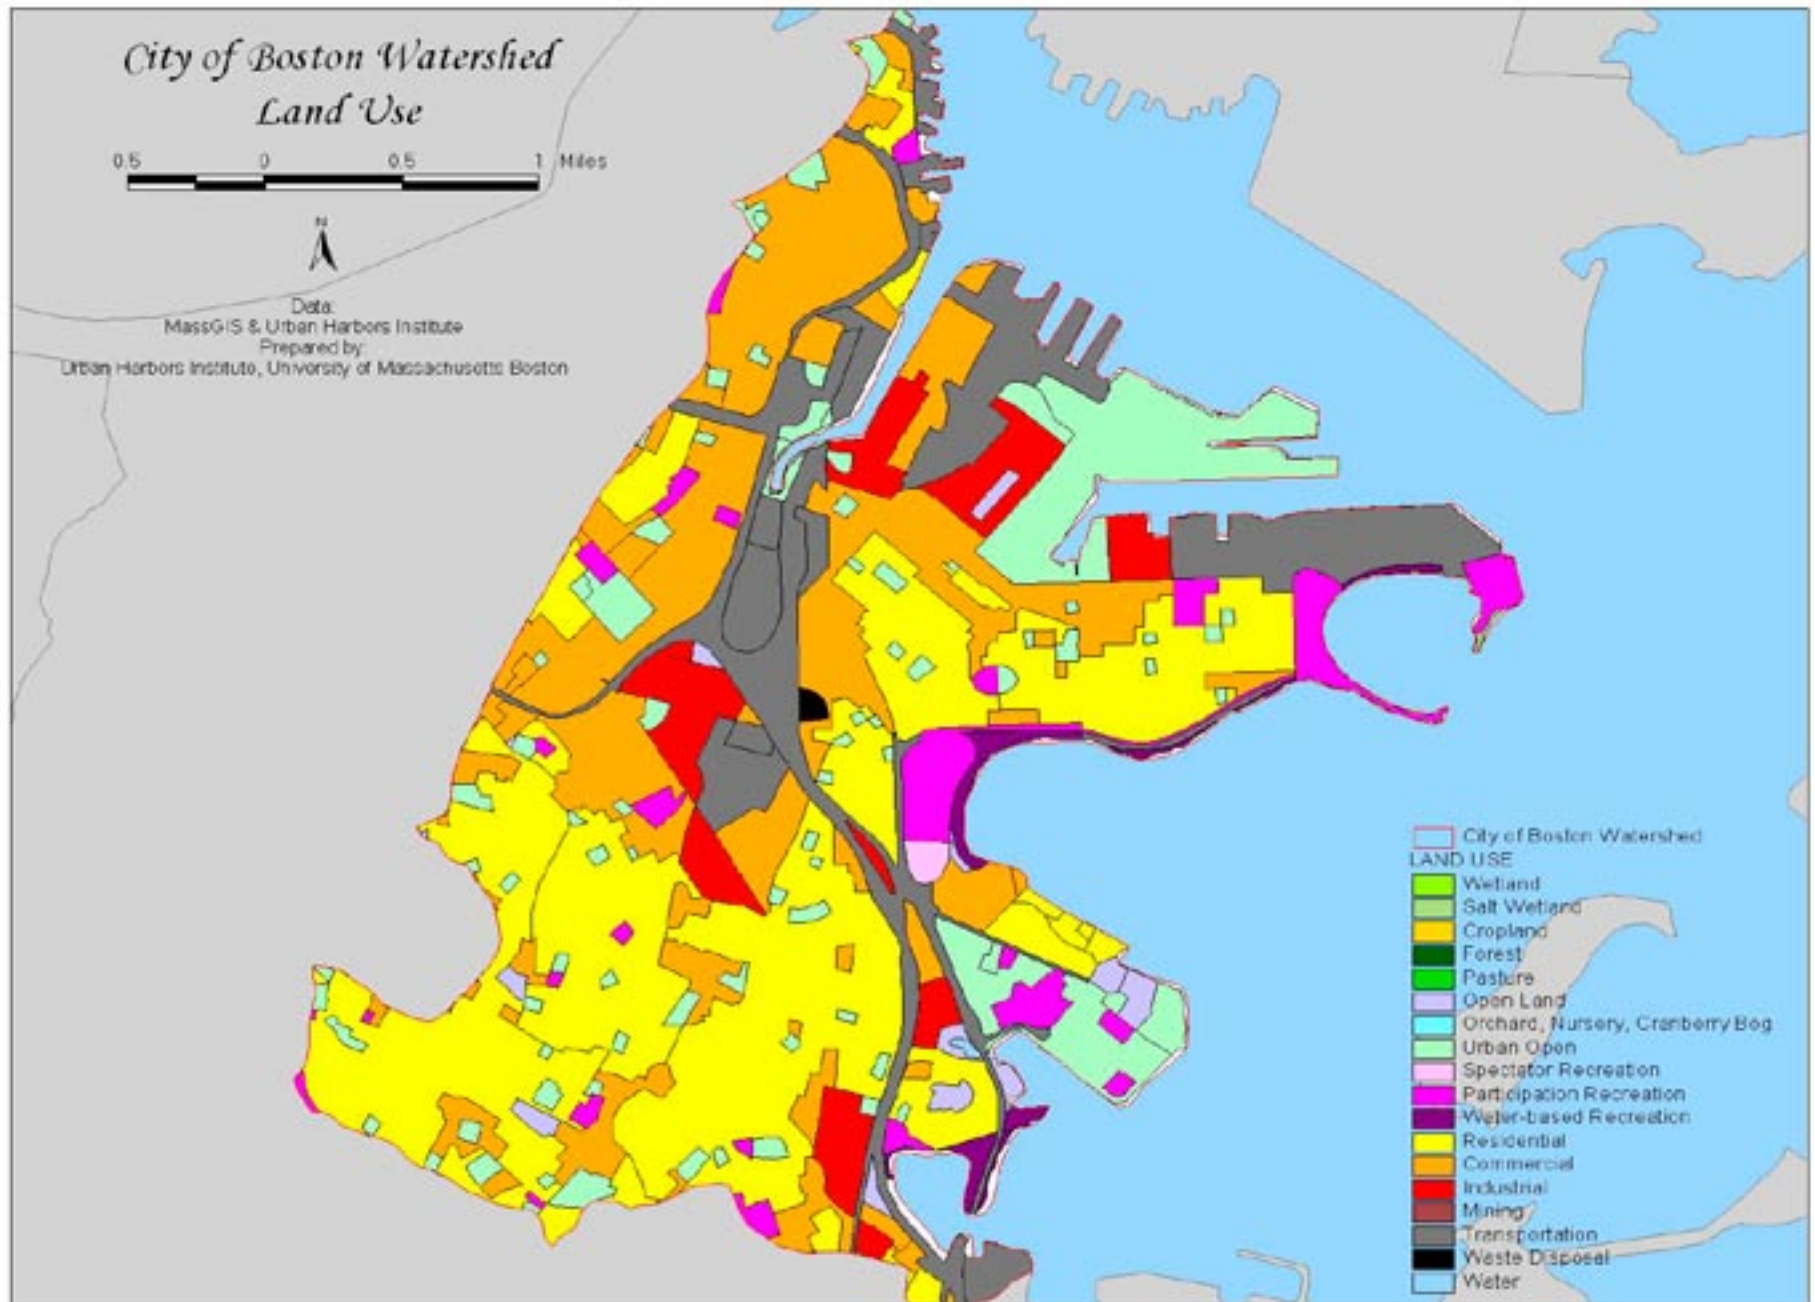
Figure 22: Boston Watershed Land Use

As indicated in the Table 6 and Figure 22, the two most significant land uses within the City of Boston sub-watershed are commercial and residential. Roadways, rail service and other transportation are also significant land uses within the watershed.

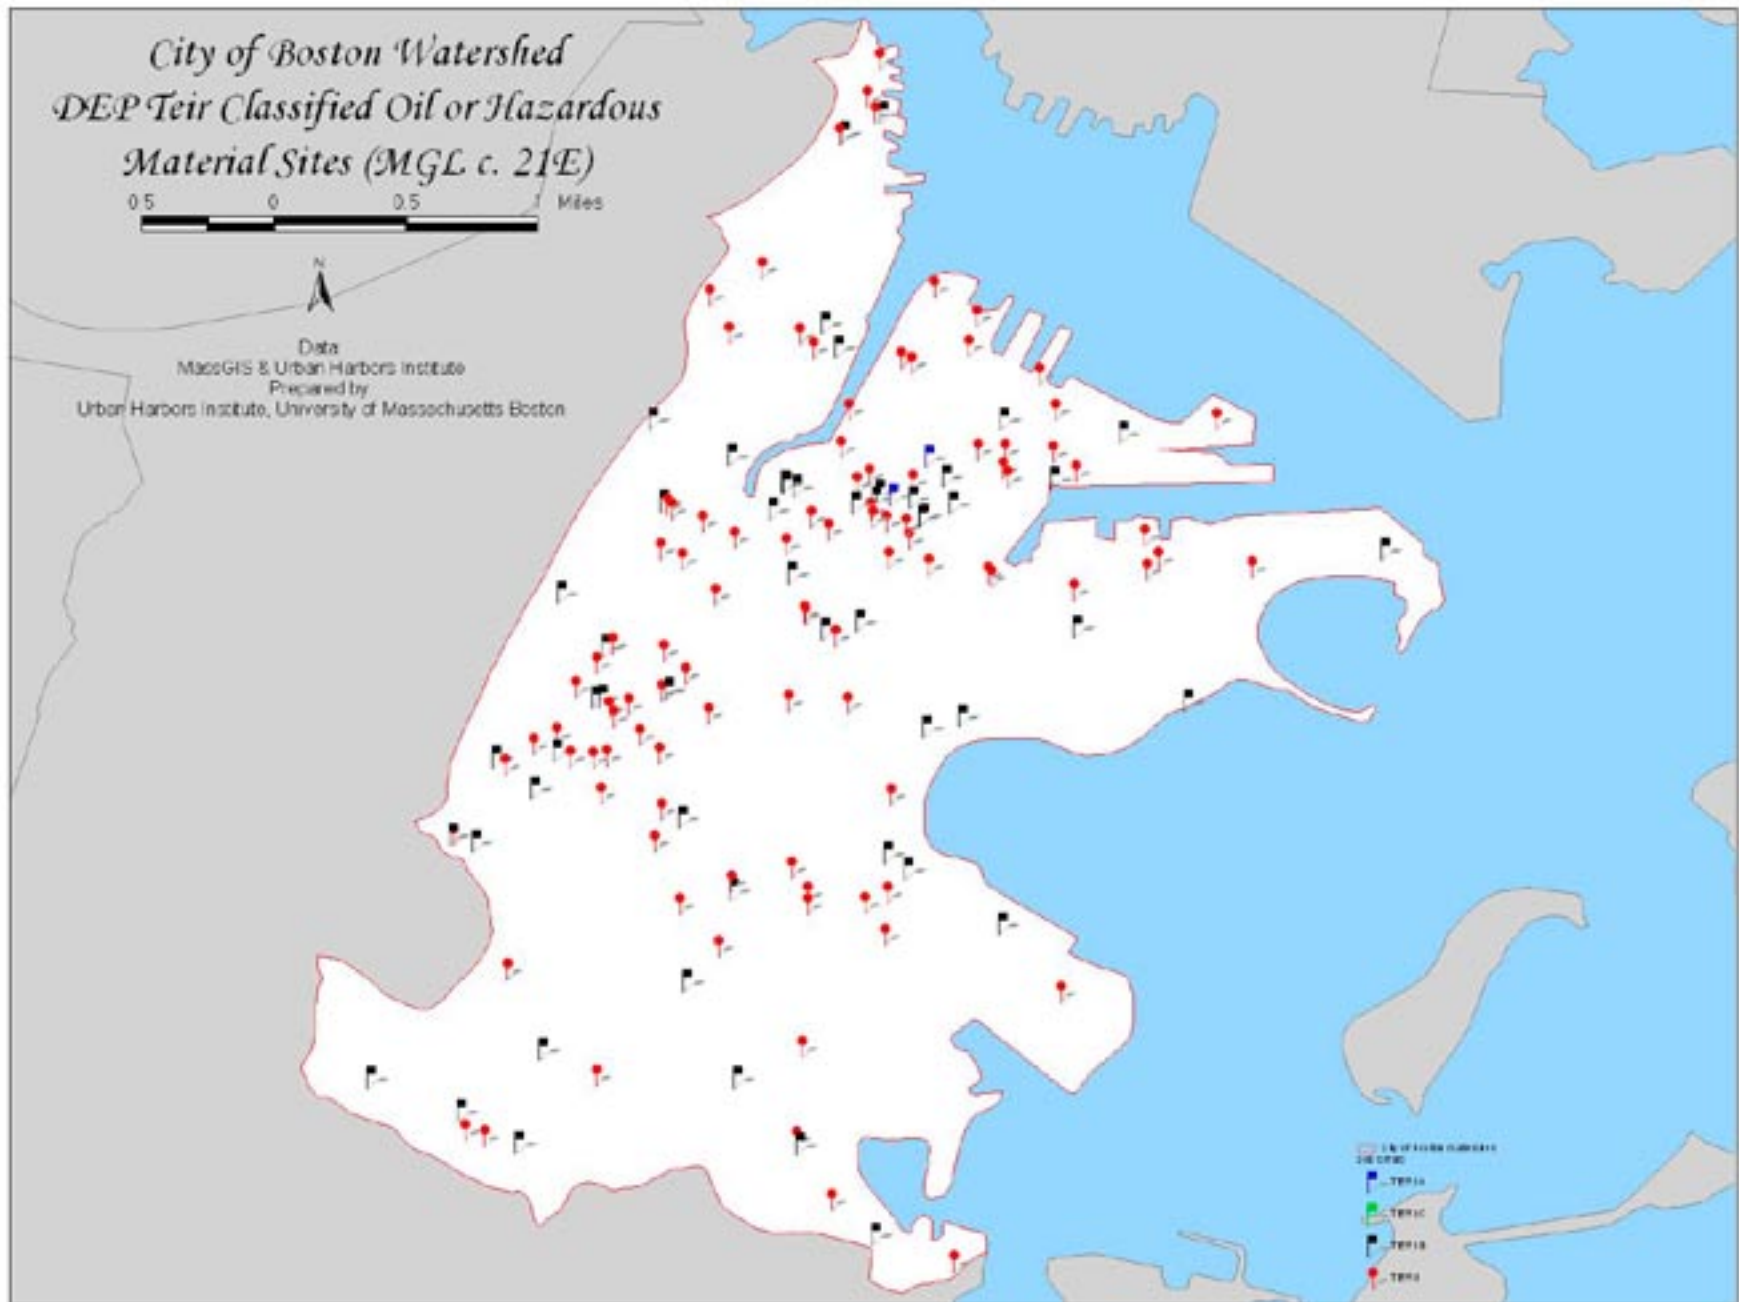
Figure 23: Boston Watershed Contaminated Sites

While environmental regulations have significantly reduced new sources of industrial pollution, Boston’s Inner Harbor is still affected by road runoff, atmospheric deposition, and numerous industrial uses within the watershed. Figure 23 on page 33 shows the relatively high number of DEP Oil or Hazardous Material Sites concentrated within the City of Boston watershed.

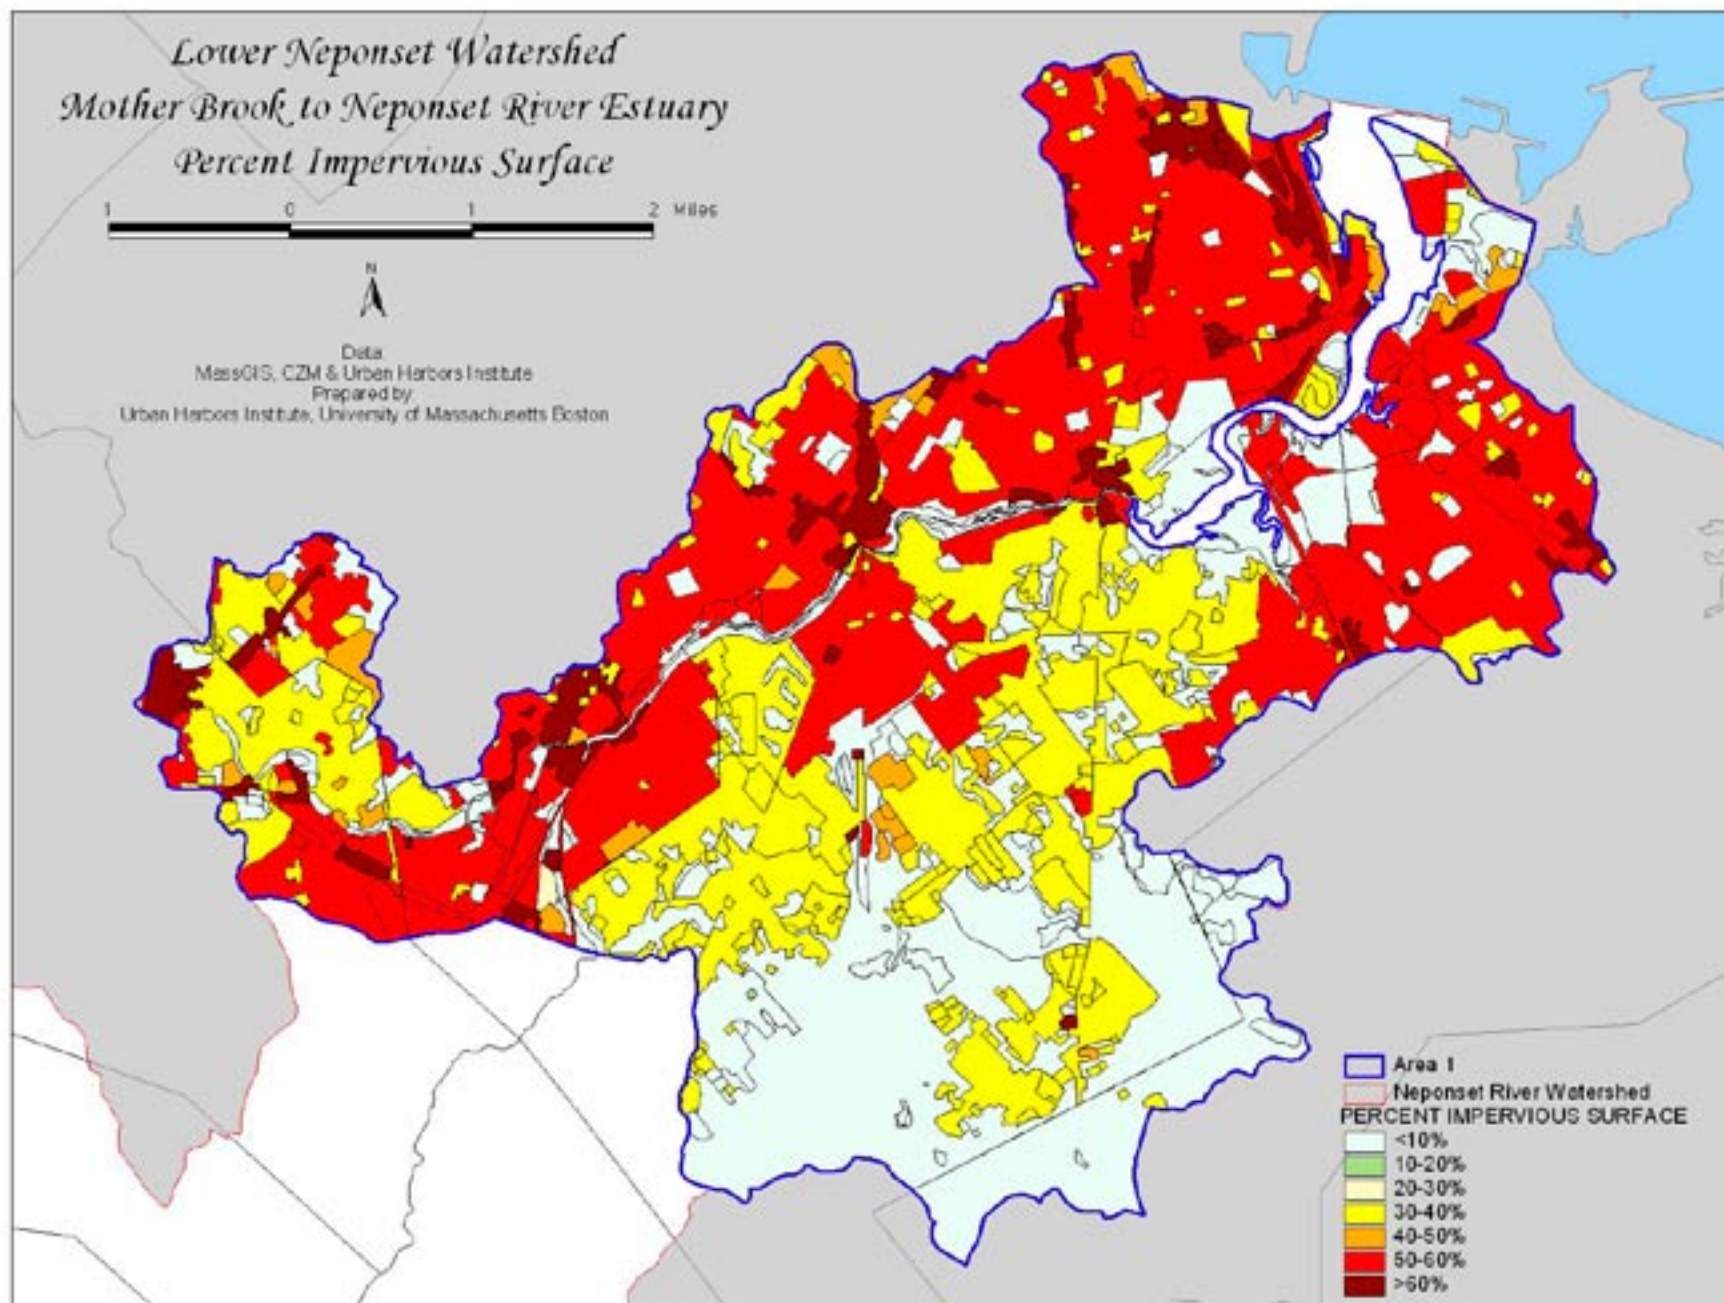
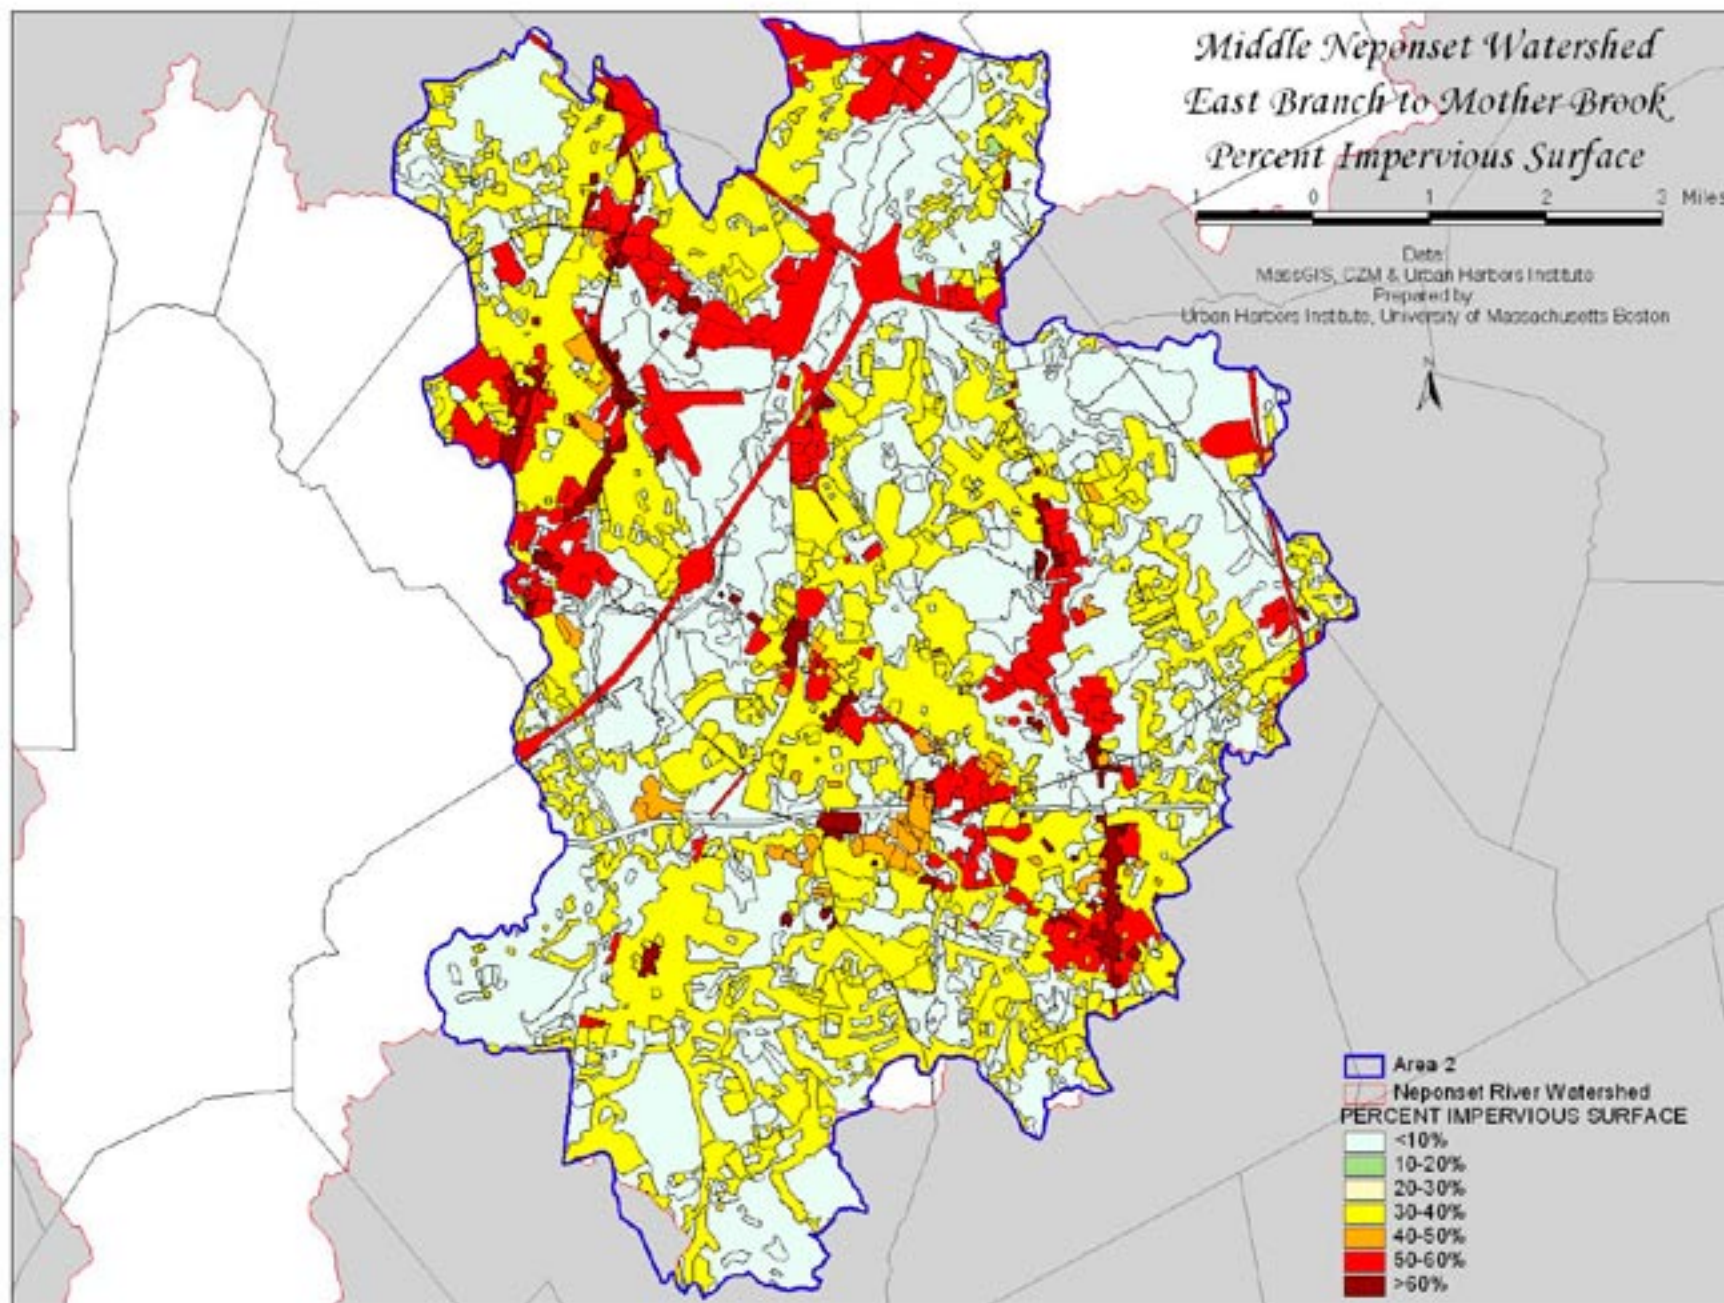
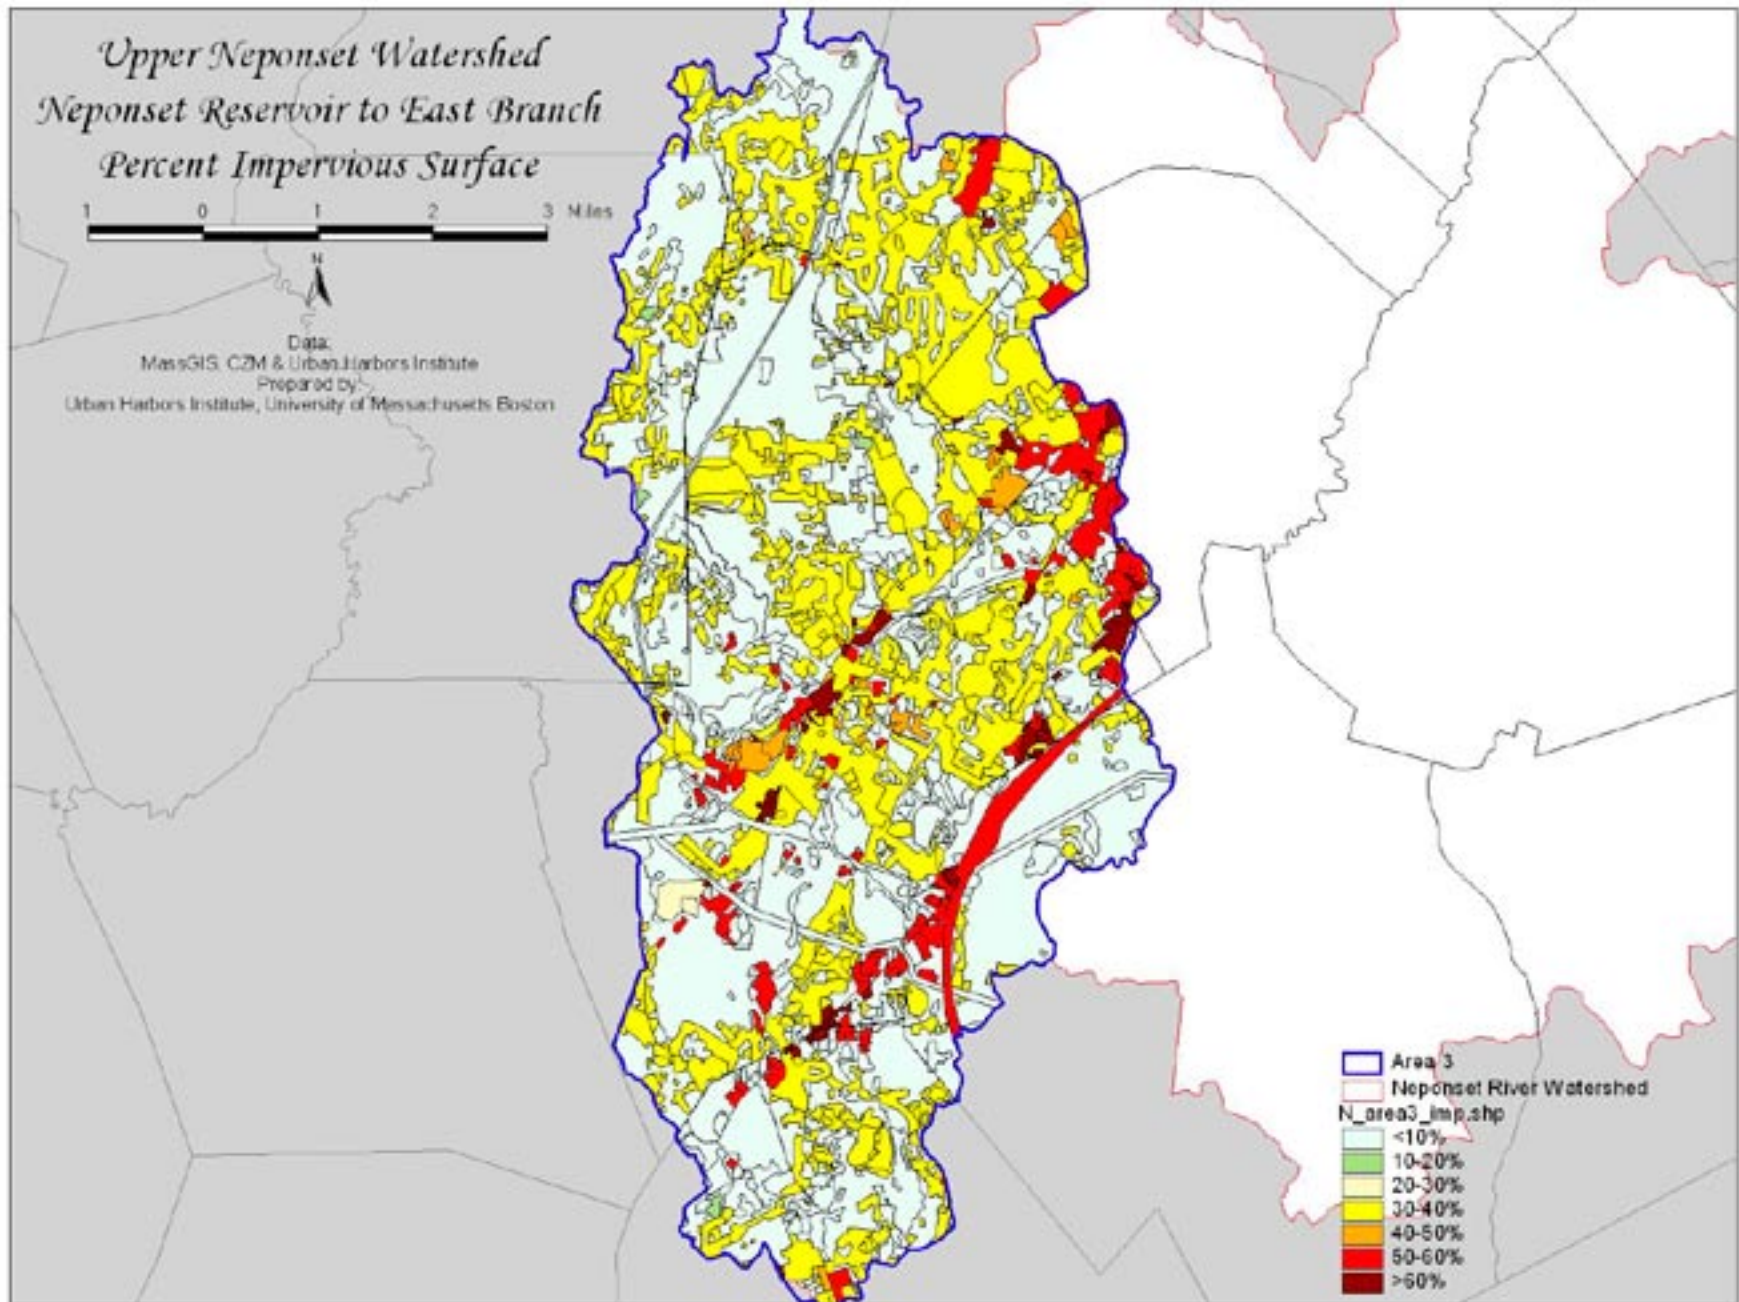
Twenty-four percent of the total acreage in the Neponset River Watershed consists of impervious surfaces, although the amount of development – and hence imperviousness – varies greatly from town to town and even within most towns and cities. See Figures 31 - 34 below.

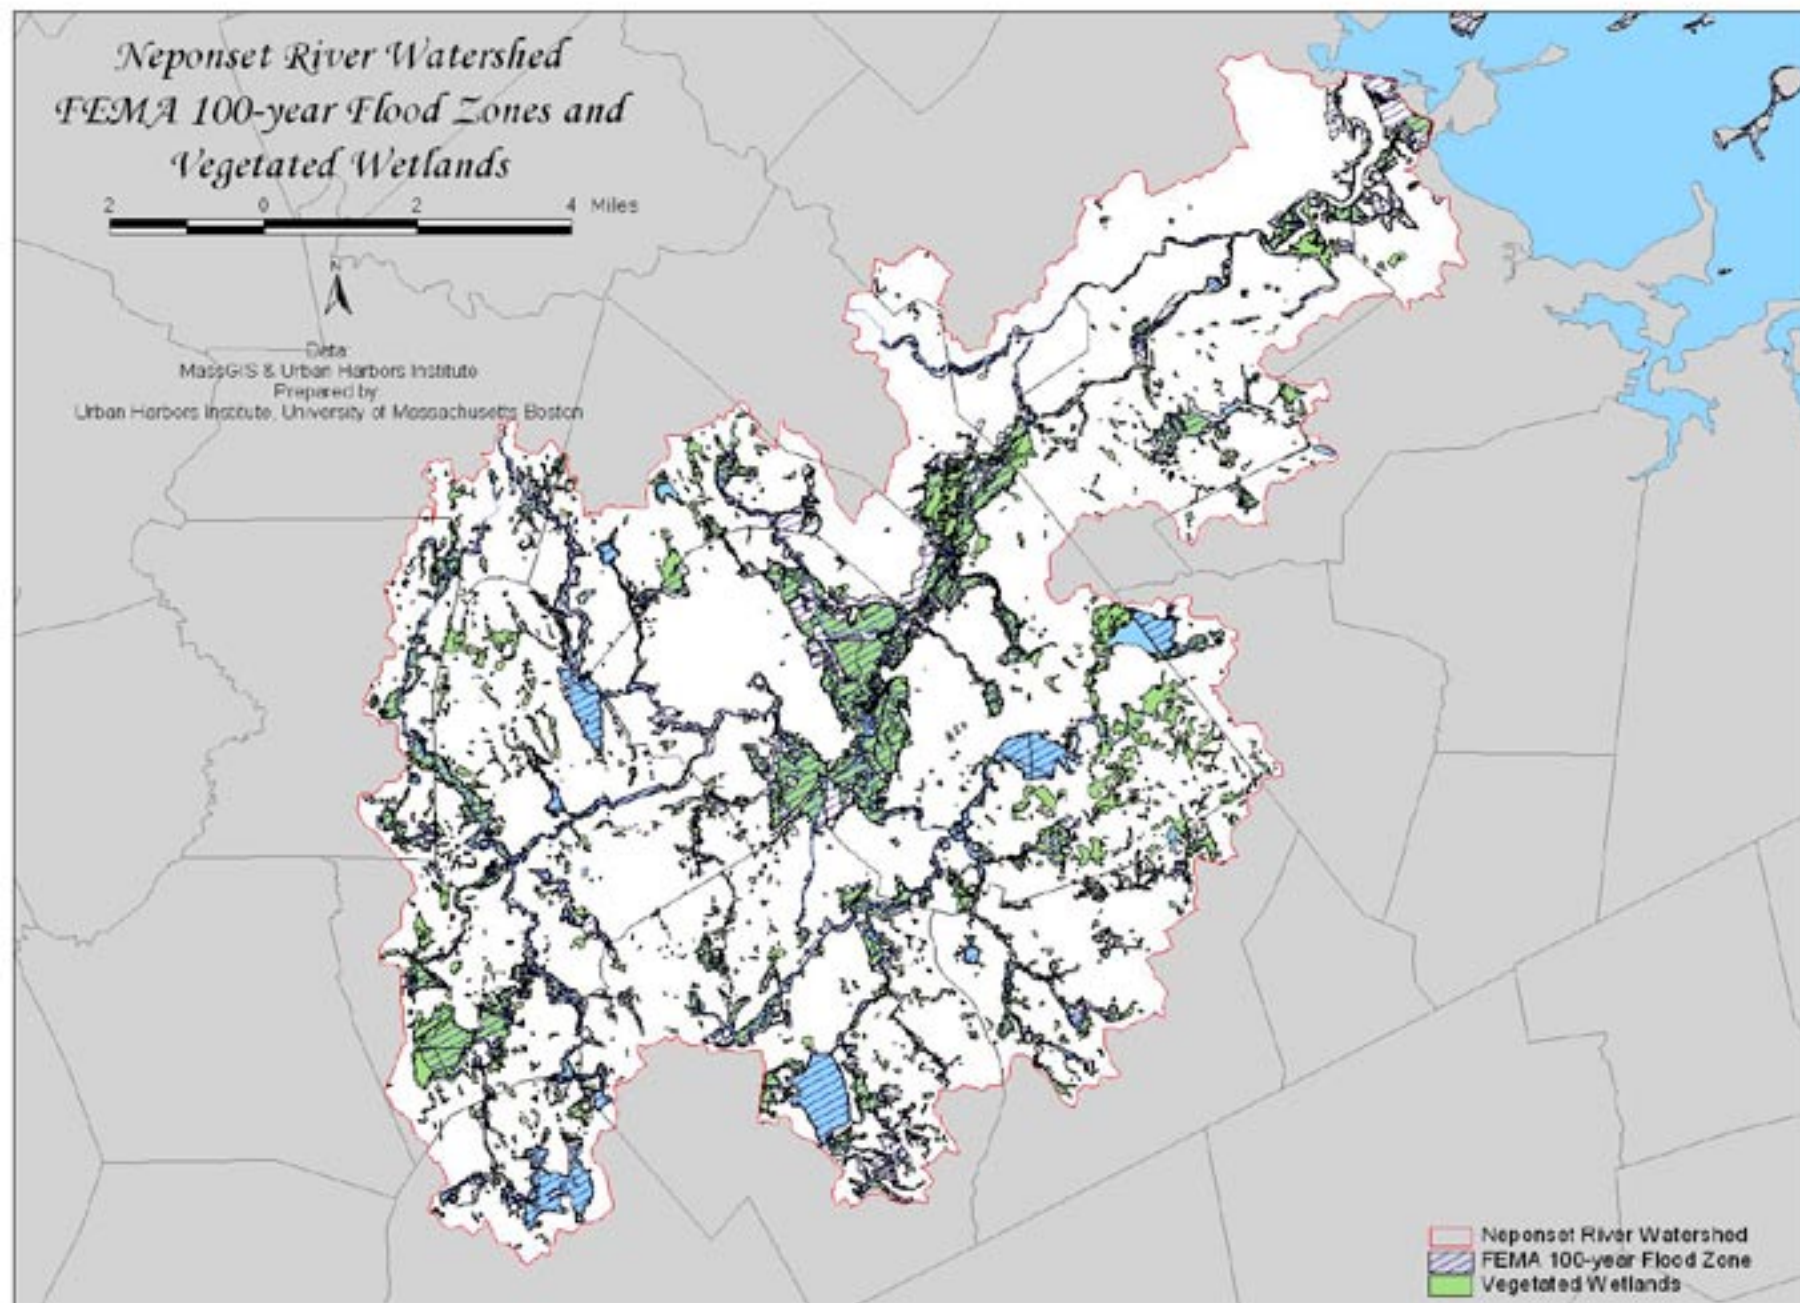
Figure 35: Neponset Floodplains and Vegetated Wetlands

Figure 35 shows areas that, if protected, would provide suitable habitat over the long-term for the maximum number of Massachusetts’ terrestrial and wetland plant and animal species and natural communities. The BioMap focuses primarily on state-listed rare species and exemplary natural communities, but also includes the full breadth of the State’s biological diversity.

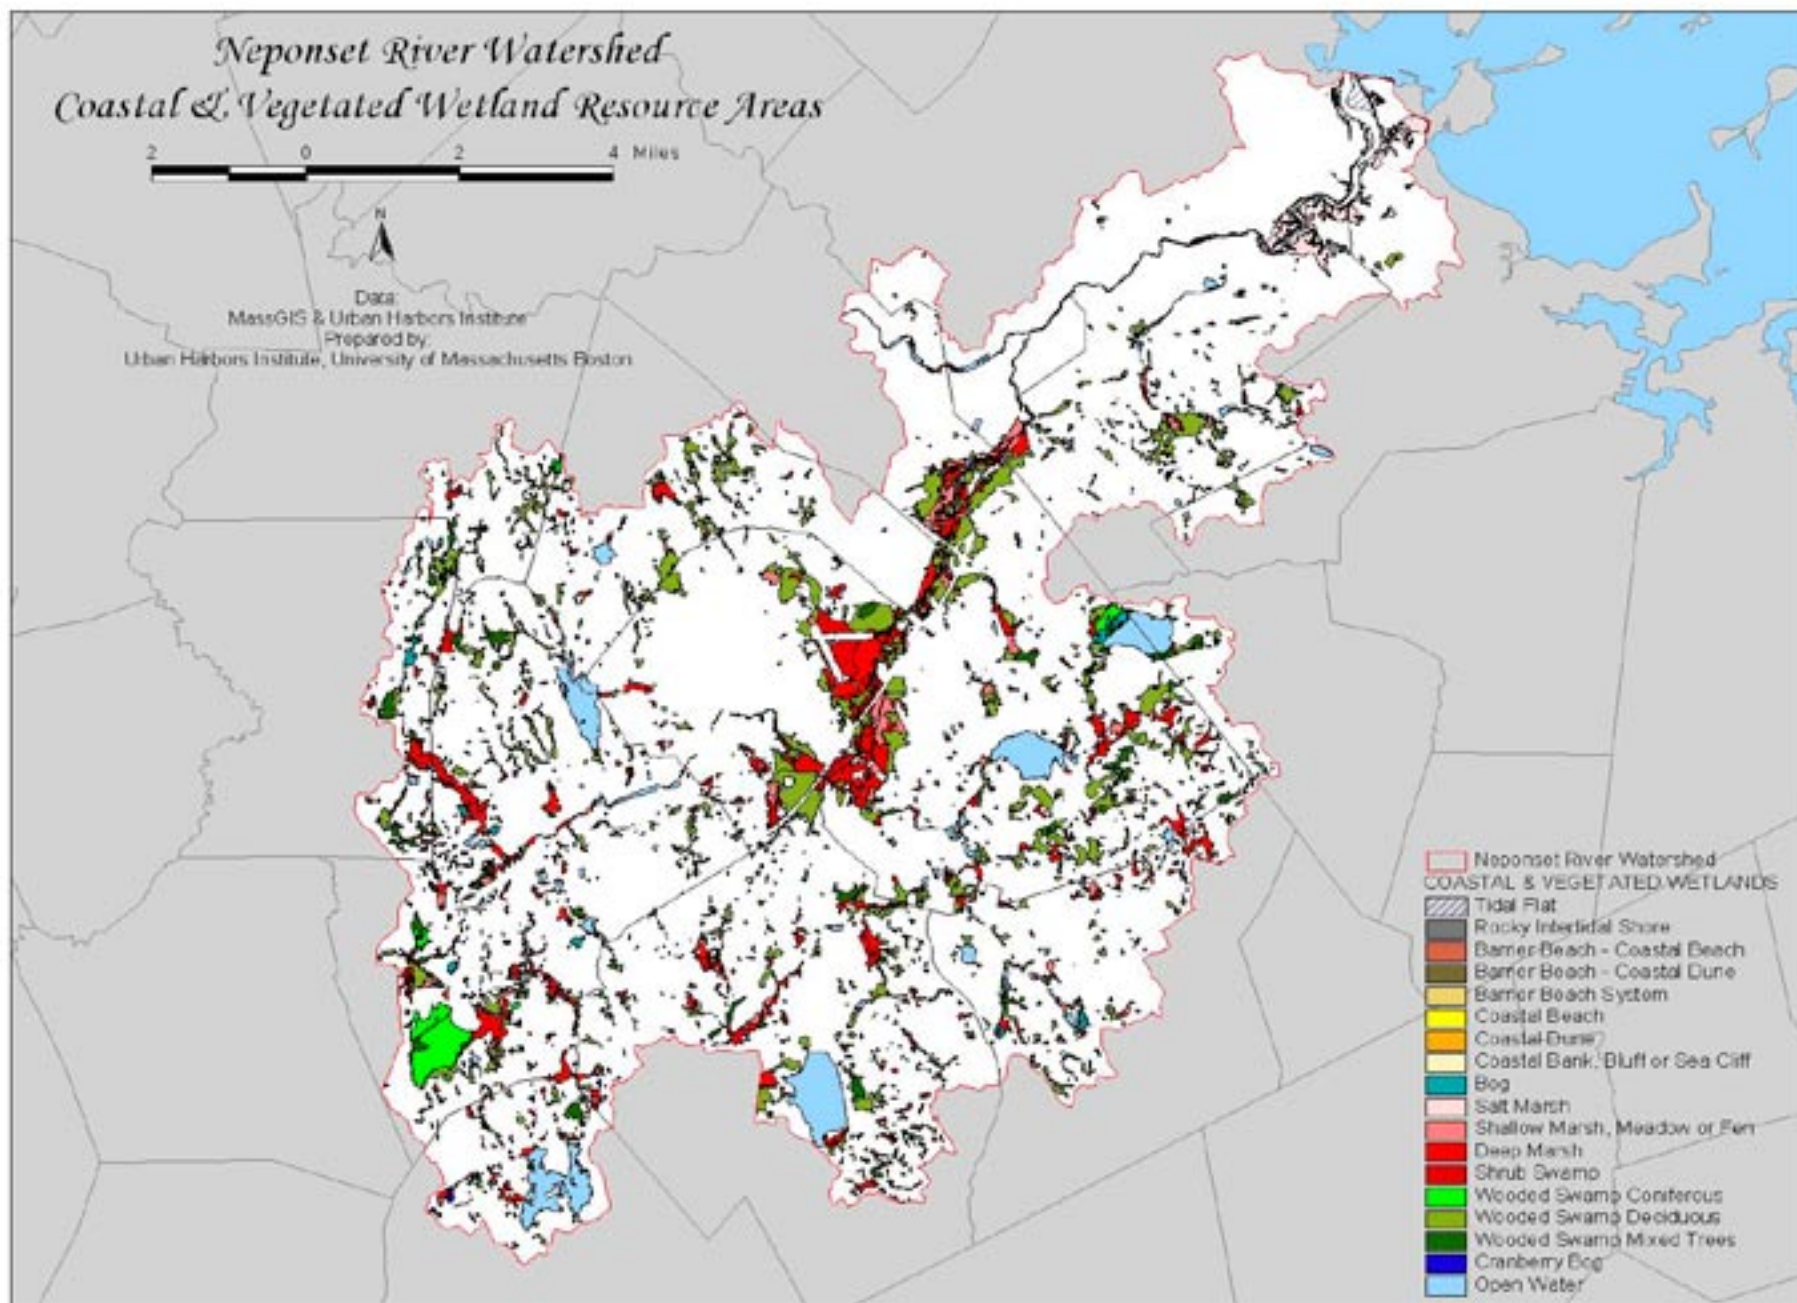
Figure 38: Neponset Coastal and Vegetated Wetland Resource Areas

Figure 40, entitled "Approximate Extent of Wetland Resource Areas," covers all wetland "resource areas" protected by the MA Wetlands Protection Act, including the 100 year floodplains. "Riparian corridors" on Figure 40 correspond generally to the riverfront resource area. Figure 38 (Coastal & Vegetated Wetland Resource Areas) shows open water, and specific types of coastal wetlands and inland bordering vegetated wetlands. These wetland resource areas make up 15.8% of the acreage in the watershed, and are subject to particularly strong protection in
