# **Boston Harbor South Watersheds 2004 Assessment Report**

**June 30, 2004**

**Massachusetts Executive Office of Environmental Affairs**

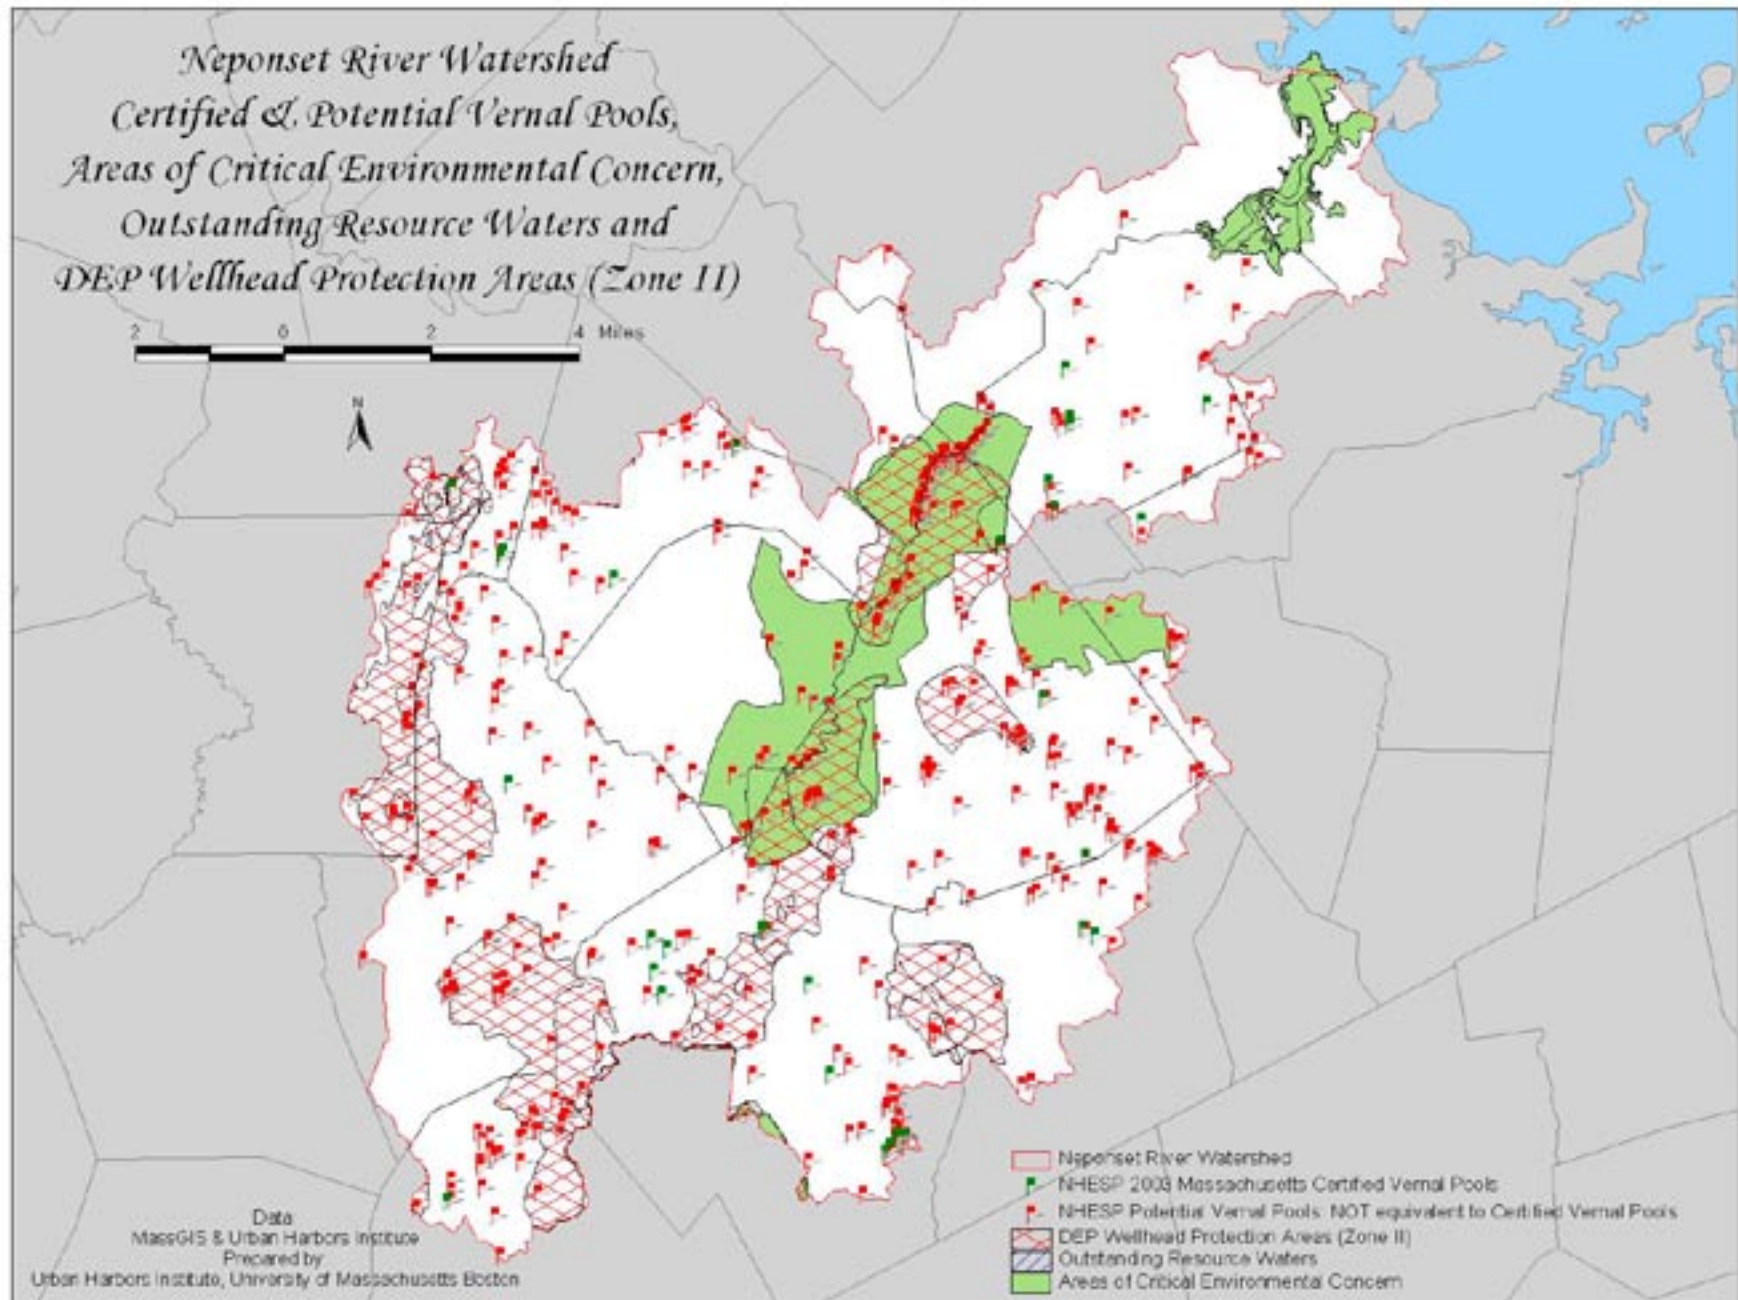
Figure 39: Neponset Vernal Pools, ACECs, ORWs and Zone II

See Figure 39. Vernal pools are unique wildlife habitats best known for the amphibians that use them to breed. Vernal pools typically fill with water in the autumn or winter due to rising ground water and rainfall, then dry out completely by the middle or end of summer each year, or at least every few years. Occasional drying prevents fish from establishing permanent populations. Many amphibian and invertebrate species rely on breeding habitat that is free of fish predators. Some vernal pools (limited mostly to those within the 100 year floodplain of perennial rivers and streams) are protected in Massachusetts under the state Wetlands Protection Act. The state Natural Heritage and Endangered Species Program serves the important role of officially "certifying" vernal pools that are documented by citizens. Within the Neponset River Watershed there are approximately 23 certified vernal pools. There are approximately 350 potential vernal pools. (Figure 39 shows both "certified" and "potential" vernal pool locations [not necessary in protected wetland resource areas].)

See Figure 39. The Neponset River Watershed contains two ACECs, the Fowl River/Ponkapoag Bog ACEC and the Neponset River Estuary ACEC. ACECs are places in Massachusetts that receive special recognition because of the quality, uniqueness and significance of their natural and cultural resources. These areas are identified and nominated at the community level and are reviewed and designated by the state's Secretary of Environmental Affairs. ACEC designation creates a framework for local and regional stewardship of critical resources and ecosystems.

See Figure 39. These areas are given extra protection in the state Water Quality Certification process, required whenever a federal wetlands permit is mandated. (See map below.)

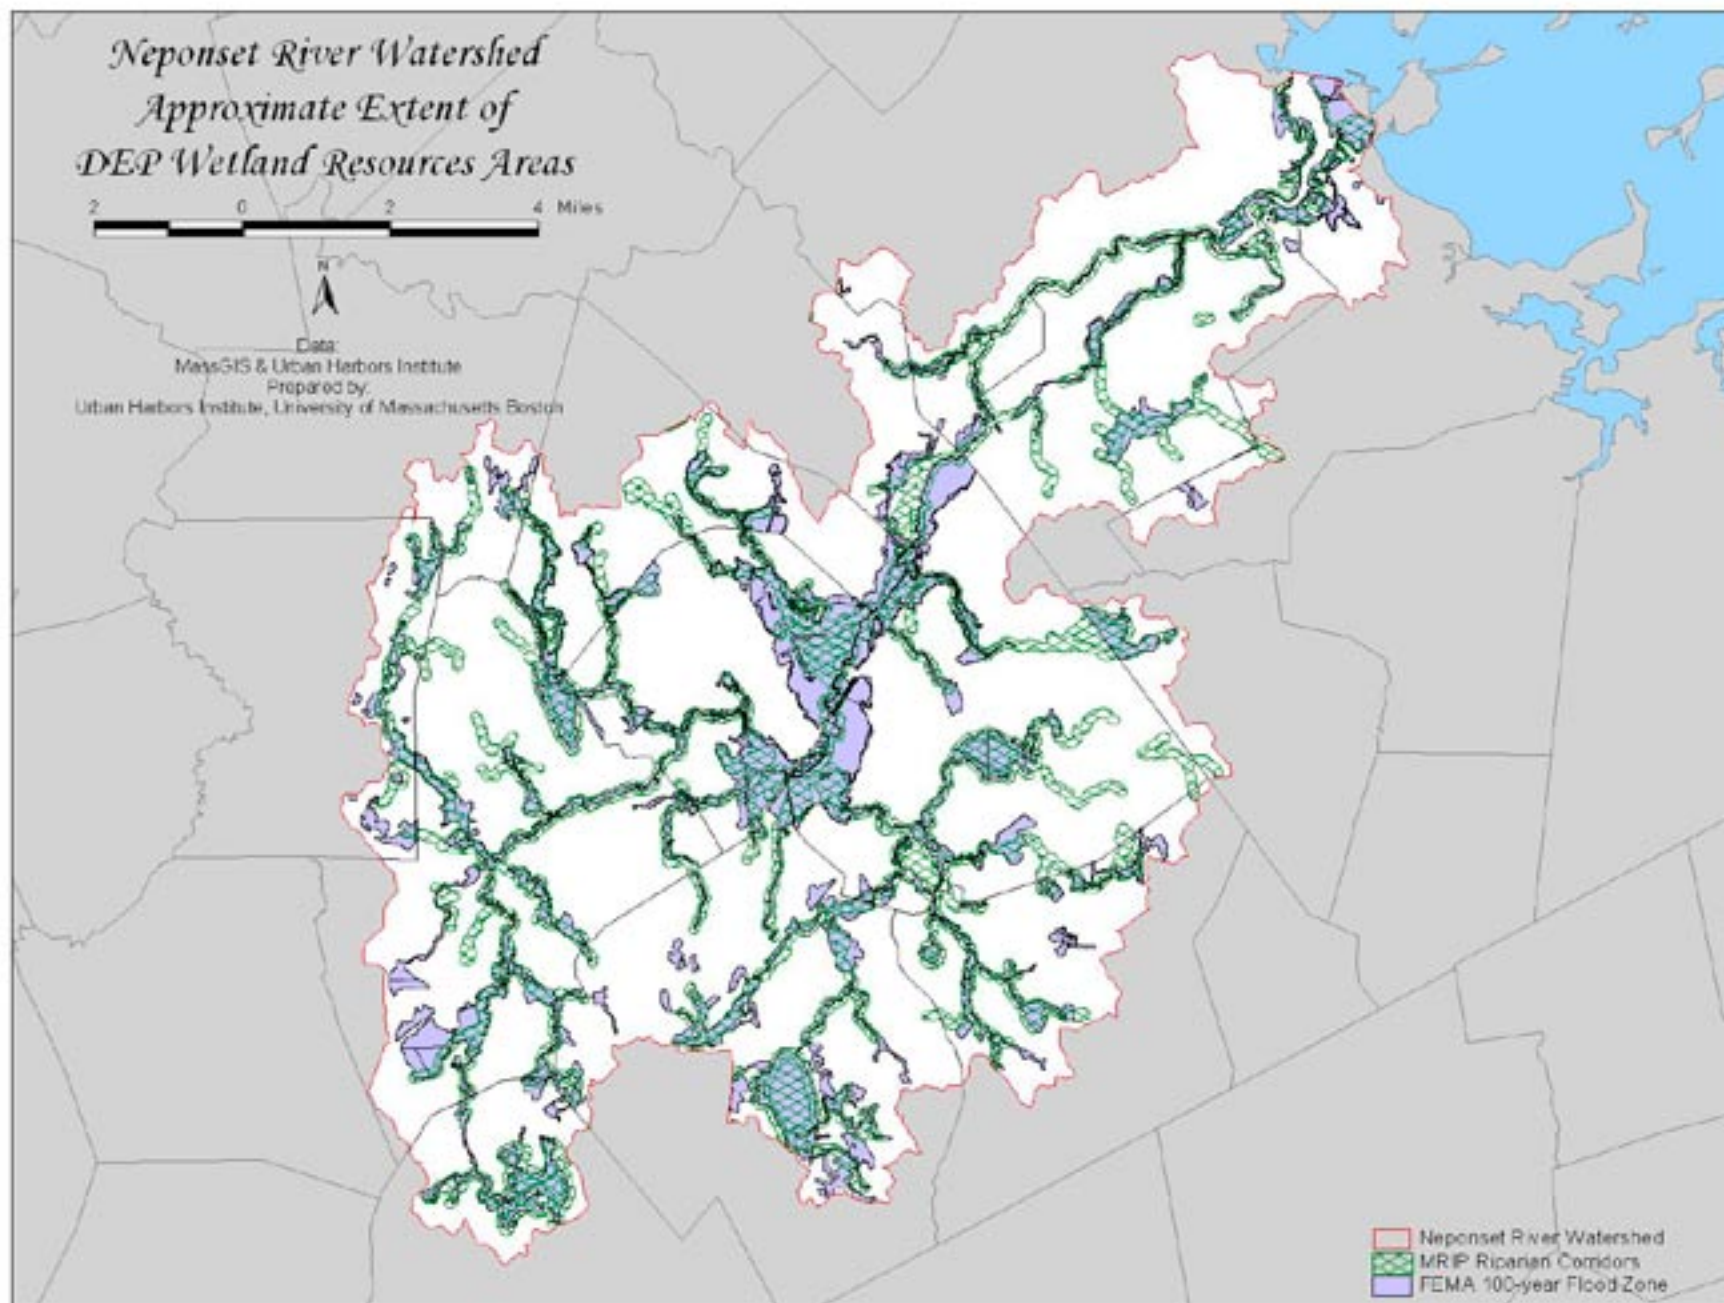
Figure 40: Neponset Approximate DEP Regulated Wetlands

Figure 40, entitled "Approximate Extent of Wetland Resource Areas," covers all wetland "resource areas" protected by the MA Wetlands Protection Act, including the 100 year floodplains. "Riparian corridors" on Figure 40 correspond generally to the riverfront resource area. Figure 38 (Coastal & Vegetated Wetland Resource Areas) shows open water, and specific types of coastal wetlands and inland bordering vegetated wetlands. These wetland resource areas make up 15.8% of the acreage in the watershed, and are subject to particularly strong protection in

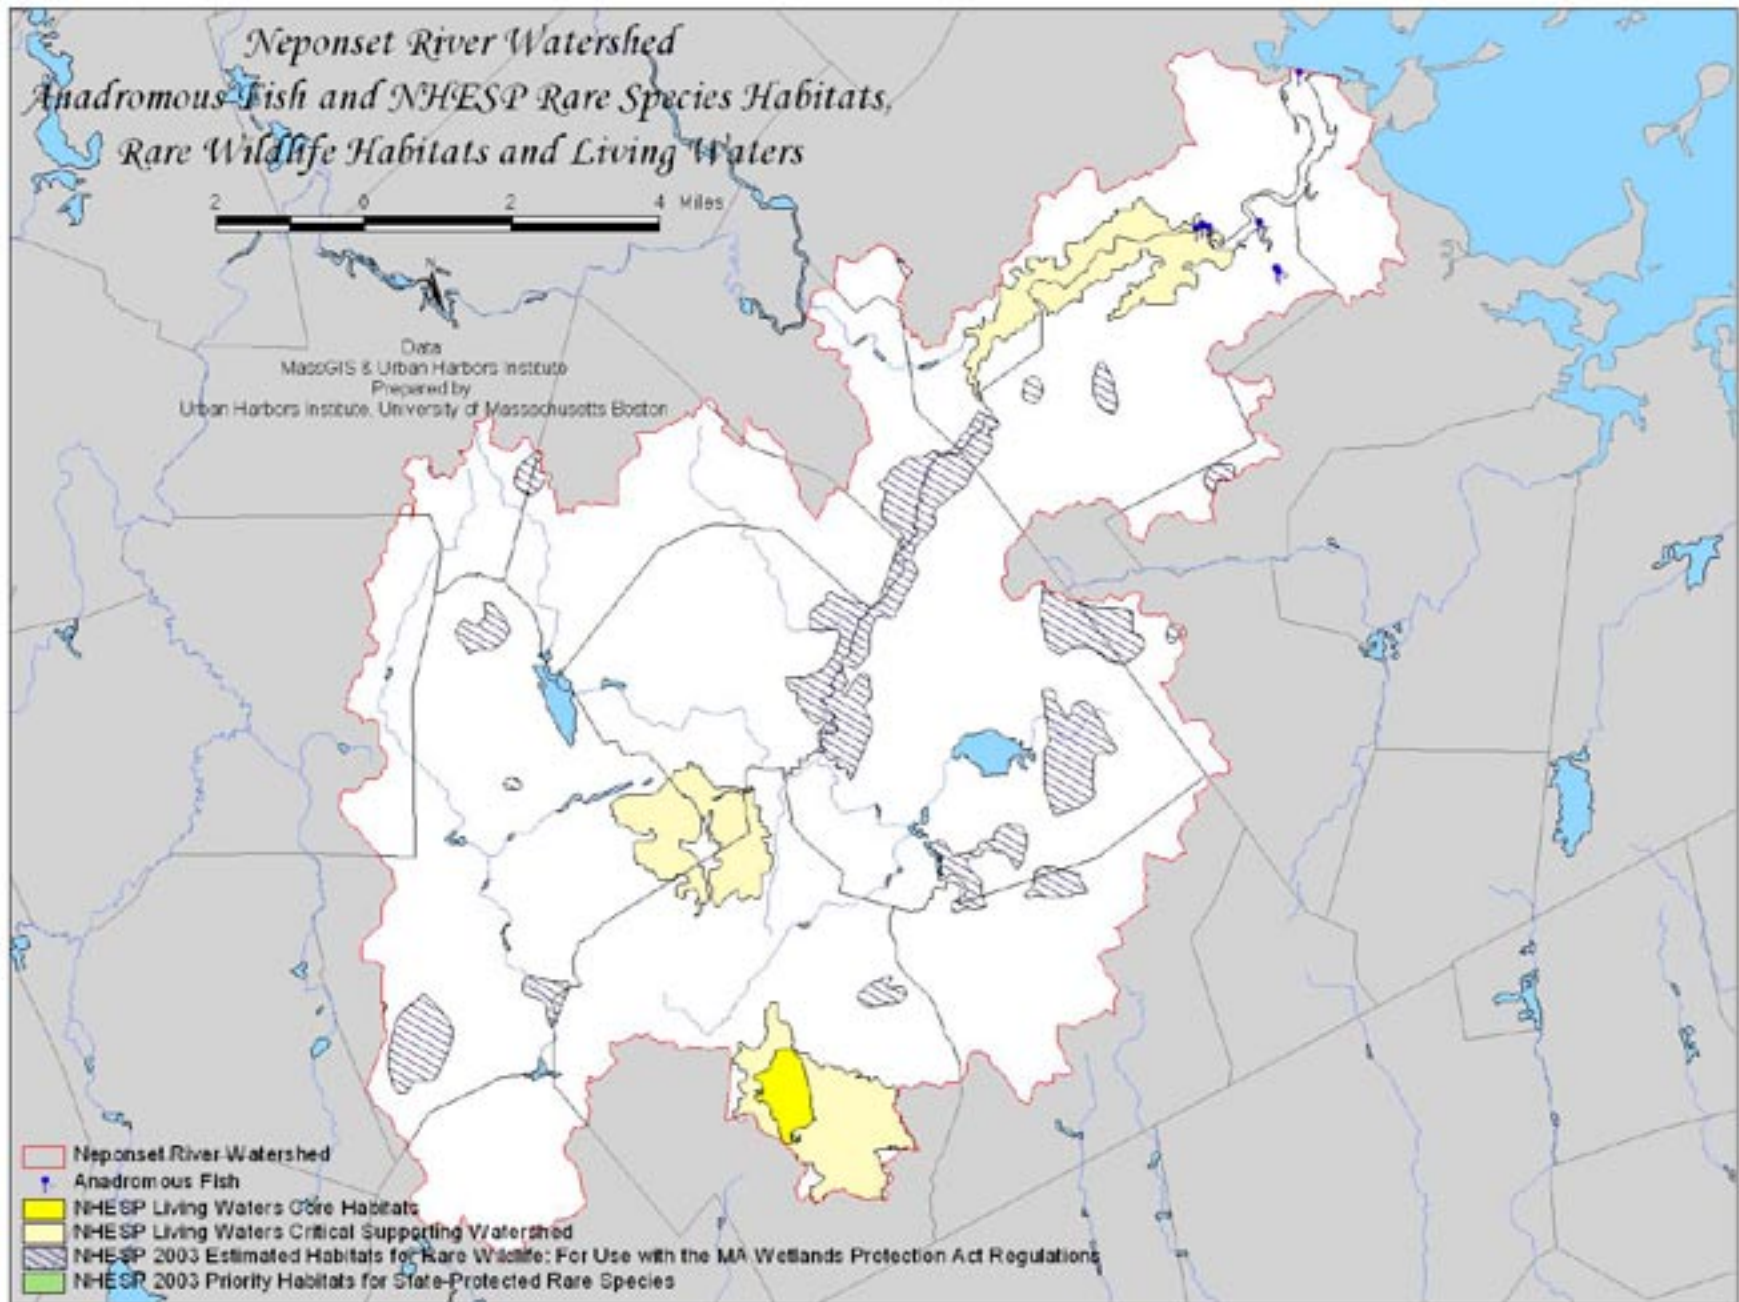
Figure 41: Neponset Anadromous Fish and Rare Species Habitats

See Figure 41. Historically a number of anadromous fish runs existed on the Neponset River, but today only 1000 feet or so (upriver of the Milton Town Landing) are used as a fish run by Rainbow Smelt. The much more extensive historic Herring and American Shad runs might be fully restored if the fish could get around the two most downstream dams on the river. This would open up the river a full seventeen miles. (See map below.)

Figure 41 covers, among other things, estimated habitats of state-protected rare animal (but not plant) species that are given extra protection if they fall within the jurisdiction of the MA Wetlands Protection Act (generally, all open waters, marshes, bogs, and their 100 year floodplains plus a 50 to 100 foot corridor around perennial rivers and streams).

Figure 41 covers, among other things, all priority habitats for state protected rare plant and animal species, not just those subject to the protection of the MA Wetlands Protection Act.

Figure 41 includes Living Water Core Habitats, which identify

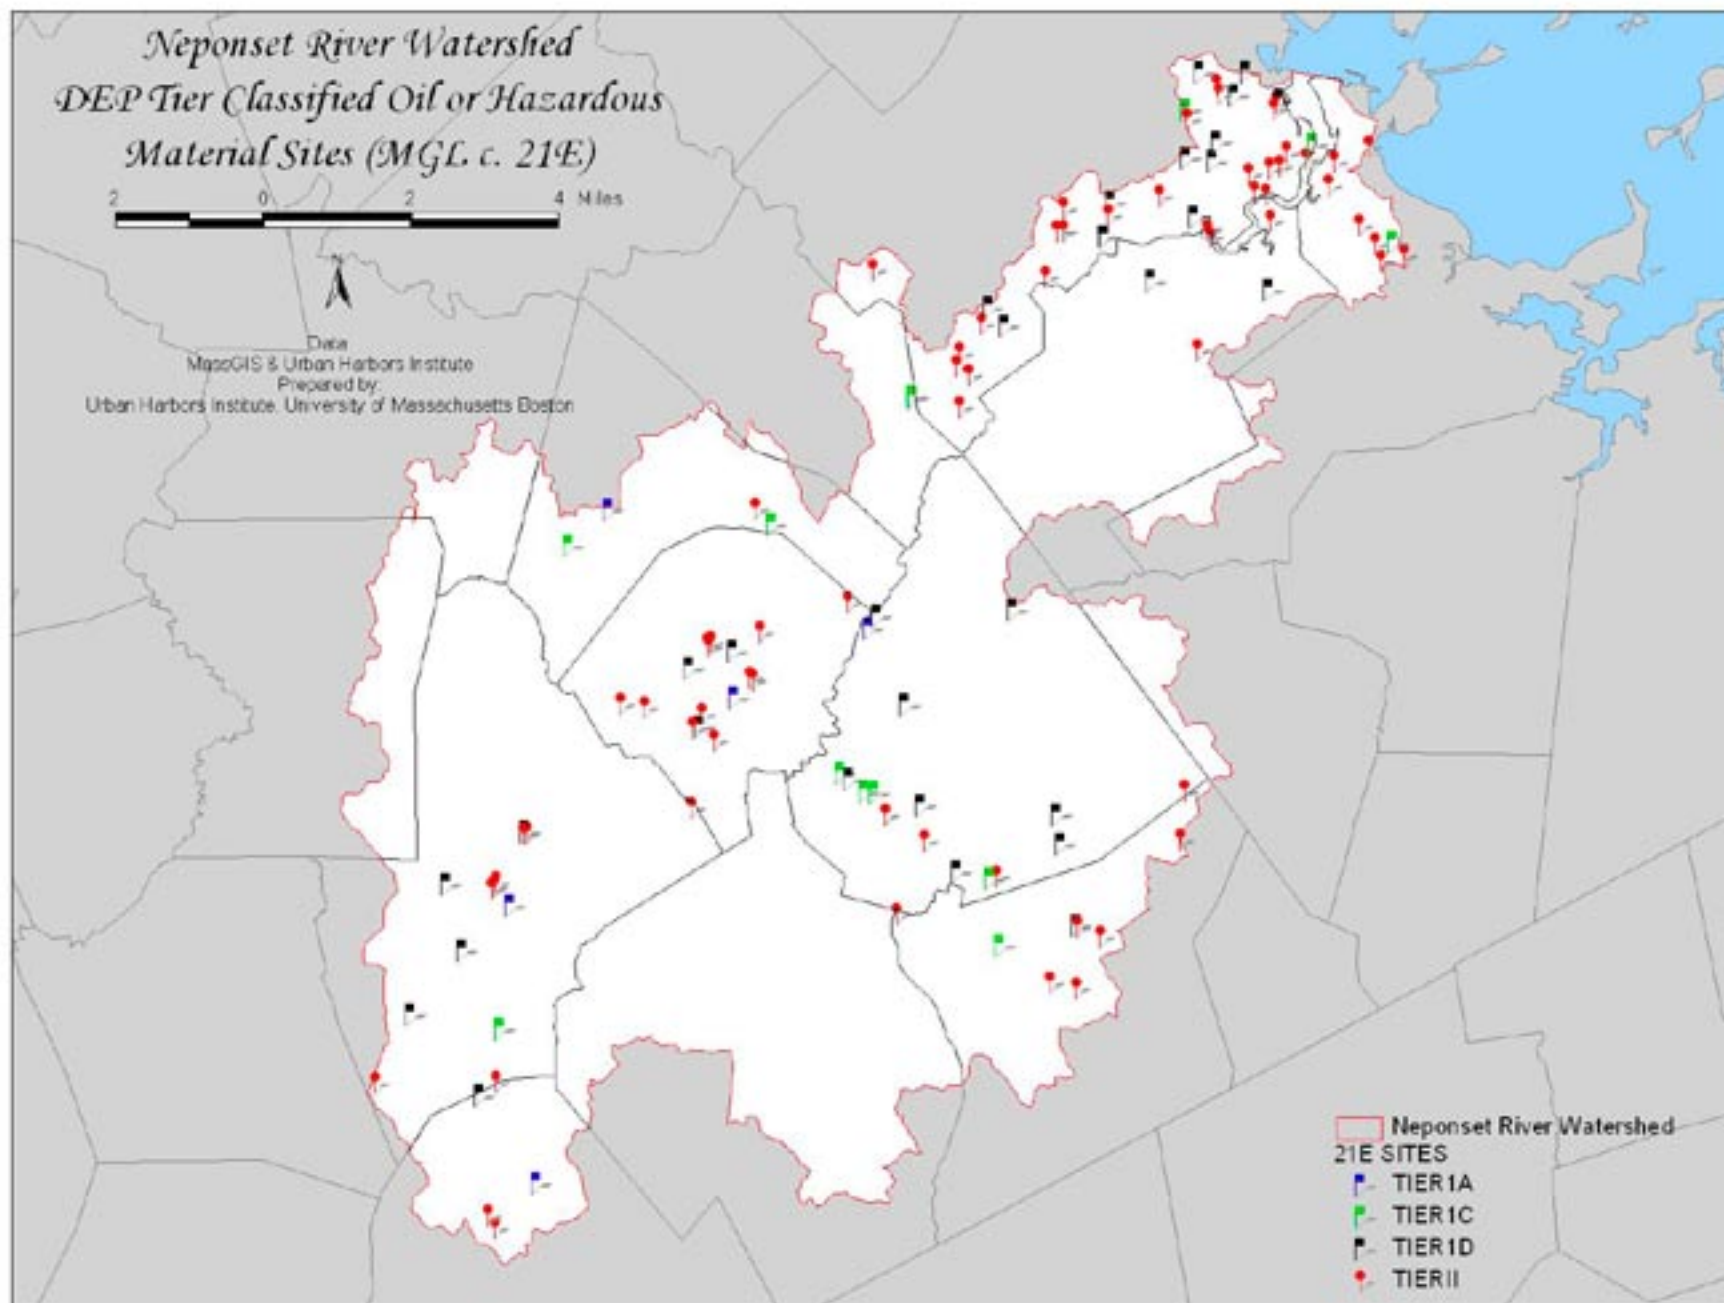
Figure 43: Neponset Contaminated Sites

Yes. See Figure 43 regarding “21E” hazardous waste sites

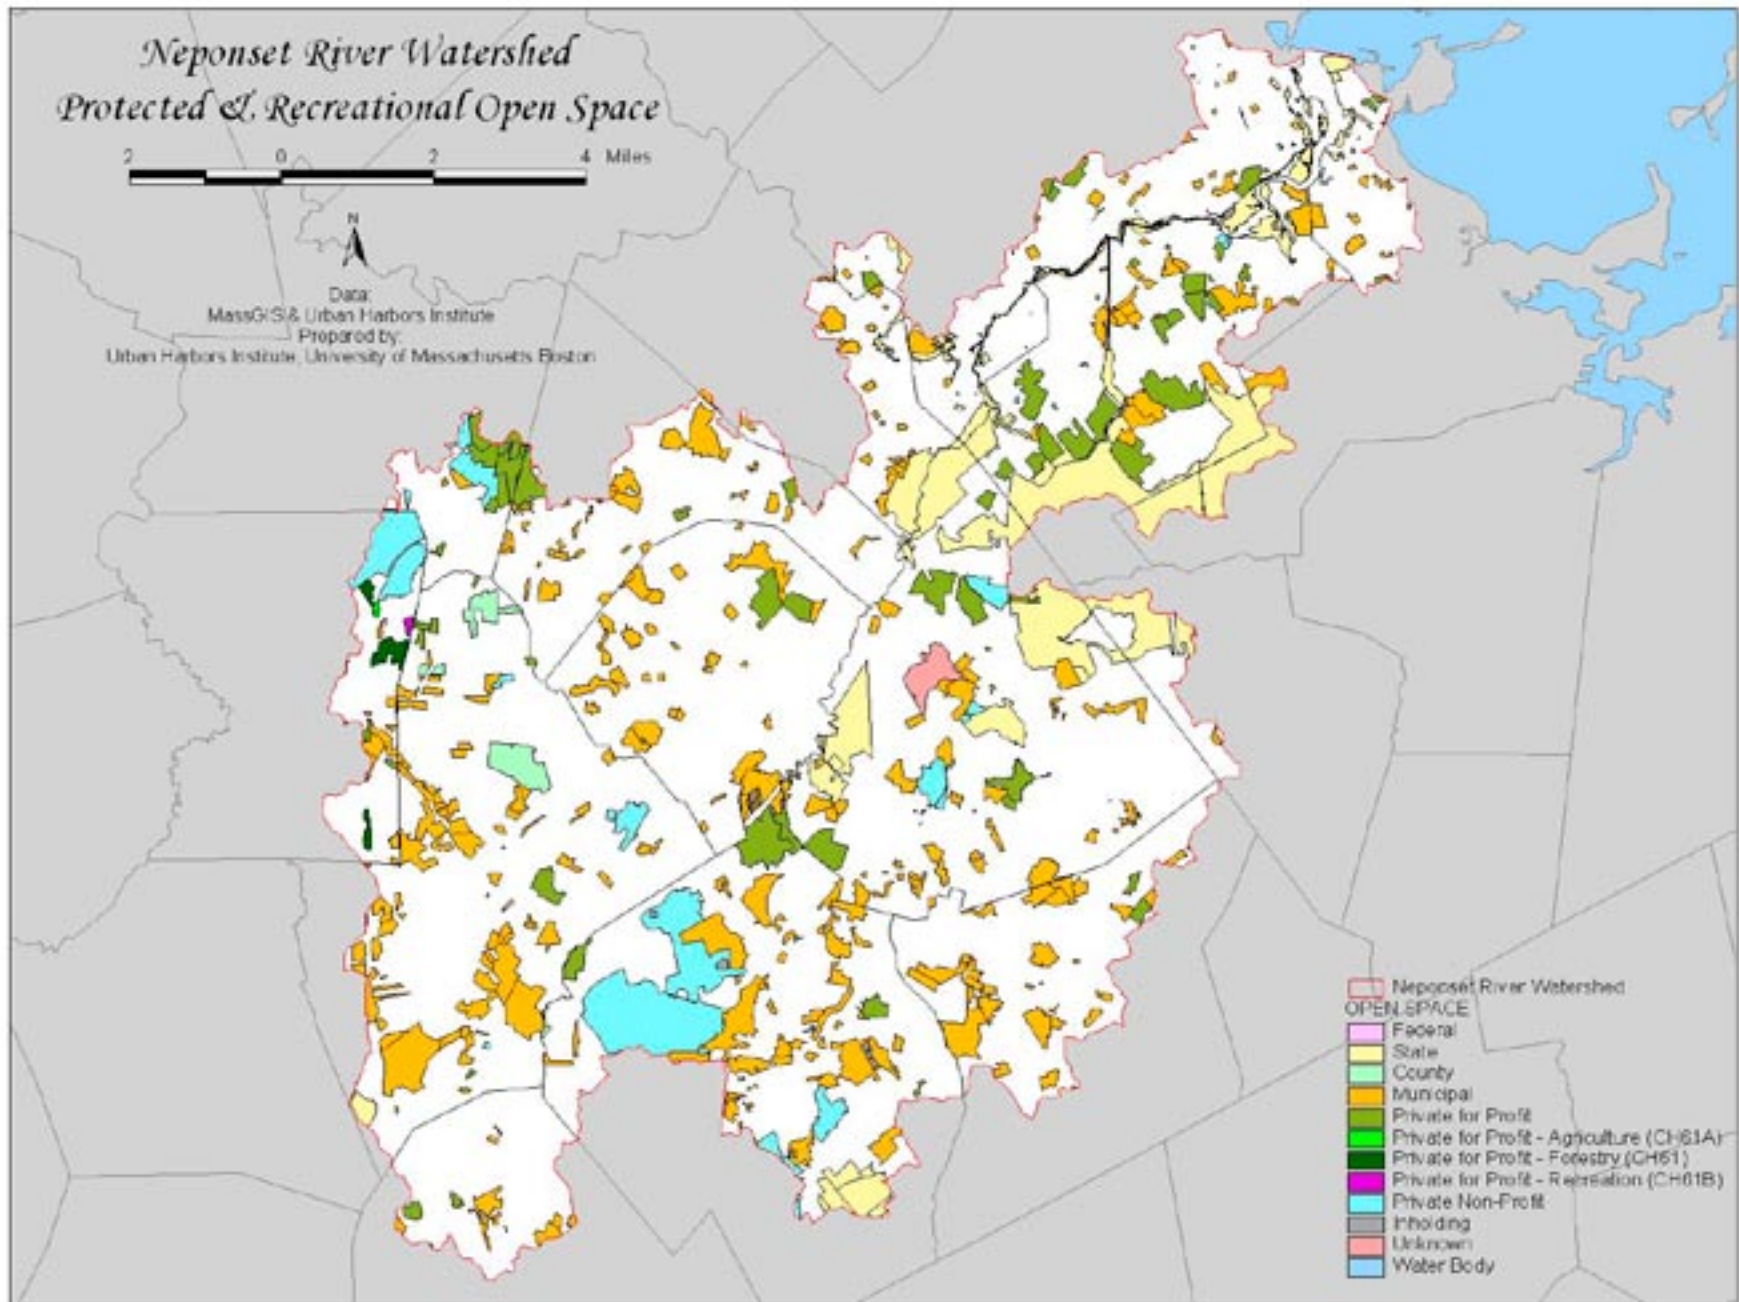
Figure 44: Neponset Open Space

20.7% of the Watershed’s total acreage is “protected” or recreational open space owned by some level of government or by nonprofit organizations. An additional 4.3% is owned by private for-profits. It is uncertain, however, how much of this land could be considered “permanently protected open space.” (See Figure 44 .)

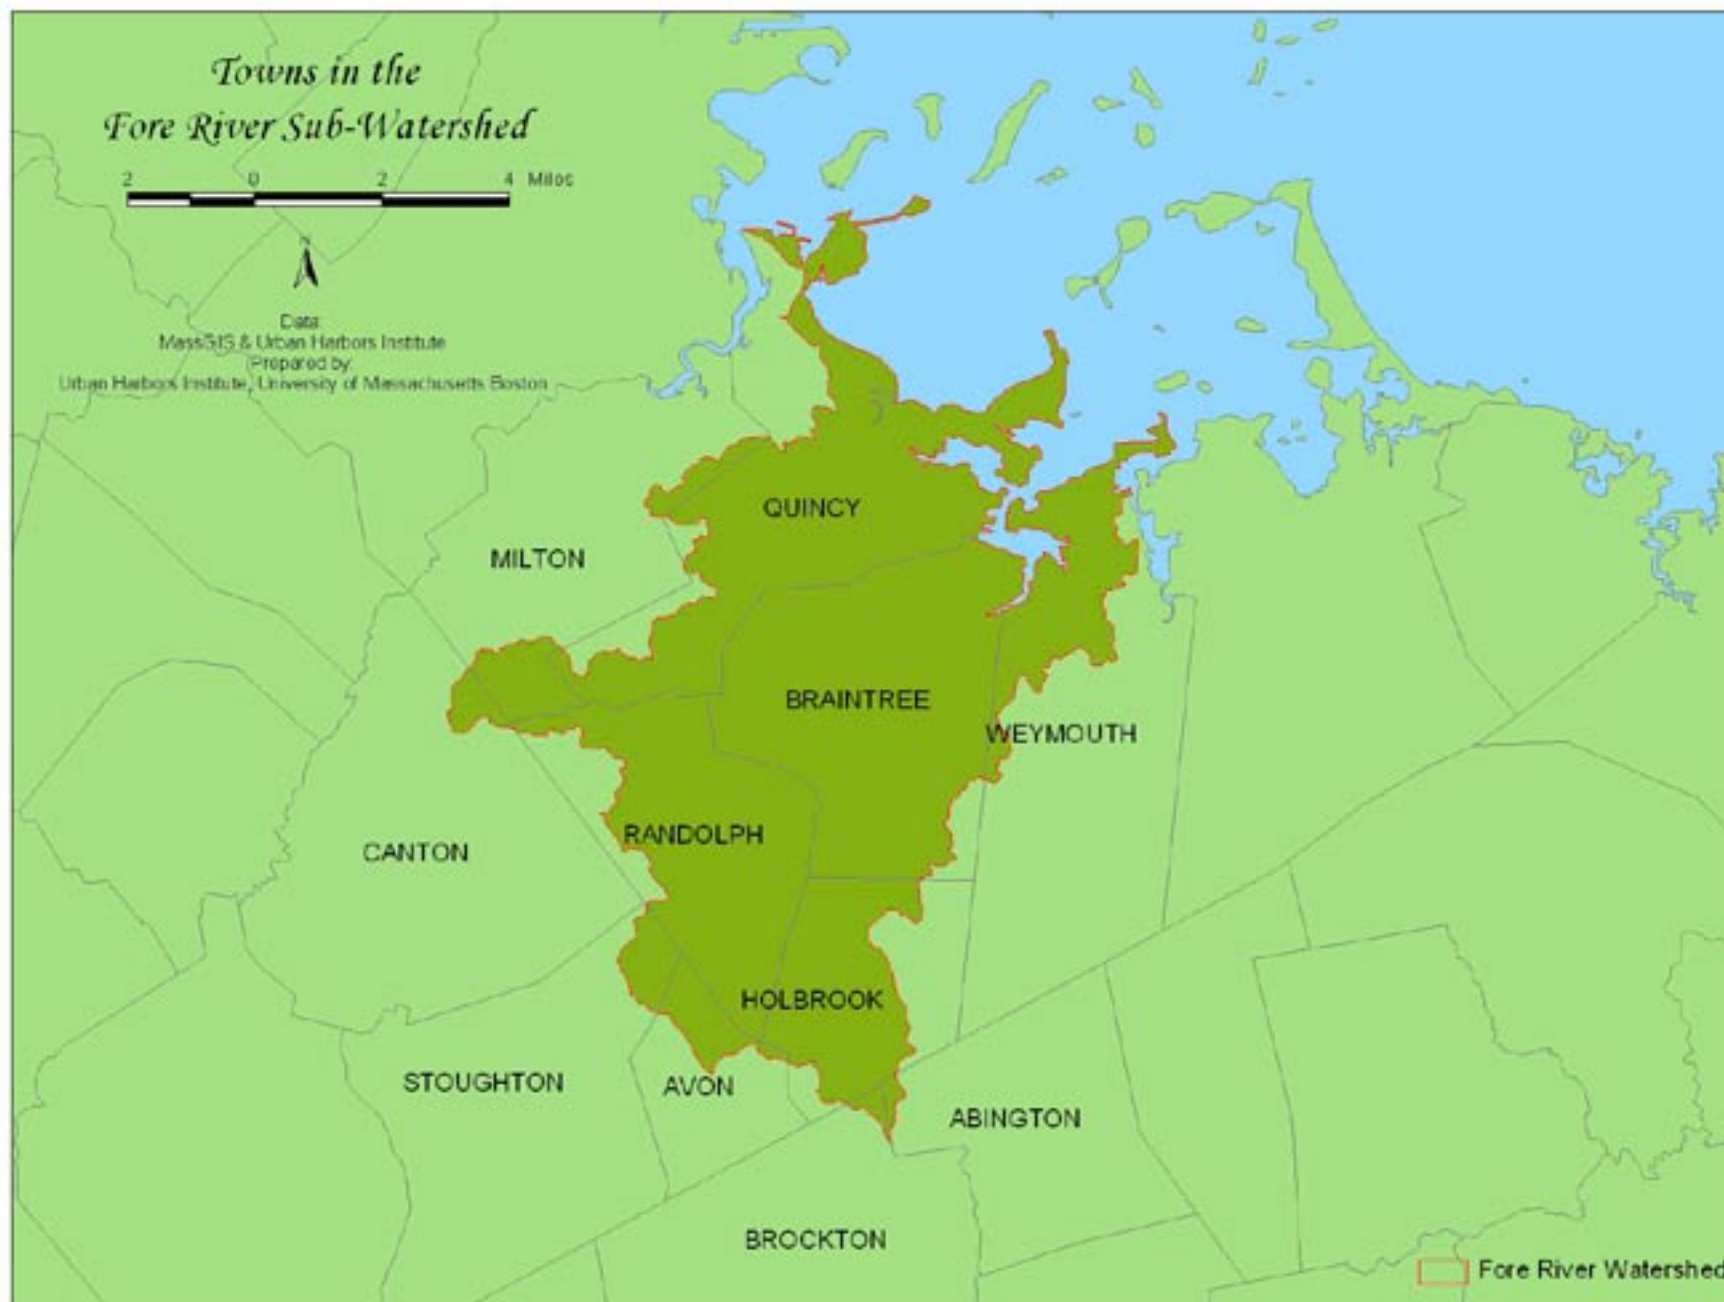
Figure 45: Fore Towns

The Fore River watershed is illustrated in Figure 45. It is a small watershed contained within the larger Weymouth and Weir watershed, which in turn is a component of the larger Boston Harbor watershed. The Fore River watershed covers an area of approximately 49.2 square miles and encompasses portions of the towns of Quincy (27%), Weymouth (8%), Braintree (28%), Randolph (18%), Holbrook (10%), Milton (3%), Canton (1%), Stoughton (2%), and Avon (2%).

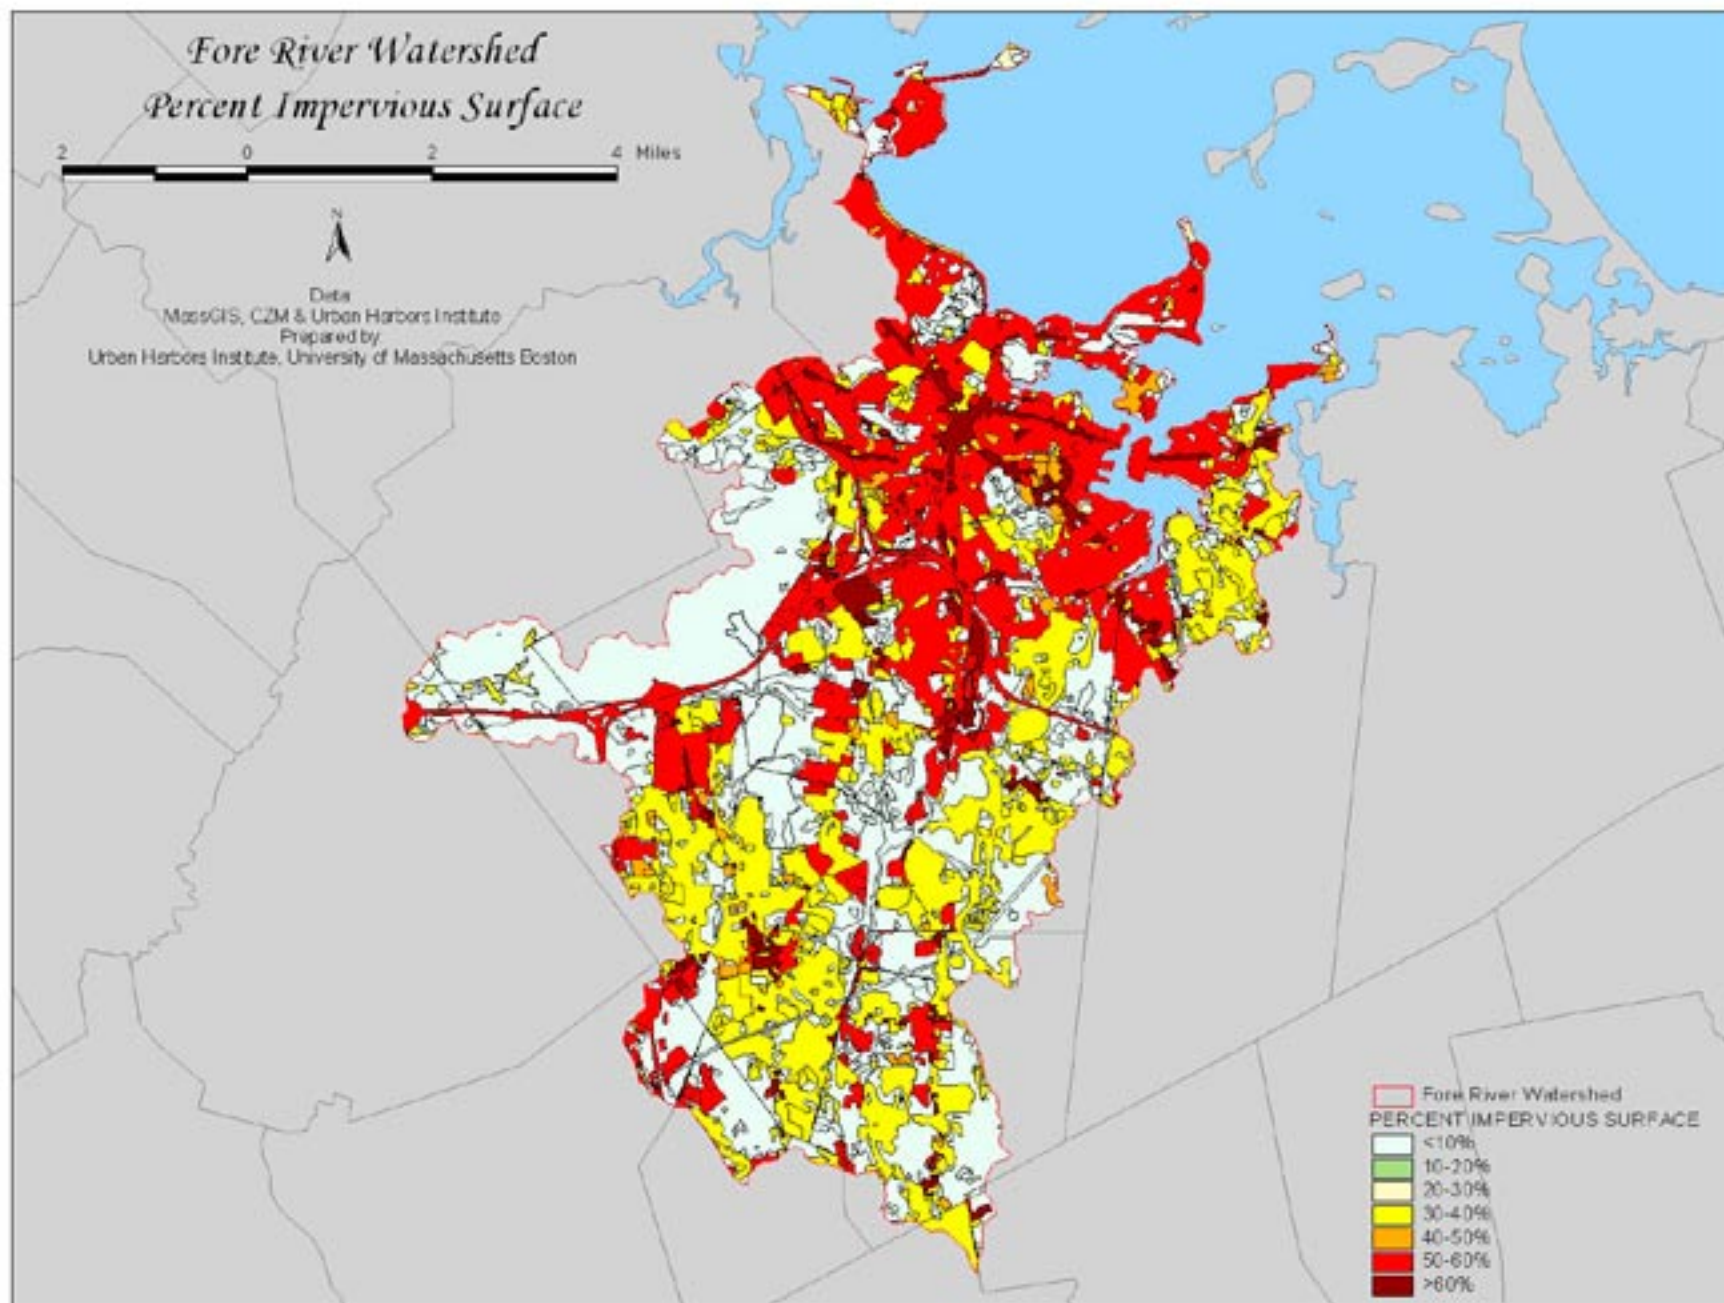
Figure 50: Fore Impervious Surface

Resources Science Cooperative Extension (Joubert et al. 2000) for use with the 21 class data provided by MassGIS. Using these impervious surface coefficients, estimates of the total amount of impervious surface within the watershed can be made.

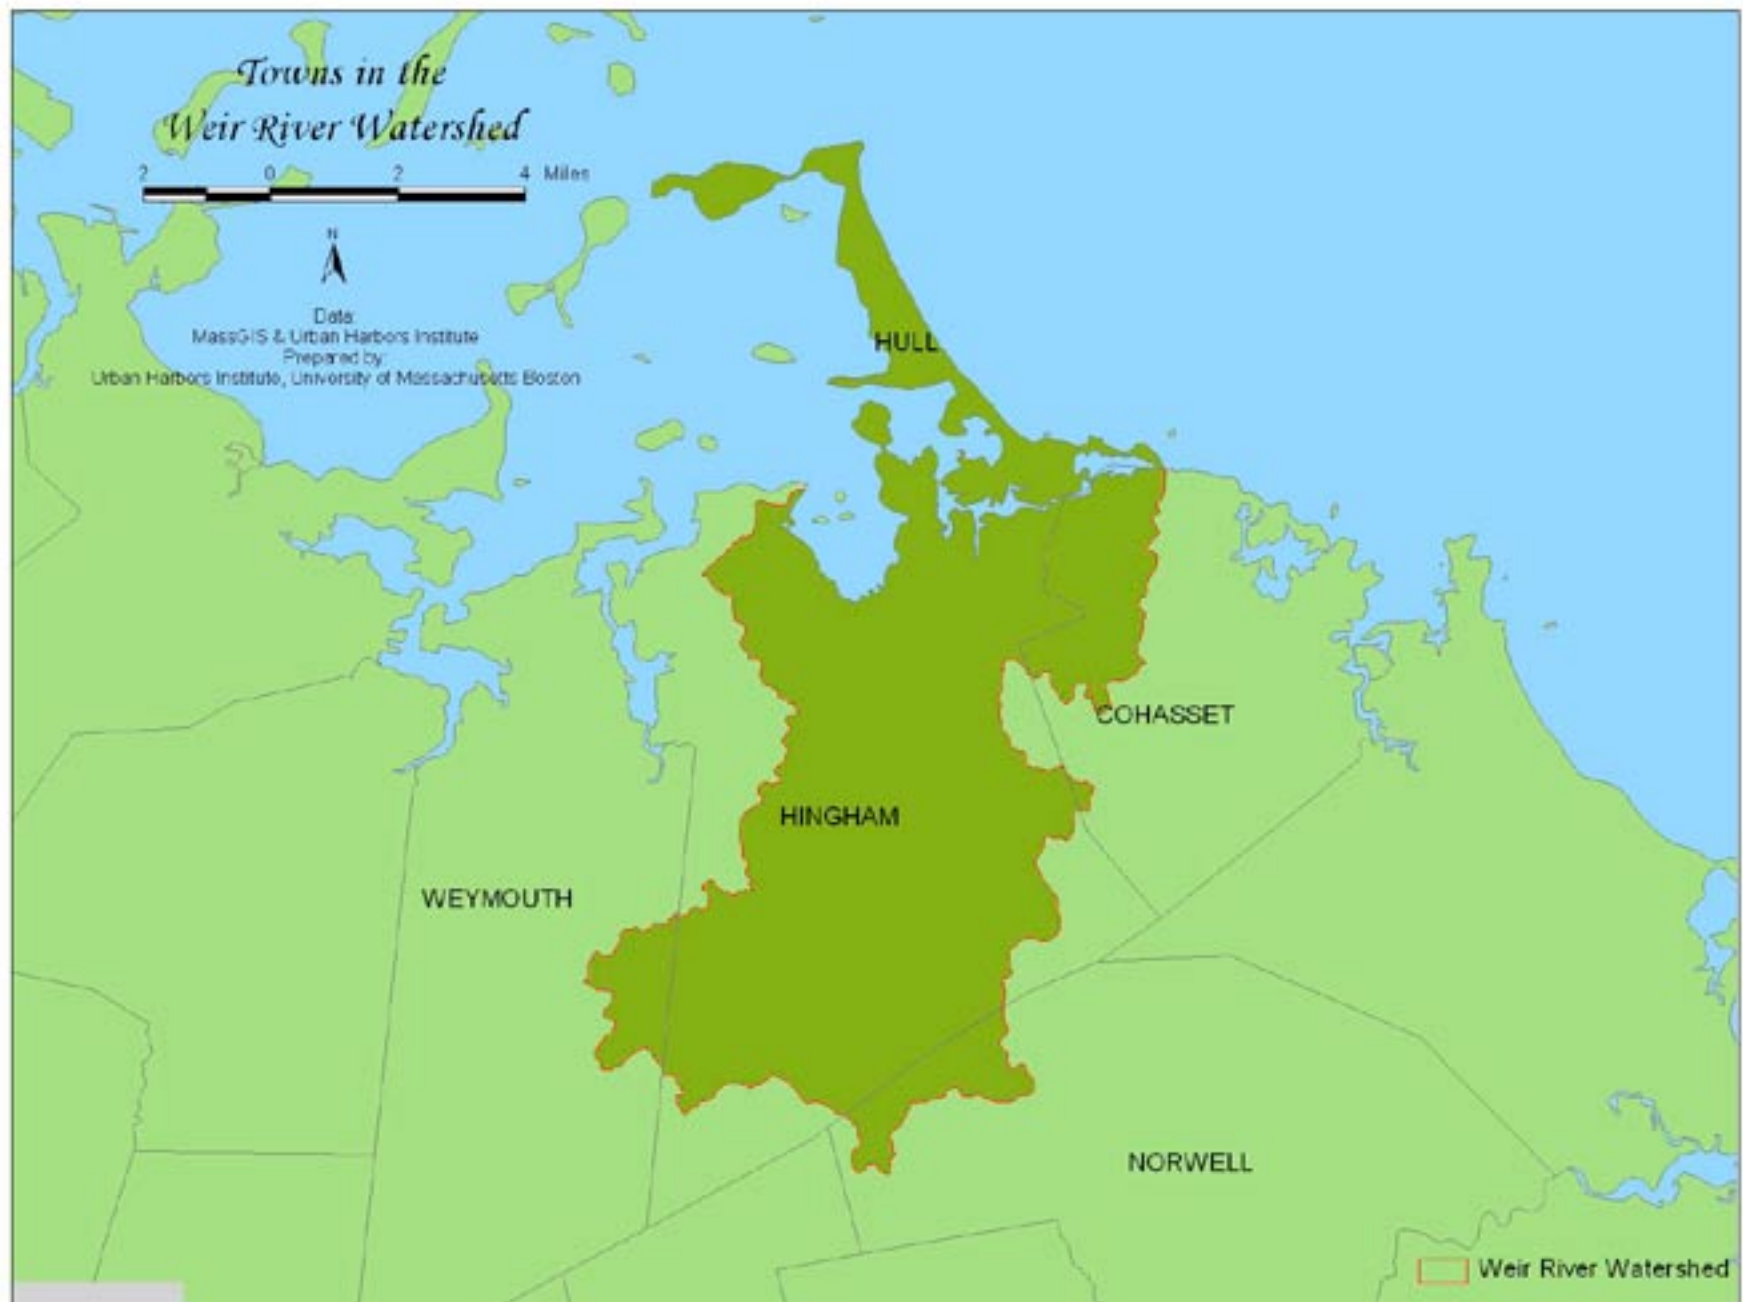
Figure 79: Weir Towns:

Town	Acreage of town	Acreage in watershed	Percent of town in watershed	Percent of the watershed
Cohasset	6431.8	1320.5	20.5	9.1
Hingham	14513.8	10375.2	71.5	71.5
Hull	1640.2	1640.2	100	11.3
Norwell	13566.9	634.9	4.6	4.4
Weymouth	11250.4	537.0	4.8	3.7
<b>Totals</b>	<b>47403.1</b>	<b>14507.8</b>		<b>100.0</b>

The Weir River Watershed is comprised of approximately 14,500 acres. Table 31 presents the acreage of each town, acreage of the town in the Weir river watershed, the percentage of the town in the watershed, and the percent each town is of the watershed.

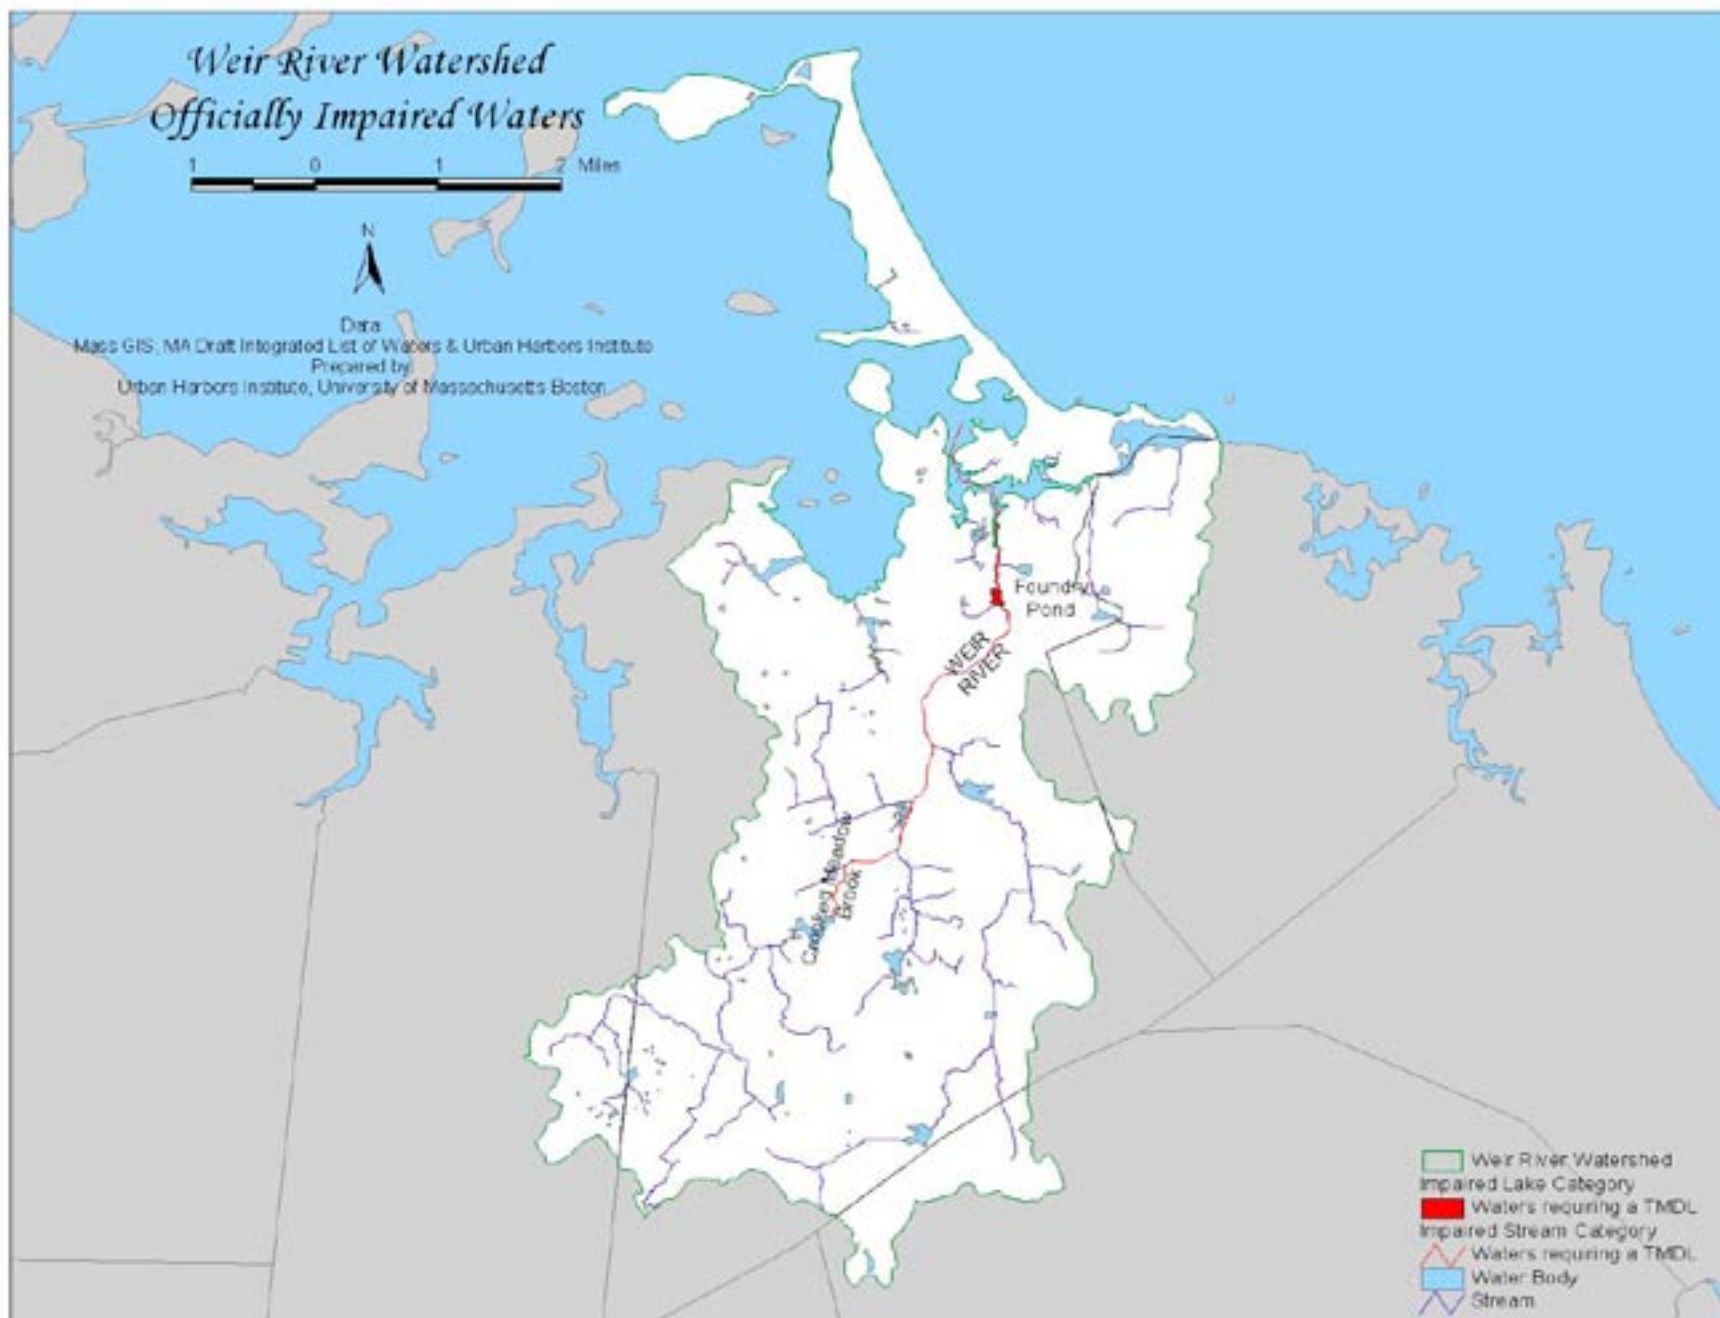
Figure 83: Weir Officially Impaired Waters (note majority of watershed is unassessed)
