# **Boston Harbor South Watersheds 2004 Assessment Report**

**June 30, 2004**

**Massachusetts Executive Office of Environmental Affairs**

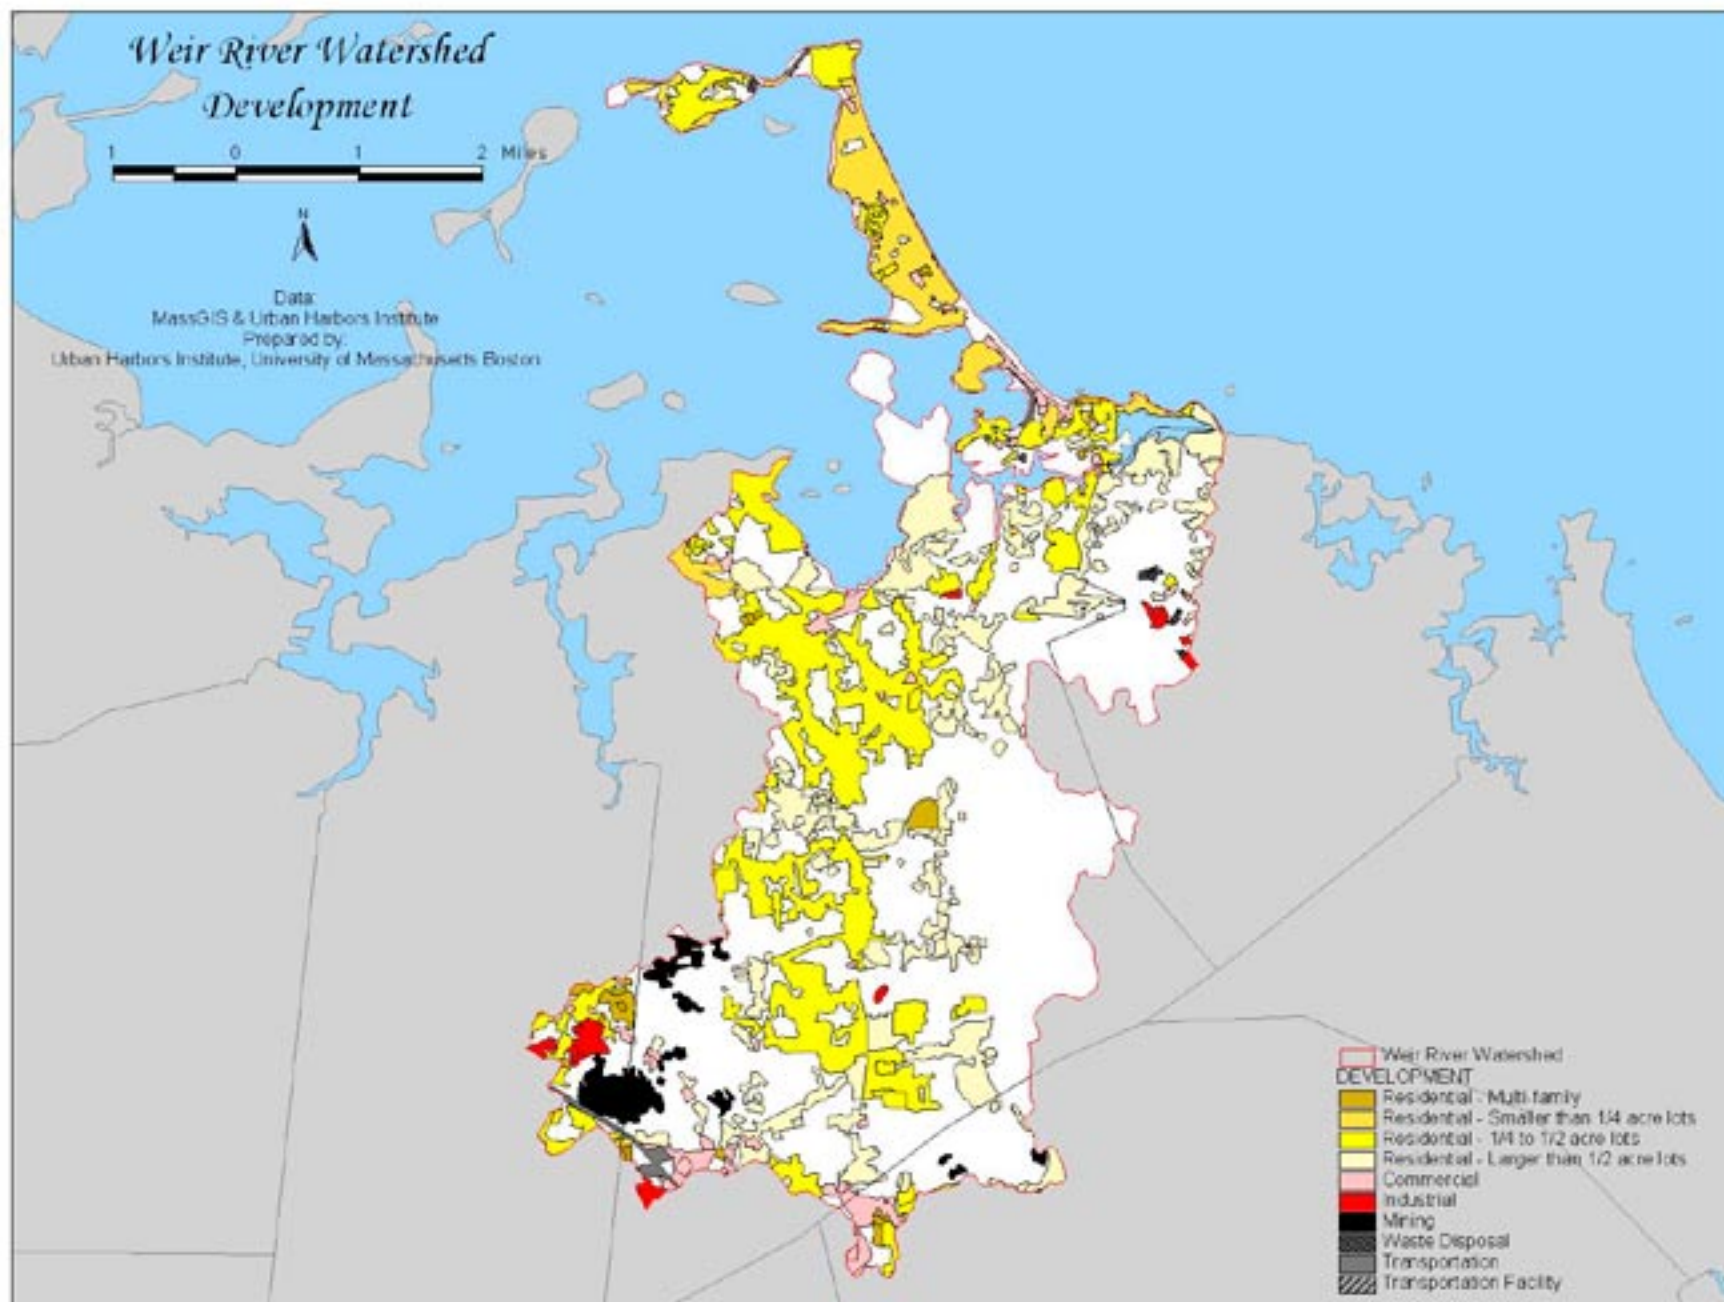
Figure 84: Weir Development

combination of public sewer systems and private septic systems. In general, much of north Hingham and all of Hull are sewered. Less than half of Cohasset residents use septic systems, but all Norwell residents have septic systems. Virtually all of Weymouth is connected to municipal sewers.

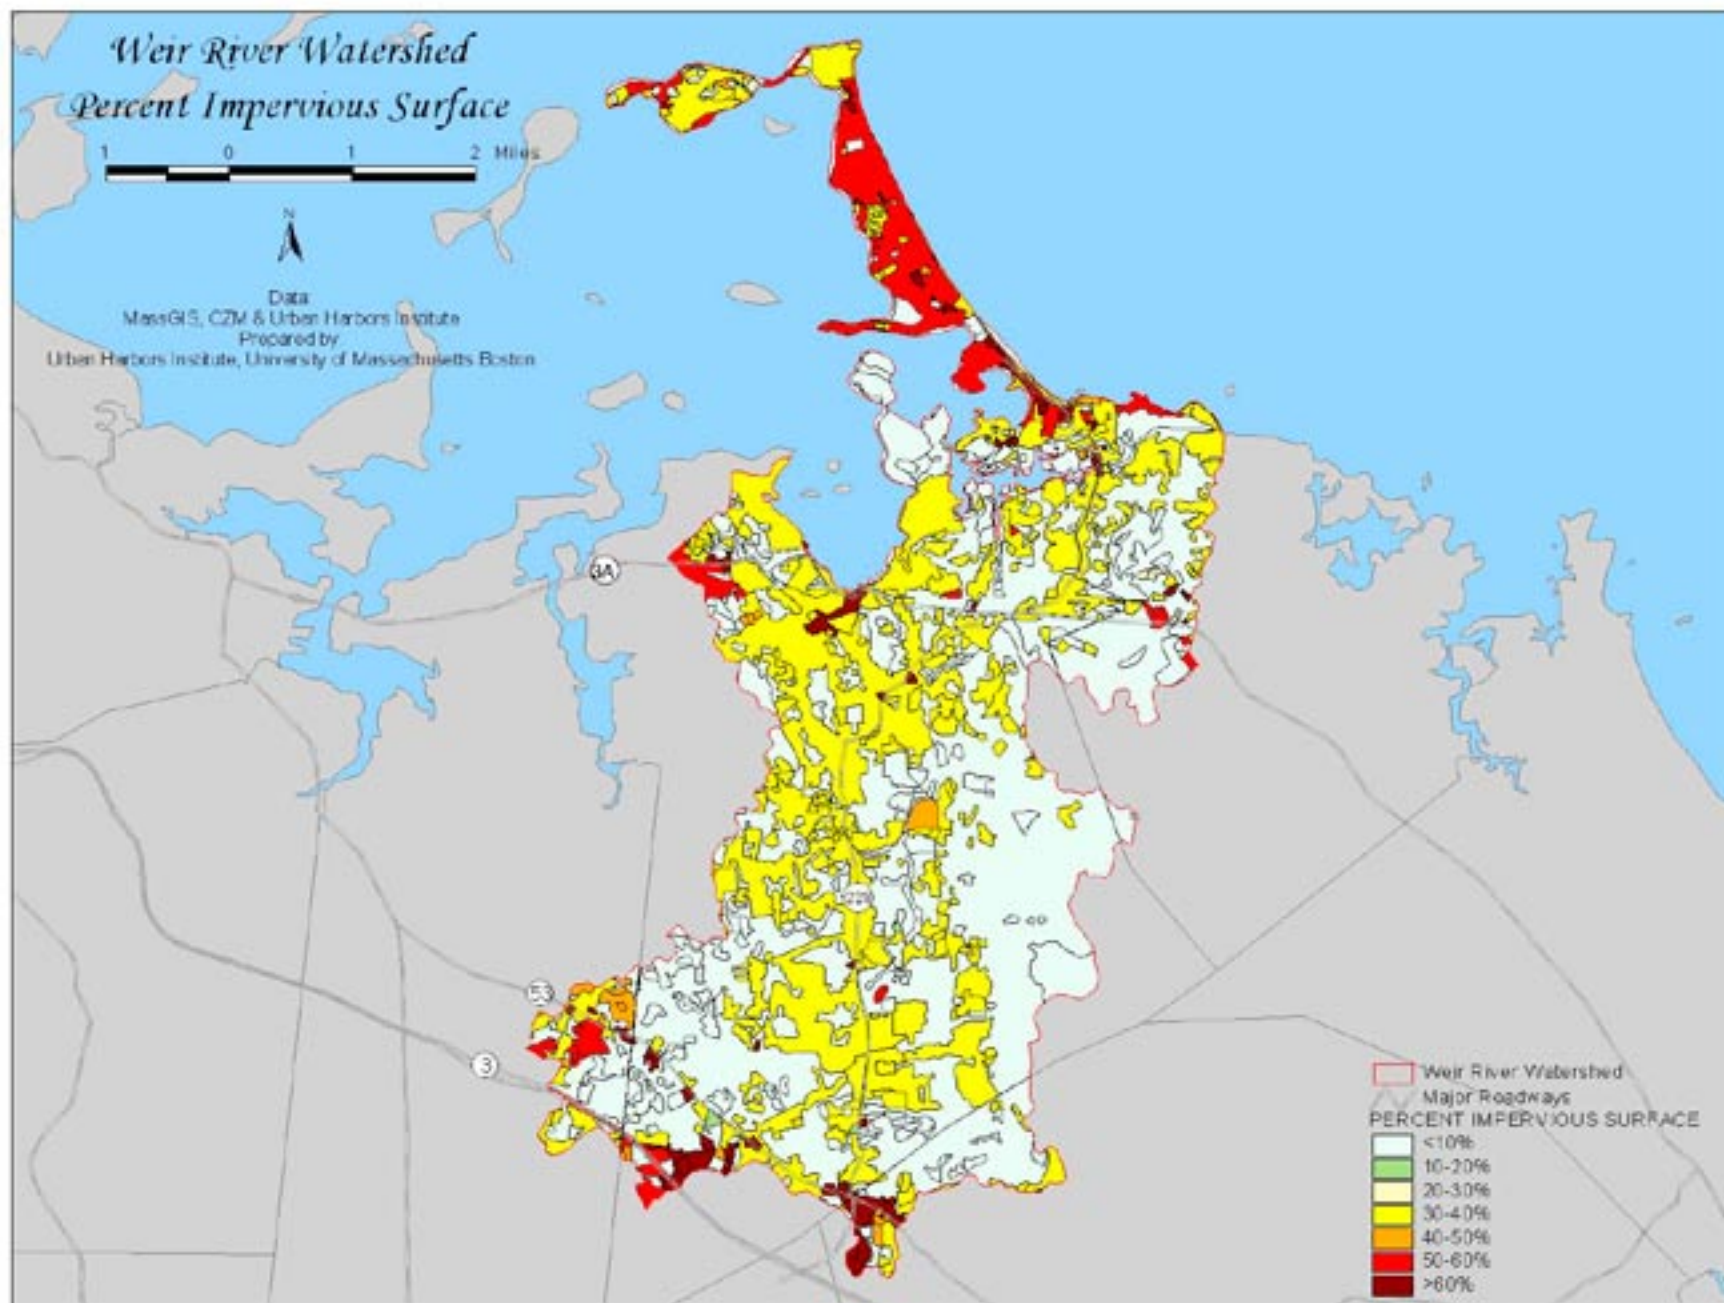
Figure 85: Weir Impervious Surface

Approximately 2,855 acres (20 percent) of the Weir River watershed is impervious surface, with the greatest amount of imperviousness concentrated closer to the coastline and along major thoroughfares. The figures and table below illustrate the impervious surface coverage for the watershed. Impervious coverage is an effect of land cover disturbance and is a widely-used indicator of human impact. A surface is considered impervious if it has been covered or compacted with a layer of material that substantially reduces or prevents rain or storm water from filtering into the ground. Estimates of impervious cover for disturbed land cover classes have been developed by University of Rhode Island’s Department of Natural Resources Science Cooperative Extension (Joubert et al. 2000) for use with the 21 class data provided by MassGIS. Using these

Land Use Type	Mean Impervious Area Ratio	Weir River Sub-Watershed	
		Total Acreage	Total Impervious
Cropland	0.090	97.9	8.8
Pasture	0.080	244.6	19.6
Forest	0.078	6019.3	469.5
Wetland	0.055	221.3	12.2
Mining	0.067	258.0	17.3
Open Land	0.029	263.8	7.7
Participation Recreation	0.060	457.4	27.4
Spectator Recreation	0.050	0.0	0.0
Water Based Recreation	0.343	83.4	28.6
Residential (Multi-family)	0.454	142.8	64.8
Residential (Smaller than 1/4 acre lots)	0.543	674.6	366.3
Residential (1/4 - 1/2 acre lots)	0.305	2603.2	794.0
Residential (Larger than 1/2 acre lots)	0.304	2005.8	609.8
Salt Wetland	0.016	168.9	2.7
Commercial	0.640	348.2	222.9
Industrial	0.547	116.1	63.5
Urban Open	0.311	301.0	93.6
Transportation	0.508	63.6	32.3
Waste Disposal	0.218	21.5	4.7
Water	0.029	228.3	6.6
Orchard, Nursery or Cranberry Bog	0.154	15.1	2.3
<b>TOTAL</b>		<b>14334.9</b>	<b>2854.6</b>
<b>% of Sub-Watershed Impervious</b>			<b>19.9</b>

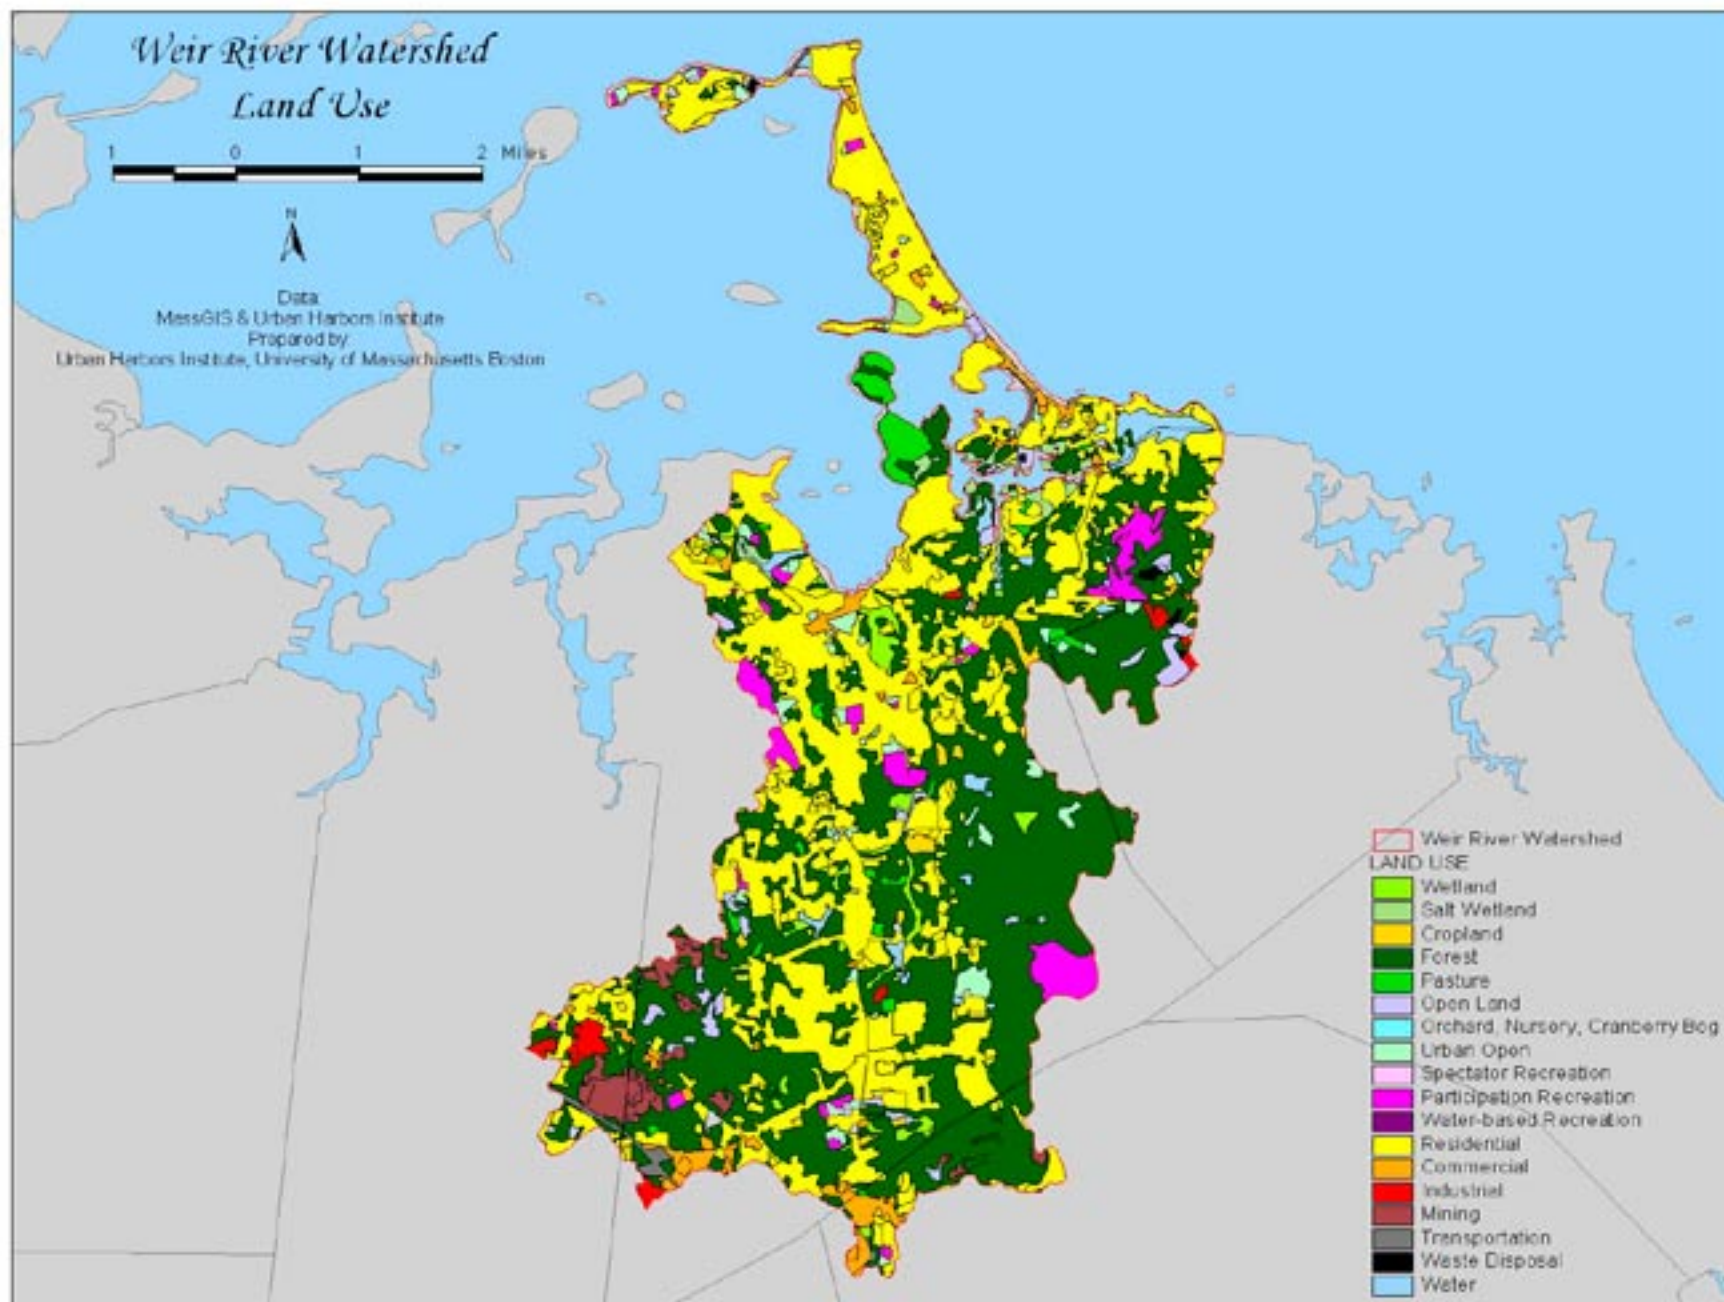
Figure 93: Weir Land Use

As can be seen in Table 33, nearly one-half (42 percent) of the watershed is forested. The only other significant category of land use is residential, at almost 40 percent.
