**Documentary Research and Archaeological
Investigations at the Waite-Kirby-Potter Site,
Westport, Massachusetts**

**Prepared for:
The Community Preservation Committee
Town of Westport
Westport, MA**

**Prepared by:
Katharine M. Johnson and Christa M. Beranek
With contributions by Kathryn A. Catlin and Laura W. Ng
Fiske Center for Archaeological Research
University of Massachusetts Boston**

Cultural Resource Management Study No. 37

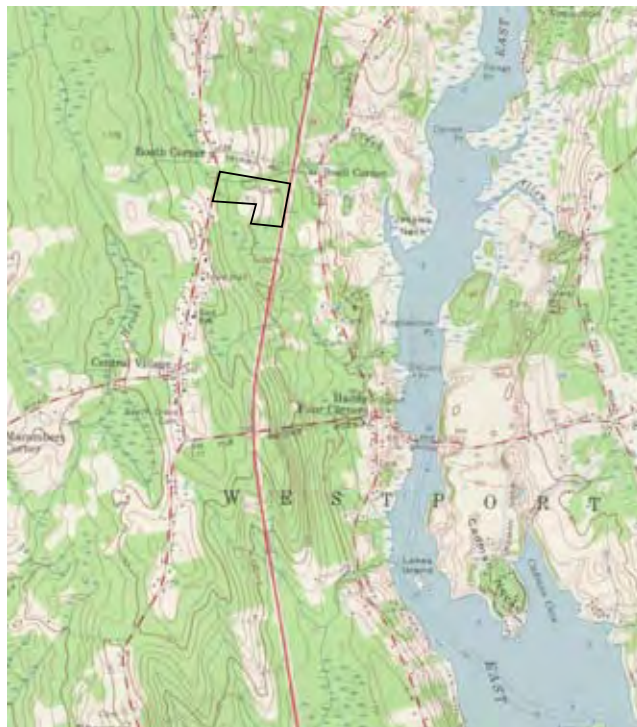
Figure 1.1: Property boundaries on the USGS Westport quad map.

The Waite-Kirby-Potter site (WSP.HA.22) is situated approximately one mile north of Westport's Central Village on the east side of Main Road (Figures 1.1 and 1.2). Site forms were submitted to the Massachusetts Historical Commission by the Public Archaeology Lab following their intensive survey of the town's historical and

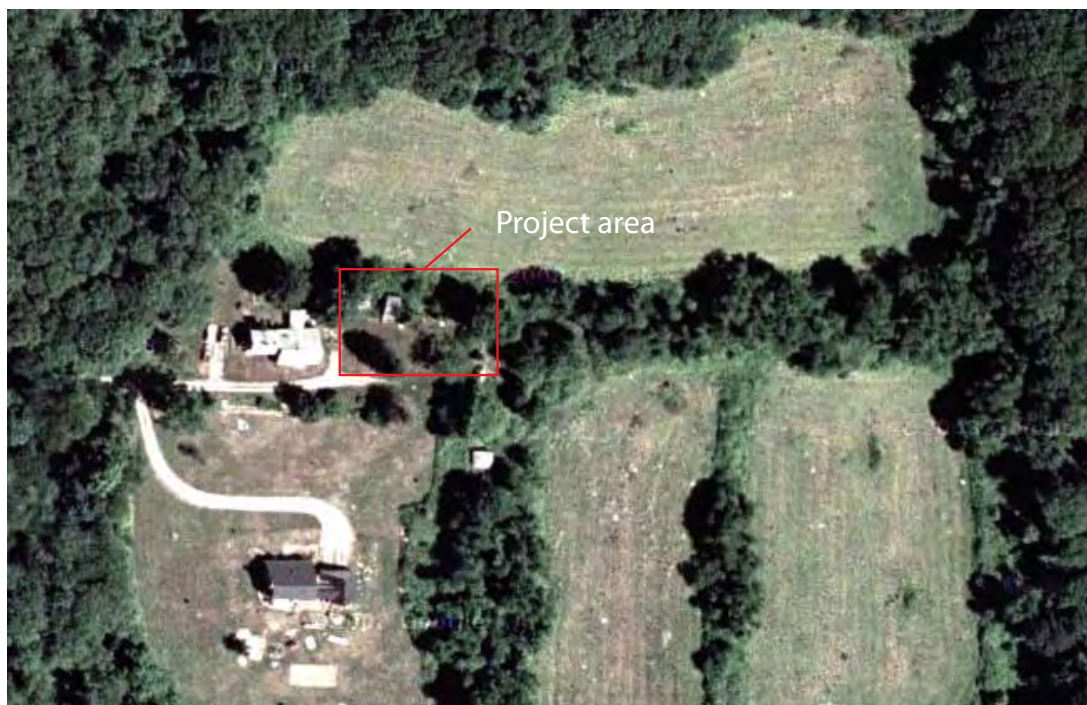
Figure 1.2: The project area within the larger property boundaries.

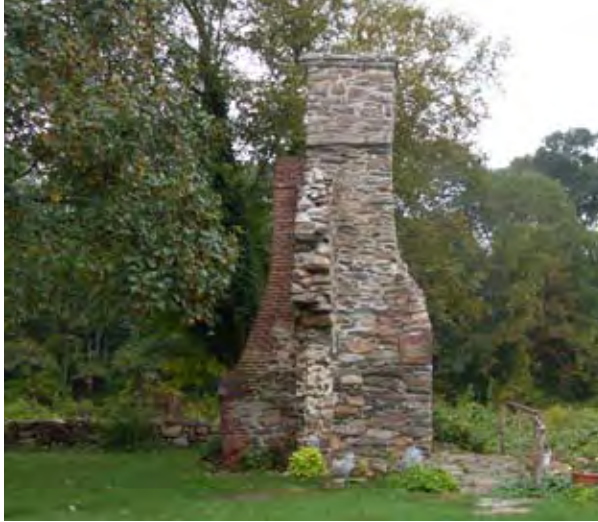
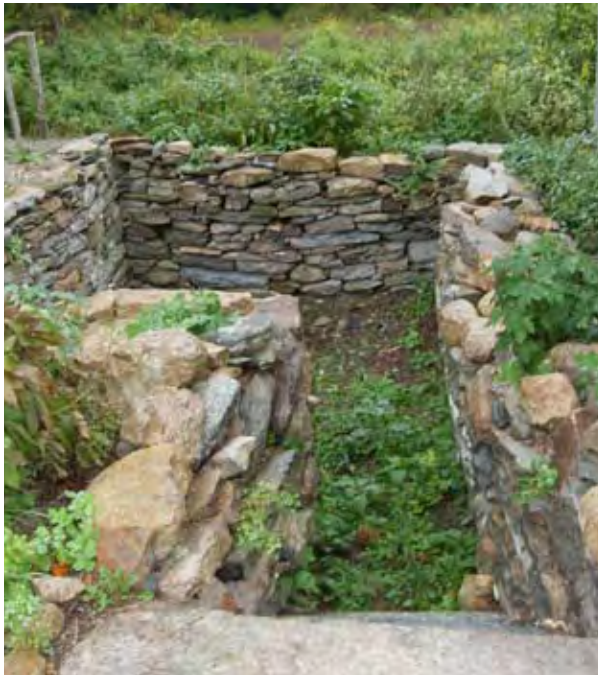
Figure 1.3: Photograph of current conditions. Top) Standing chimneys; Bottom) Open cellar hole east (to the right) of the stone chimney.

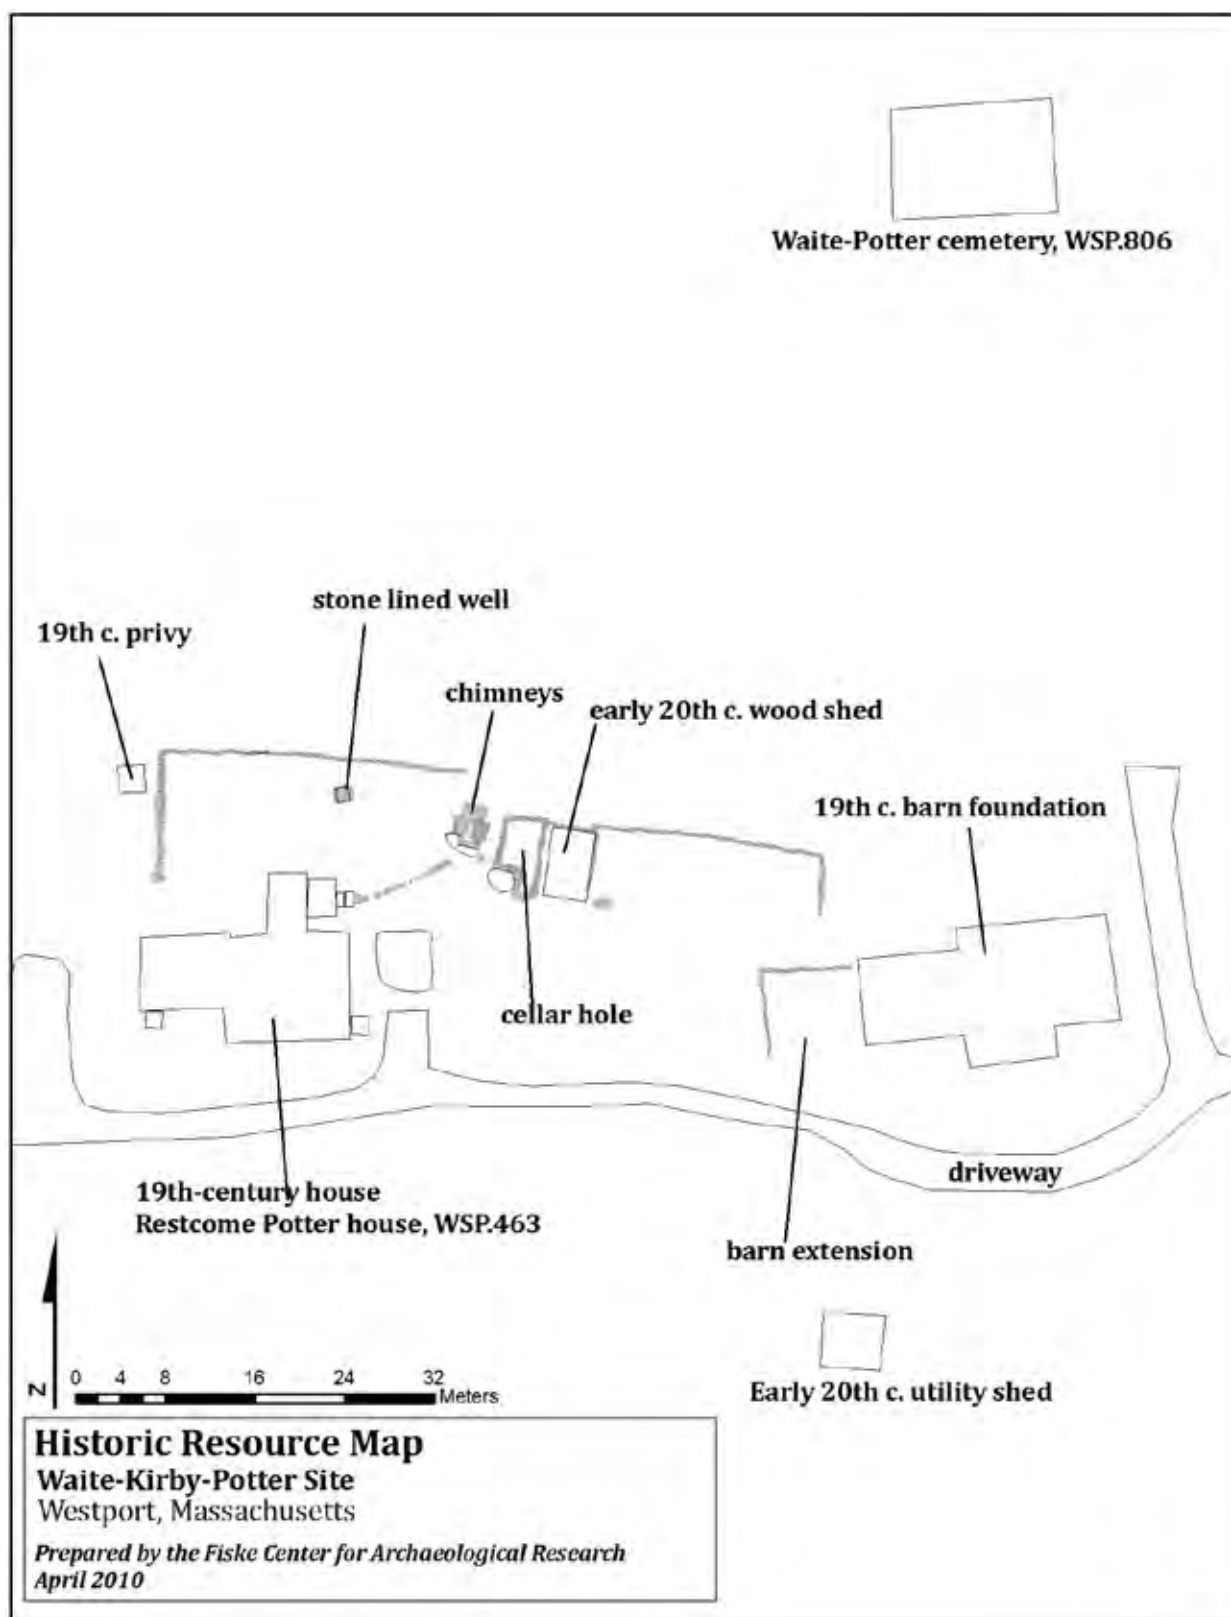
Figure 1.4: Overview of all above-ground cultural resources on property.

property that relate to its use in both agricultural and domestic contexts (Figure 1.4). These include a 19th-century barn foundation, privy (Muriel Bibeau, personal communication, 2009), and the farmhouse mentioned earlier. These elements are integral to the site because they exemplify the continued use of the property from the early 18th century to the present, a common characteristic of many farmsteads in this region.

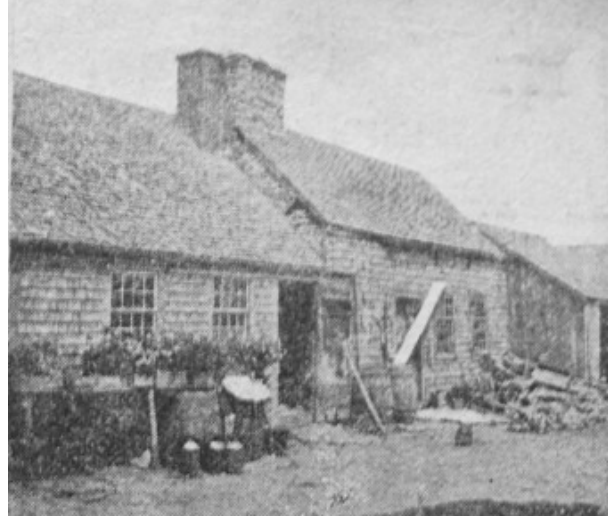
Figure 1.6: Waite-Kirby-Potter house, 1905, from Henry Worth's article. Photographer F.W. Palmer (Westport Historical Society).

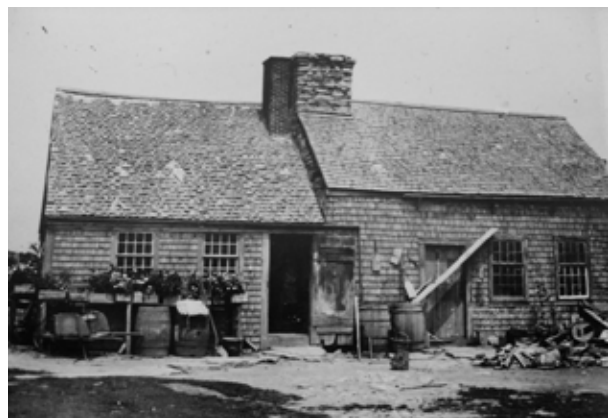
Figure 1.7: House at some point between 1905 and 1934.

Figure 1.7 is another view of the house from approximately the same time period. Note that all four windows have the same 12-over-12 pane windows. The stepping stones are exposed within a worn dirt work surface. Additionally, both roofs appear to be wood-shingled.

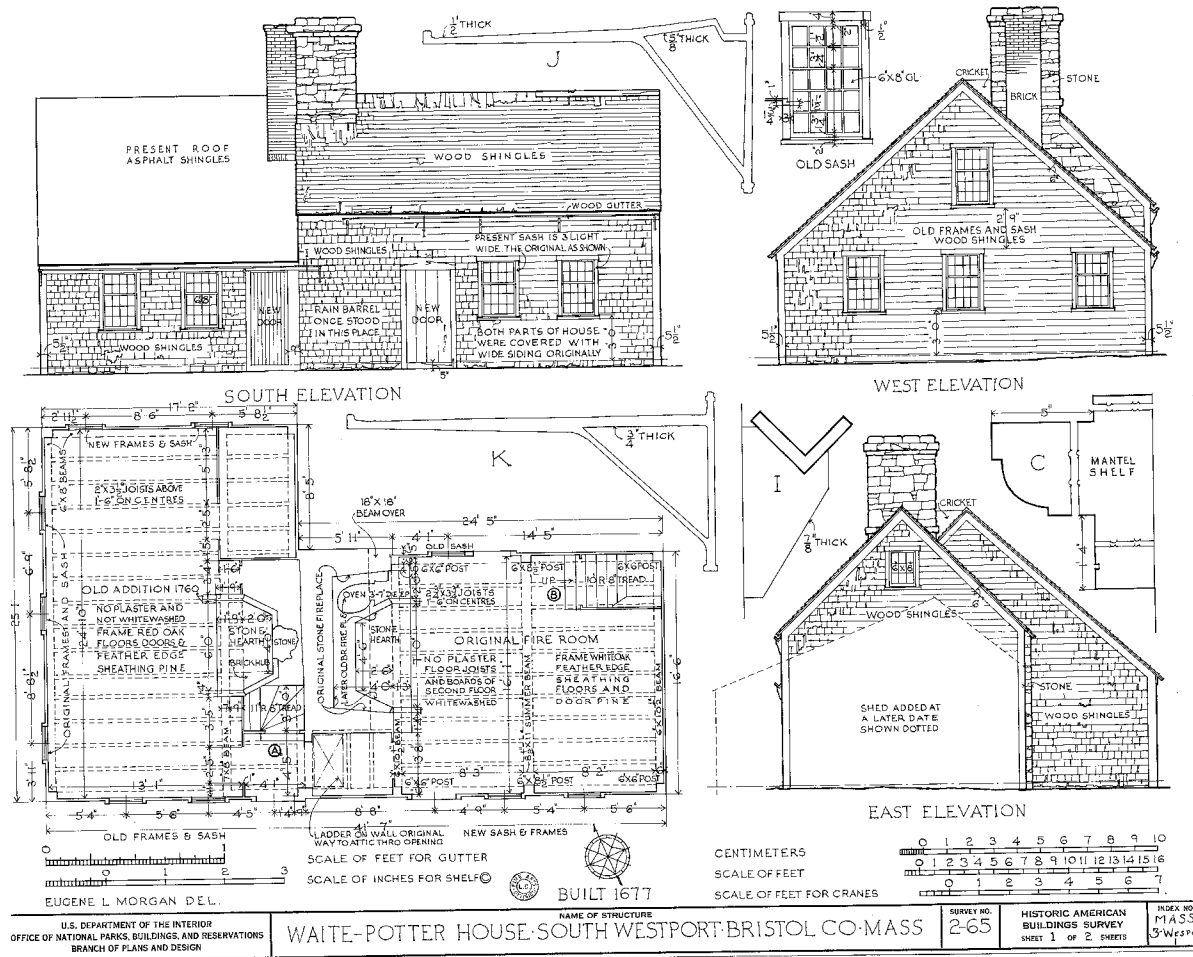
Figure 1.8: 1934 HABS plan of the Waite-Kirby-Potter House (HABS MASS 3, Wespos 1, plan 1 of 2).

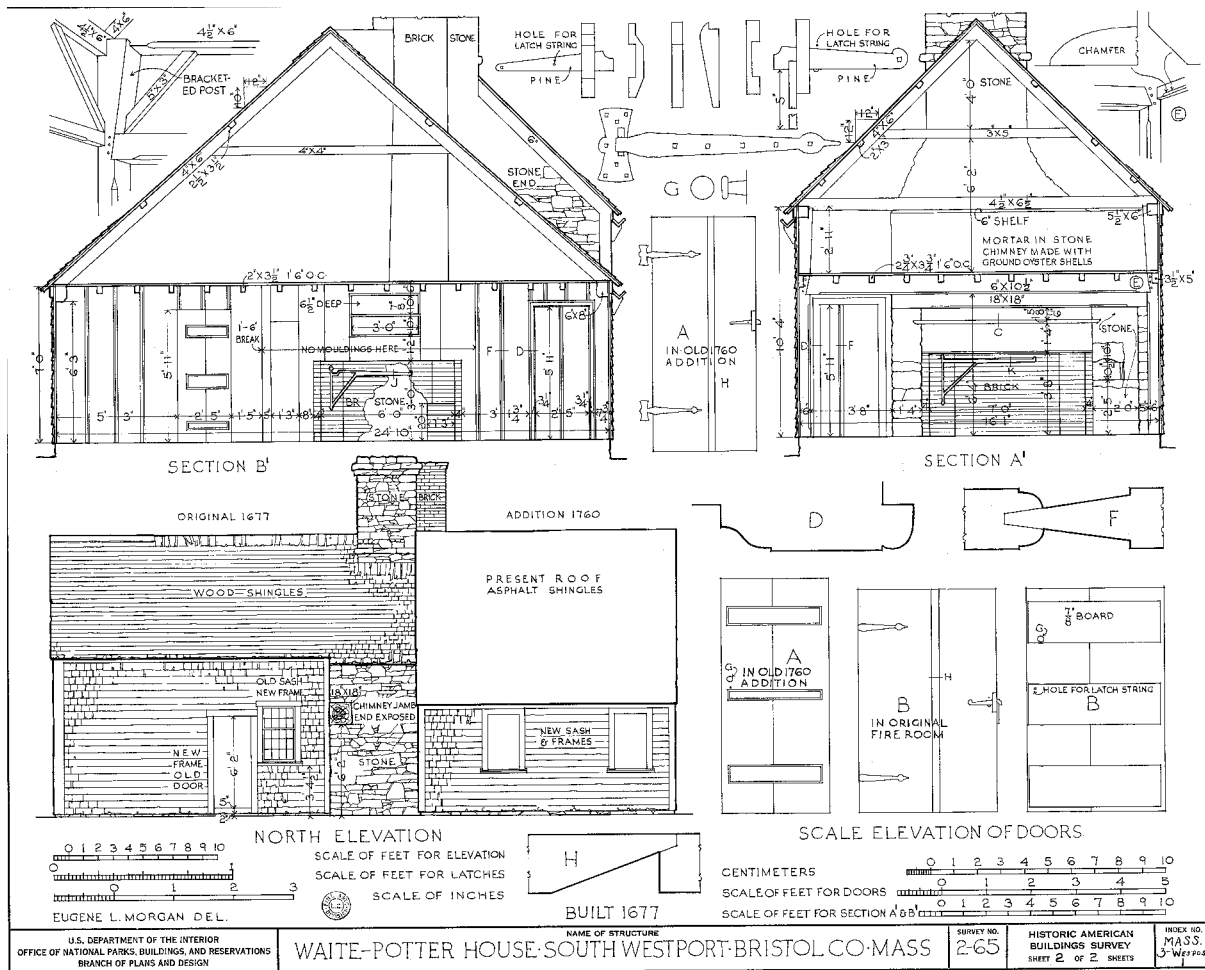
Figure 1.9: 1934 HABS plan of the Waite-Kirby-Potter House (HABS MASS 3, Wespos 1, plan 2 of 2).

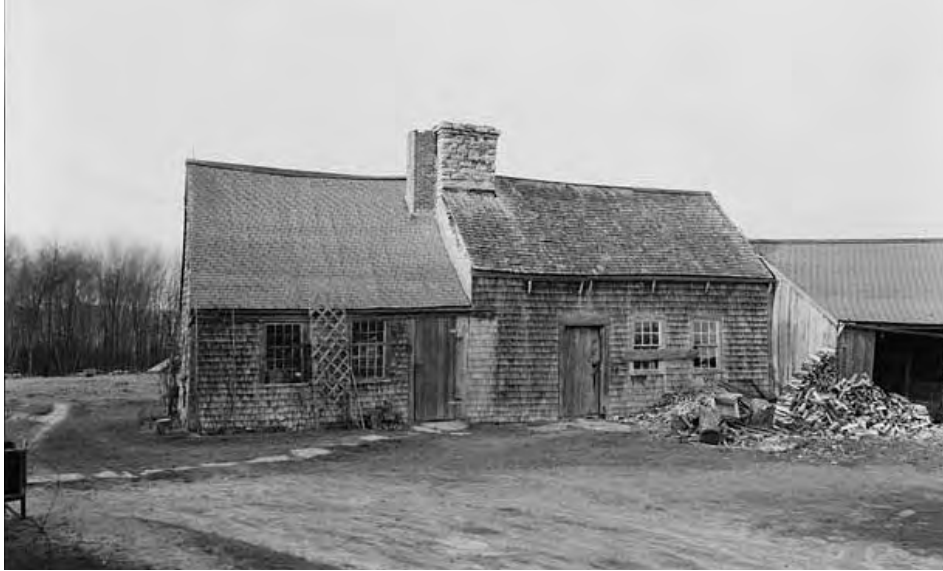
Figure 1.10: The house in 1934. HABS, Arthur C. Haskell, photographer, General view from southwest, HABS MASS, 3 WESPOS, 1-1.

In 1934, the house was documented by the Historic American Buildings Survey (HABS) (MA-2-65). The survey noted that the date of construction as 1677, although the available data page does not describe the house in any detail in terms of construction or land evidence. Two architectural drawings were made as well (Figures 1.8 and 1.9). Note that the two windows on the right had been replaced with 9/6 panes. The weathering of the exterior wood is visible next to the protected area where the western entry door stayed open (Figure 1.10). The roof on the 18th-century addition also appears to have been reshingled with asphalt shingles, while the original portion of the house still had wood. These small modifications suggest some minimal repair work to the house.

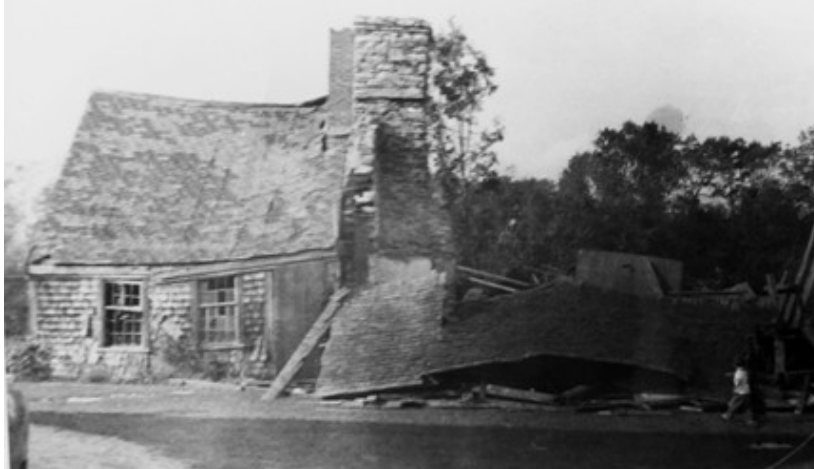
Figure 1.11: Waite-Kirby-Potter house after 1954 hurricane (Courtesy M. Bibeau).

In 1954, the eastern (older) half of the house was destroyed and the western half badly damaged by Hurricane Carol. The western half was taken down between 1956 and 1960 because it was so badly damaged and unstable (Figure 1.11). Some of the wood and other parts of the western half of the house were sold by Alice Potter to Carlton Brownell who at the time was President of the fledgling Little Compton Historical Society in that town just to the west (Muriel Bibeau, personal communication). By the 1950s Carlton was in the process of restoring the 17th-century Wilbor House to become a house museum, and he used many wood planks and doors in the Wilbor House that had once been part of the Waite-Kirby-Potter house (Carlton Brownell, personal communication). For example, large wooden planks now extant in the Wilbor House "long kitchen" were taken from the Waite-Kirby-Potter house's western addition and support the oral tradition that this part of the house may have been used as a workshop (Figures 1.12 and 1.13). At least one object from the house, a wooden chest marked P.G. Potter, also entered the collections of the Little Compton Historical Society (catalog #1979.119).

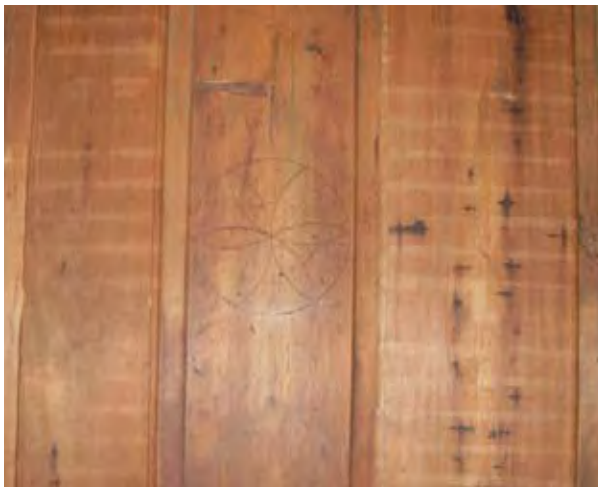
Figure 1.12: Compass carvings and lath/plaster marks on reused board sheathing currently in the Wilbor House in Little Compton, but salvaged from the Waite-Kirby-Potter house in the 1950s. (Courtesy Little Compton Historical Society).

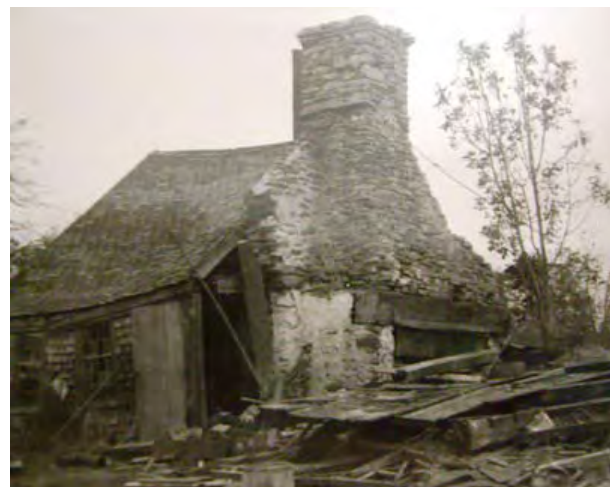
Figure 1.13: Waite-Kirby-Potter house following 1954 hurricane, during salvage efforts (Courtesy Little Compton Historical Society).

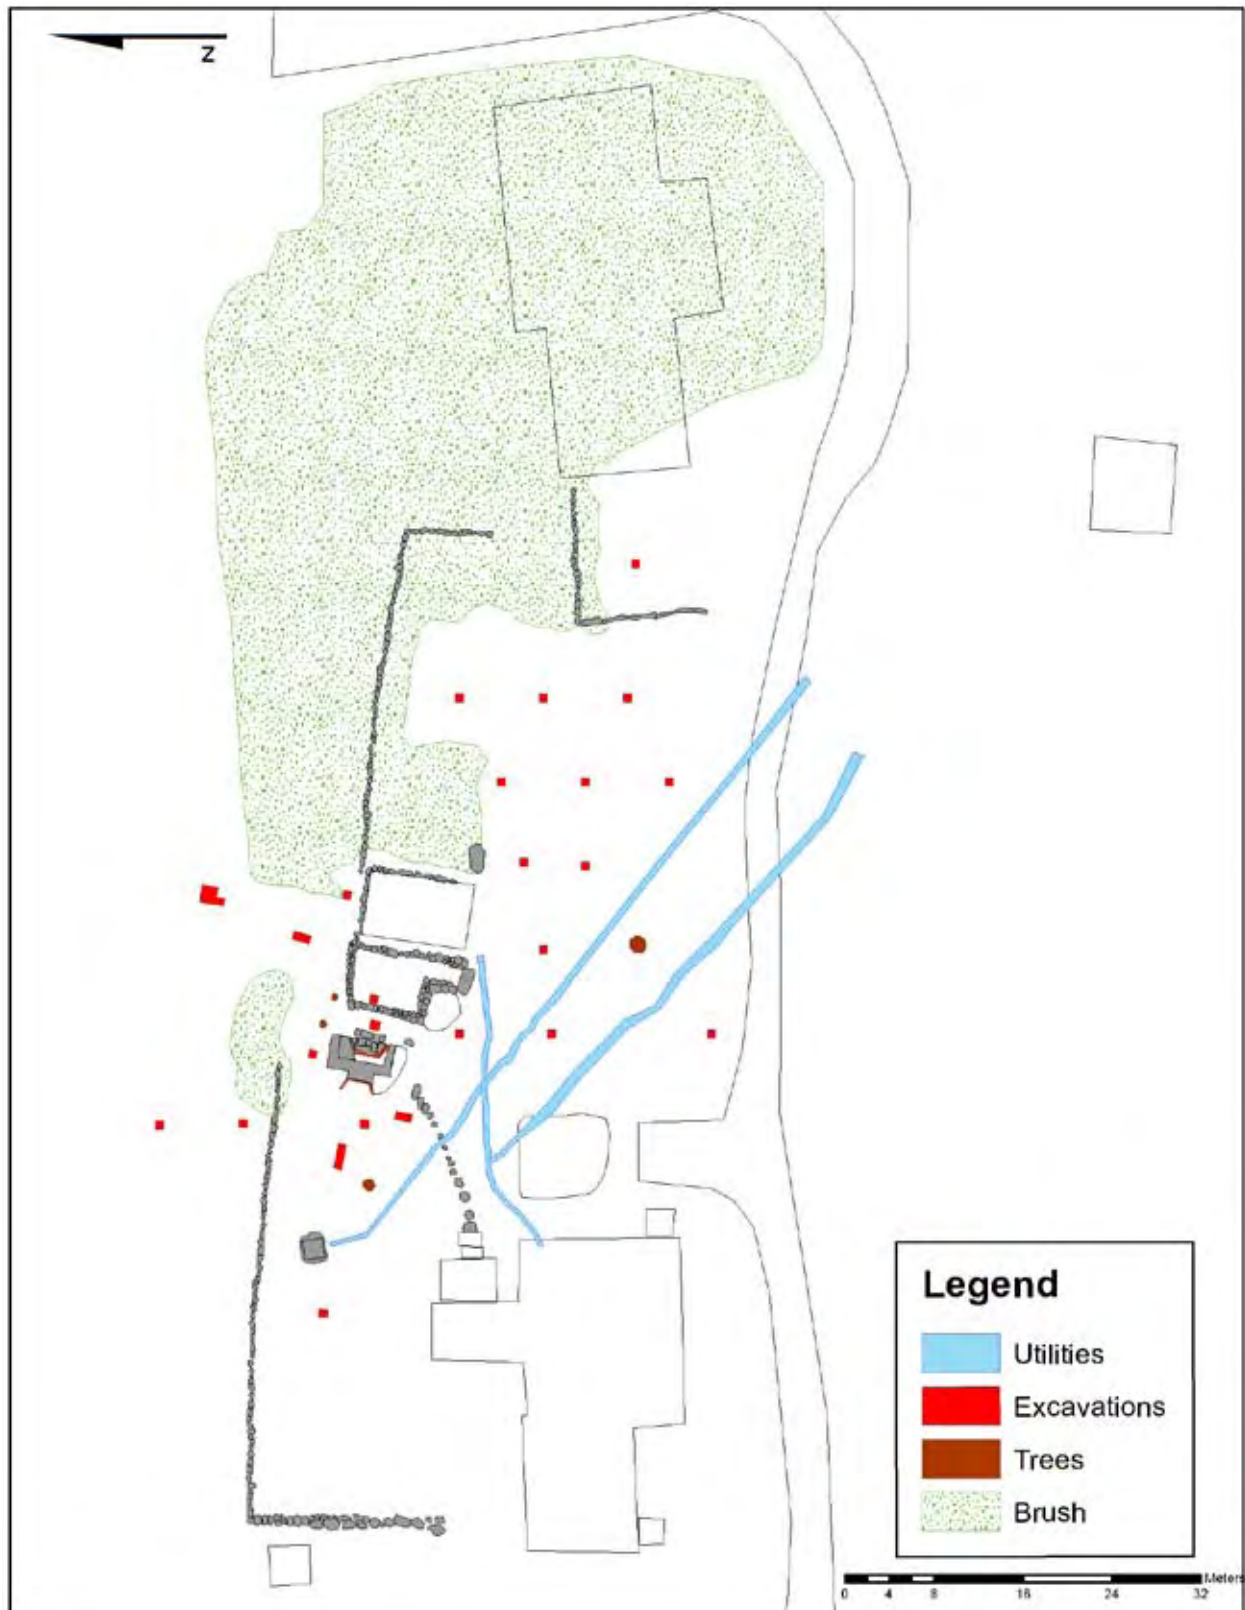
Figure 2.1: Map of excavation areas, utilities, surface conditions, and historic structures.

The survey, in addition to archaeological excavation, included a walkover of a larger area to assess other cultural resources visible on the surface (Figures 1.4 and 2.1). This also included a walkover of the two adjacent plowed fields. Surface features were then mapped using a Topcon single-operator transit and are included in our site plan. This part of the survey was successful in locating and digitally mapping the foundation of a 19th-century barn on the property, as well as the location of an early 20th-century utility shed, and the location of the Waite-Potter burying ground (WSP.806), containing members of the Kirby family.

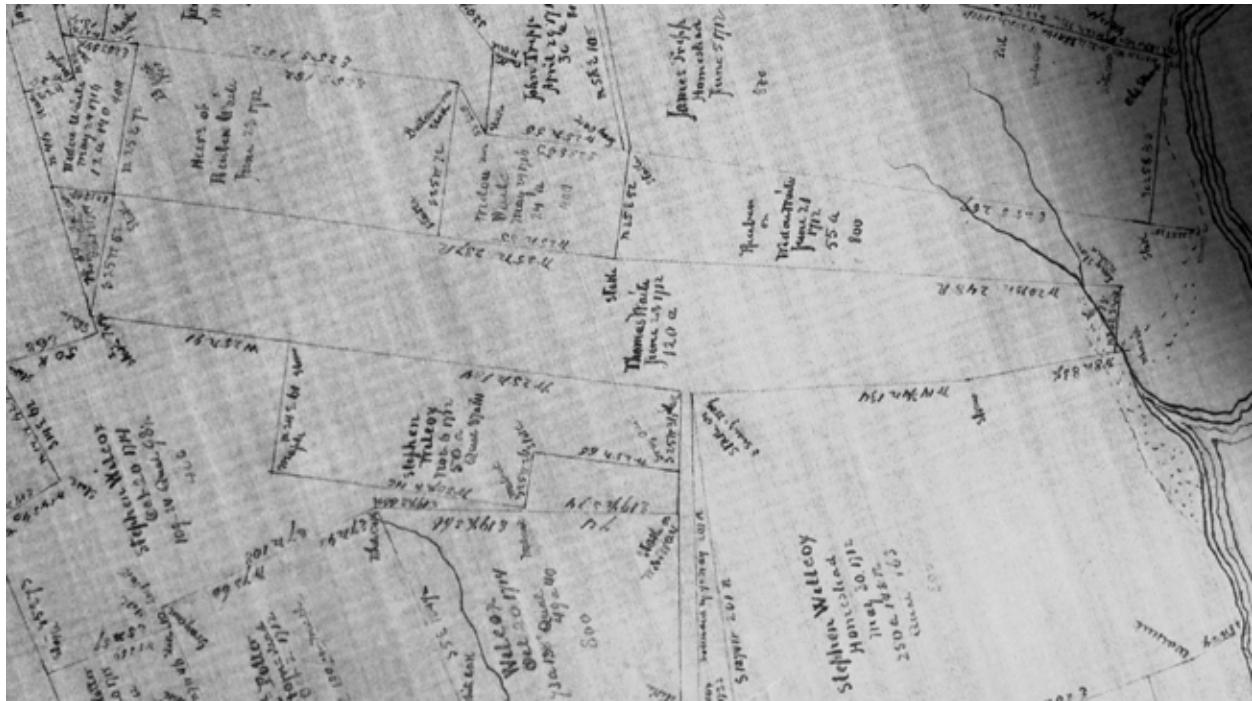
Figure 3.2: Crane map depicting land divisions in Westport between 1712 and 1716. Property owners, acreages, and important boundary features are noted. North is to the top in this and all subsequent uses of the Crane map.

In 1712, the entire town was surveyed by Benjamin Crane, Benjamin Hammond, and Samuel Smith. (Their survey notes were published in 1910, hence the citation of Crane 1910 for this 18th-century source.) The survey resulted in Crane's own handwritten notes as well as a parcel map which recorded the state of the land boundaries from 1712 to 1716 (Figure 3.2; Table 3.2). An important caveat in reading this map is that it does not show all of the properties at exactly one moment in time; it shows them over the course of over four years. It provides a valuable resource, however, because the parcel boundaries and notation correspond to the boundaries described in the land evidence. In performing research for this project, this map was scanned, and then integrated into a Geographic Information Systems database using the program ArcGIS. By doing this we were able to overlay modern tax assessor parcels as well as other historic maps and aerial photos, to cre-

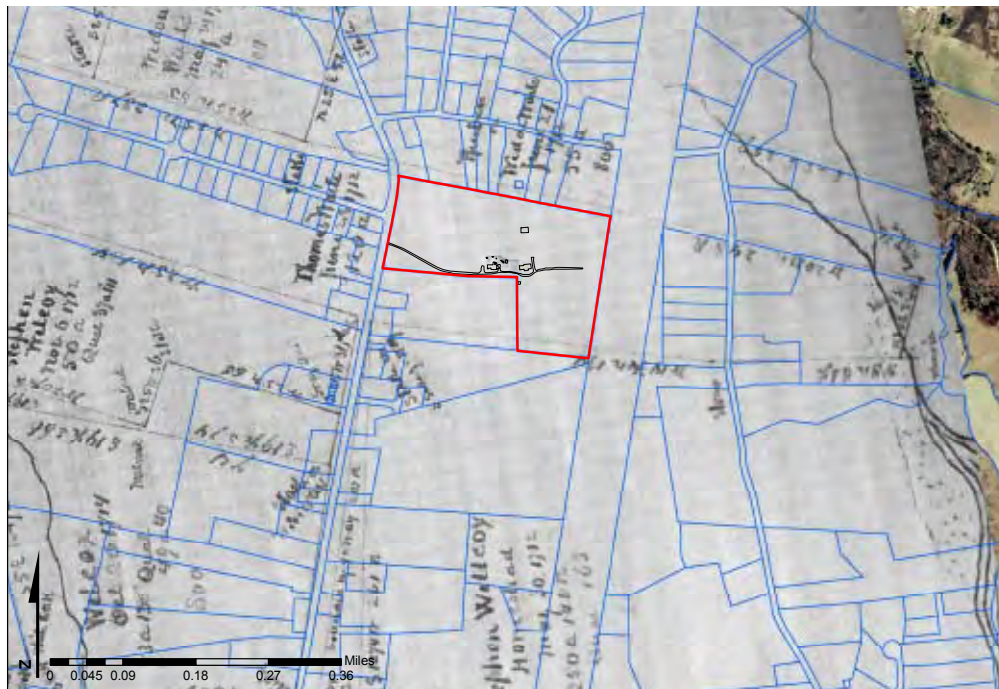
Figure 3.3: Modern property parcel boundaries overlaid on 1712 Crane survey map. Note that the Waite-Kirby-Potter house (red outline) is located on Thomas's land, not the parcel described as Reuben's homestead just to the north.

ate a more comprehensive understanding of how the Waite-Kirby-Potter house fit into the historic landscape. Figure 3.3 shows the location of the Waite-Kirby-Potter house in relation to the Crane map, and modern tax assessor parcel boundaries (from MassGIS). Note that the modern tax assessor parcel boundaries are quite similar to the 18th-century survey boundaries demarcated by Crane indicating the stability of colonial land divisions in this part of the state. While it is difficult to draw

conclusions based exclusively on a georectified 18th-century map, the land evidence is very specific about parcel boundaries, and several different versions of the georeferencing all place the Waite-Kirby-Potter house in the same location. Based on the Crane survey data combined with modern tax assessor parcel data, we have come to the conclusion that the Waite-Kirby-Potter house is not on the land that was surveyed as Reuben Waite’s homestead farm. Instead, it is located just to the

south, on the parcel shown and described as being Thomas Waite's land in 1712. Whether the house was there prior to Thomas or Reuben's ownership is unknown, however Reuben's farmstead is very specifically described as being on the parcel just to the north. Since the northern parcel was also described as being owned by Tabitha Waite after 1707, this is likely where Reuben's dwelling house was as well. Therefore, the questions of who built the Waite-Kirby-Potter house, and at what date, remains open, but the Waite-Kirby-Potter house was not Reuben Waite's primary dwelling house.

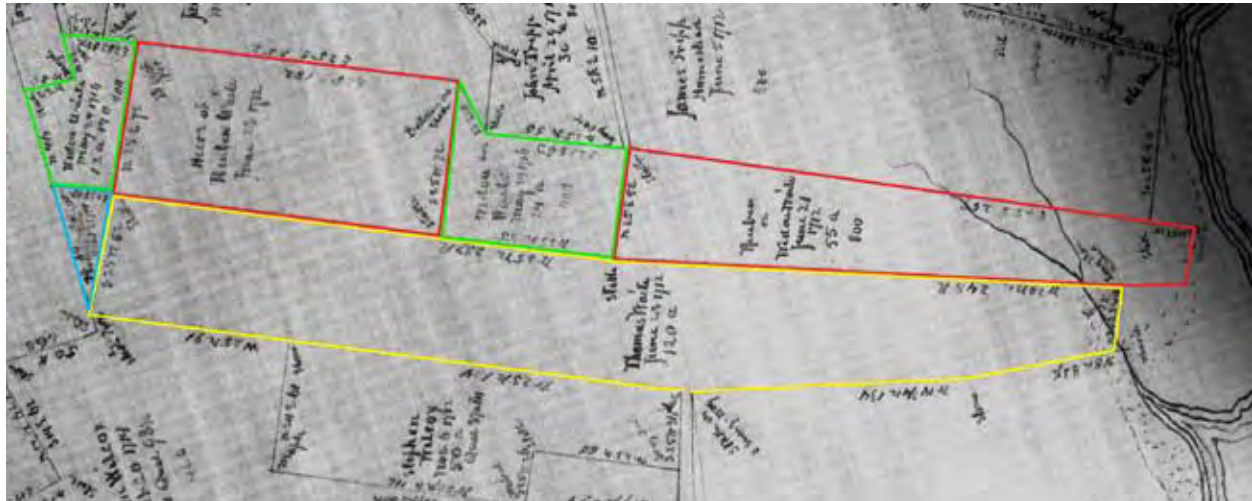
Figure 3.4: Boundaries of Waite farmstead 1712-1716. The colors indicate property ownership; see Table 3.2.

Crane's notes describe Reuben Waite's farmstead as having been comprised of a 55 acre parcel of land, as well as salt marsh within the "neck," (now Justin Point). The 55 acre parcel that is definitively part of Reuben's homestead is shown in red in Figure 3.4 and is on the eastern side of the map. His wife would have received 20 of those 55 acres, along with the house and orchard, while his sons received the other 35, along with the parcel shown in green just to the west. Thomas did in fact have the southern half of the farm, totaling 120 acres along with a small 4.5 acre tract of marsh meadow

(yellow area in Figure 3.4). That tract also included a 20 acre parcel that Thomas had purchased from Philip Taber six years prior to the survey, although the bounds of that parcel are unknown. Reuben's homestead was surveyed in two entries of the same date. The first entry describes a tract of salt meadow currently known as "Justin Point;" the second describes the bounds of Waite's homestead. Crane's notes describe how he divided the farmstead in 1712, 8 months after Reuben died:

This description exactly matches the Crane map (see Figure 3.4). The mention of a house in the mortgage means that there was a house somewhere on the southern part of the farmstead by 1714. In this description the northerly bounds correspond to the land evidence; at the time, the north parcels would have been owned jointly by those three sons. Interestingly the mortgage makes no reference to Thomas' mother Tabitha owning any of the abutting land, whereas Crane's survey specifically does. Crane surveyed a 24 acre parcel for her in May 1716, denoting that it began at the southwest corner of her homestead, and ended at the northwest corner. The rest of the description very solidly places her homestead as being the 55 acre parcel that had previously been described as the Reuben Waite homestead (shown in red in Figure 3.4). The mortgage document also mentions the 20 acre parcel of land purchased from Philip Taber in 1706. Taking that into account, it is possible that the original land that Thomas received was, in fact, a 100 acre farm. Since Reuben gave Thomas half of his farm, and this half totaled

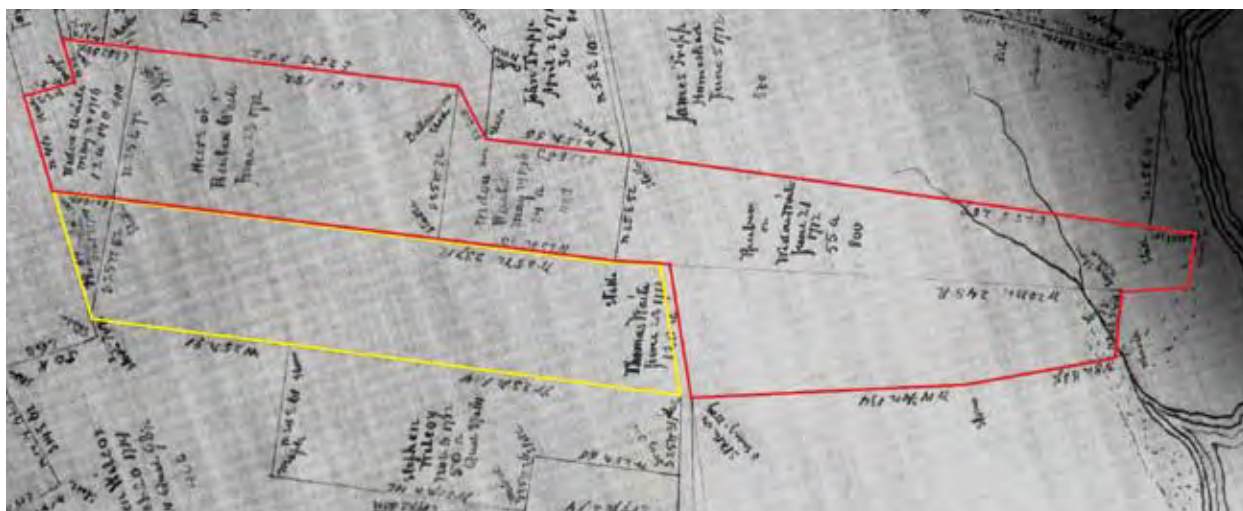
Figure 3.5: Waite farmstead boundaries January 1721. Red shows land owned by Benjamin, yellow shows land owned by Thomas. Their brother Jeremiah still owned a $\frac{1}{4}$ share of the northernmost property as part of his inheritance as well.

By this deed, Thomas relinquished some of his share in their father's homestead to his brother Benjamin. Figure 3.5 shows the distribution of land after this sale. Thomas makes no specific mention of buildings on the property, indicating that this may have just been upland and swamp at the time. Note that the first parcel referenced in the deed is the parcel on which the Waite-Kirby-Potter house now stands, and that it at one point had been part of Reuben's homestead.

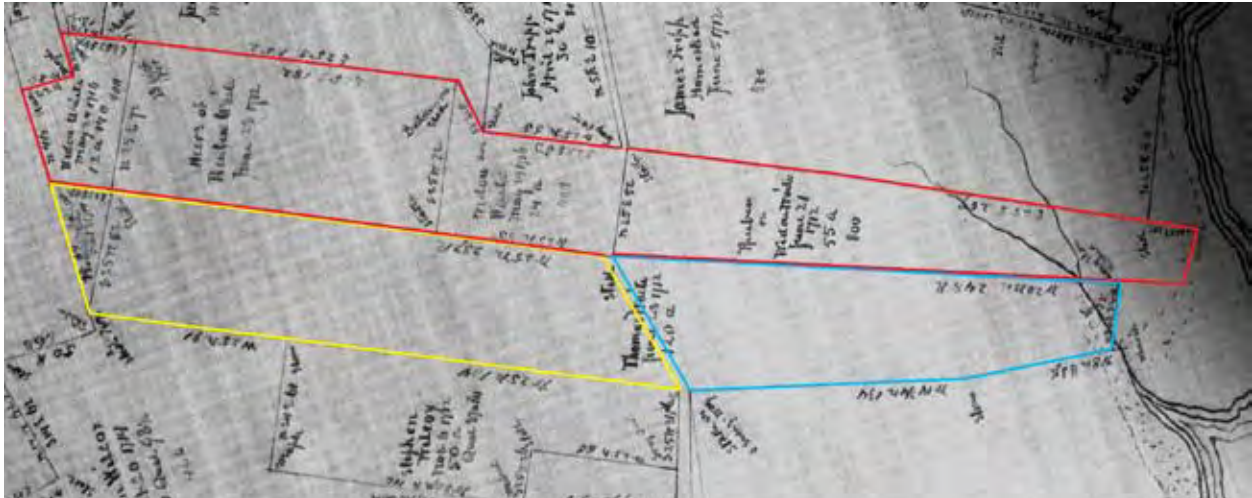
Figure 3.6: Waite farmstead, February 1721. Blue delineates the deed boundaries for land that Benjamin sold to Reuben II, with housing and orchard. Red delineates land jointly owned by Benjamin and Jeremiah Waite, with Reuben Waite's house in the northeast parcel, and yellow delineates land owned by Thomas Waite.

Just after that sale, Benjamin sold a portion of that real estate to his brother, Reuben II (Figure 3.6). The bounds do not conform to measure-ments on the Crane map, and so must have been specifically created for that land sale. The bounds seem to describe an area within the two eastern parcels of the homestead, more specifically the southeastern one; thus corresponding to the land that Thomas III had sold to Benjamin just months earlier:

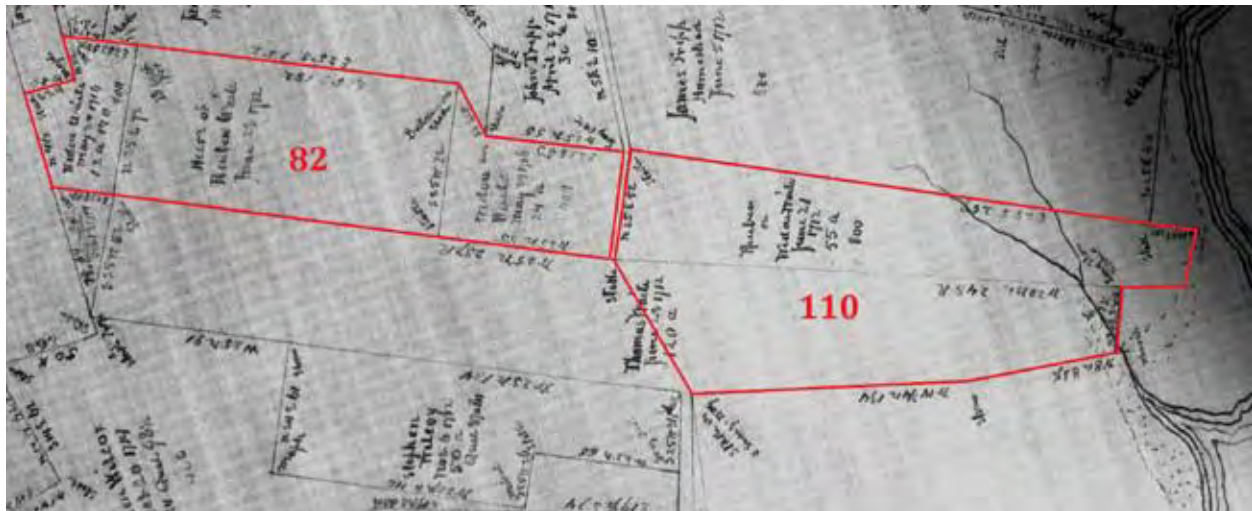
Figure 3.8: Approximate property boundaries for the 82- and 110- acre parcels that Benjamin Waite sold to Robert Kirby.

(SBCRD 4:538); his presence in town would continue. Benjamin sold the Waite family farmstead on February 14th, 1728 for 1,100 current money of New England. He split the land he sold into a 110 acre and an 82 acre parcel (Figure 3.8). The deed specifically states:

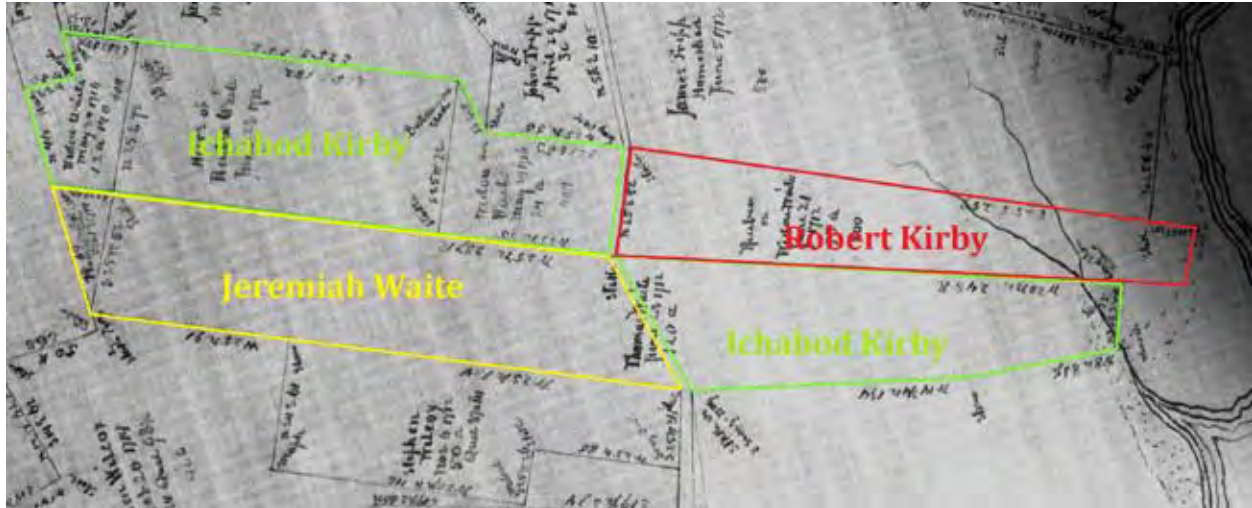
Figure 3.11: Ownership after transactions in 1735. Green parcels are those that were sold by Robert Kirby to Ichabod Kirby. The yellow parcel is owned by Jeremiah Waite. There is no evidence of Robert Kirby having sold the northeast parcel, so it is assumed that as of 1735, he still owned it.

Ichabod had married Rachel Allen three years earlier in 1732, and they would have had one child at the time of the transaction. Interestingly, Robert did not sell his son the entirety of what he had purchased from Benjamin Waite. A careful look and comparison of the northern boundary of the property shows that it is in fact the *southern* boundary of what Crane described as being the Reuben Waite farmstead. The plot of land that Robert Kirby sold his son Ichabod was, in fact, the southernmost part of that 110 acre parcel, and had in fact been part of Thomas Waite's inheritance in 1707 at Reuben's death (Figure 3.11).

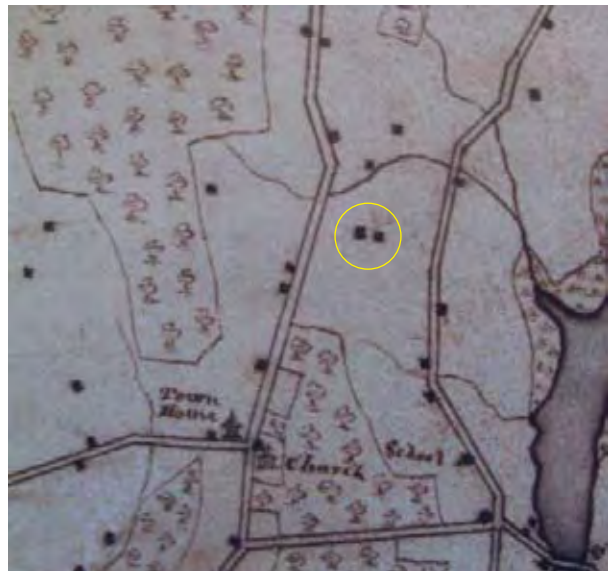
Figure 3.12: 1831 Bourne map showing the Waite-Kirby-Potter house and Restcome Potter house along with cleared land, forested land, and swamp (Westport Historical Society).

goods. No probate inventory is available for him, however, and so we must reconstruct what we know about his material possessions from what he distributed in his will. Note that in his will, he mentions his *new* dwelling house. Local history for Westport maintains that David built the addition on to the Waite-Kirby-Potter house. It seems a likely possibility, however, that his father Ichabod built the addition, and that David may have actually built what is now known as the Restcome Potter house (WSP.463) based on this wording in his will and the map shown in Figure 3.12.

reference may be to the house currently known as the Restcome Potter house (WSP.463). Traditionally dated to 1838, the date at which Restcome acquired the property, the documents suggest that the house is somewhat older and was constructed by David Kirby. Additional support for this comes from an 1831 map that depicts two houses on the property (see Figure 3.12), the stone end house and the still-standing Restcome Potter house.

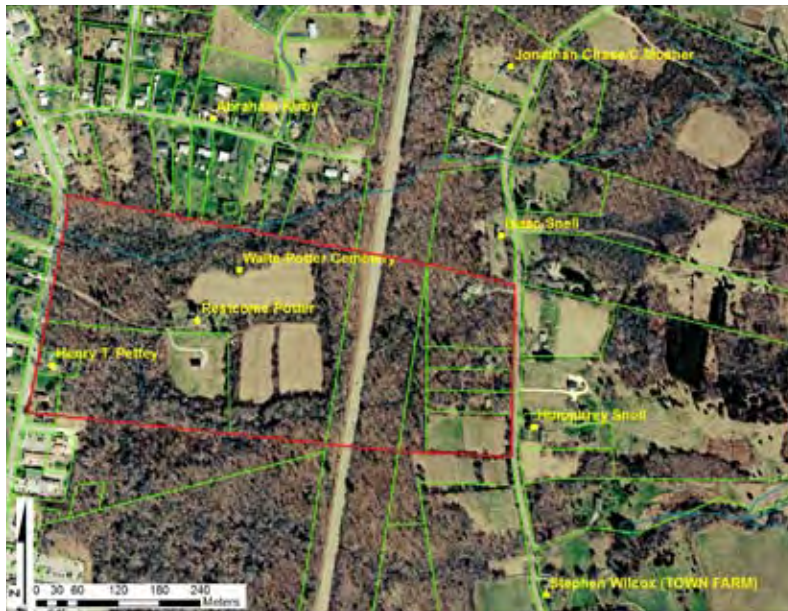
Figure 3.13: Modern parcel boundaries, with the parcel Ichabod Kirby sold to Restcome Potter highlighted in red. Note Humphrey and Isaac Snell's homesteads.

ties during this time period. Ichabod's will reveals the close-knit relationship that he had with his nieces and nephews; additionally, the federal census shows that by 1850 Ichabod and Hannah had moved into the same dwelling house as their nephew-in-law, Isaac Snell and his family (WSP.178), and that Ichabod's real estate value was \$6,000. It is certain that Ichabod still possessed land at this point in time; however he was certainly not living in his own dwelling house. Isaac Snell's dwelling house was located just next door to Humphrey Snell and Clarinda (Potter)'s dwelling (WSP.180). This is reflected in later census records, where these three families are recorded next to one another. See Figure 3.13 for building locations.

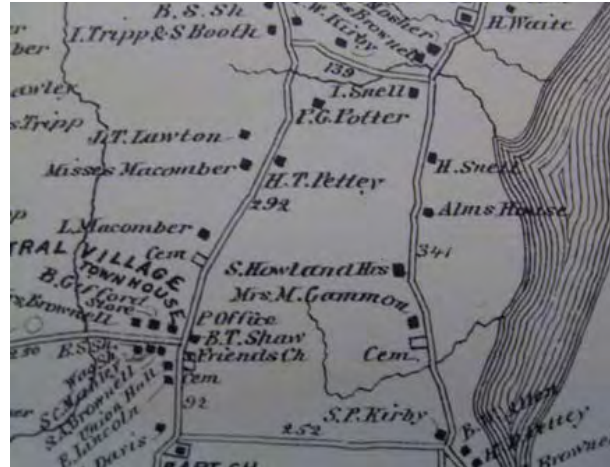
Figure 3.16: 1871 map from Atlas of Bristol County (Westport Historical Society).

from an Atlas of Bristol County (Figure 3.16). It shows Perry G. Potter's farmstead, along with Isaac Snell's farmstead to the northeast, Humphrey Snell's farmstead to the east, the "Alms House" (Stephen Wilcox's farmstead) to the southeast, and J.T. Lawton's farmstead (possible location of "Benjamin Waite house") to the southwest.

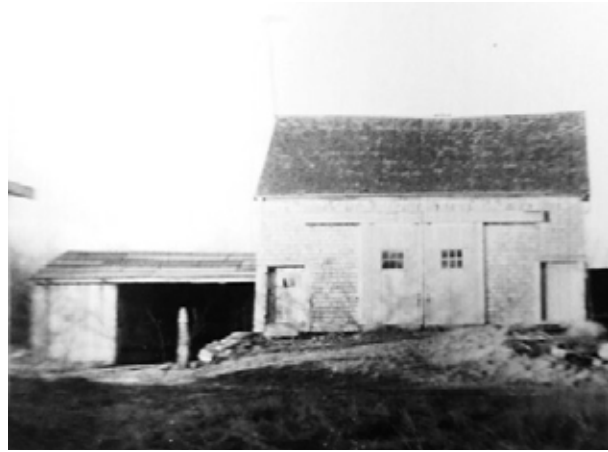
Figure 3.18: 19th century barn. Only the foundation remains. (Courtesy Muriel Bibeau.)

At some point during this time period, Perry may have constructed a new barn on the property. The locations of earlier outbuildings on the property are unknown. There is no way to know when the barn was built; however, it is certainly 19th-century based on the existing large cut granite stone foundation. The barn is not specifically shown on the 1871 map, however by 1895, a map shows the property in more detail (Figure 3.17). This map shows the Waite-Kirby-Potter house, the house that Restcome built in c1830, and the present barn (Figure 3.18).

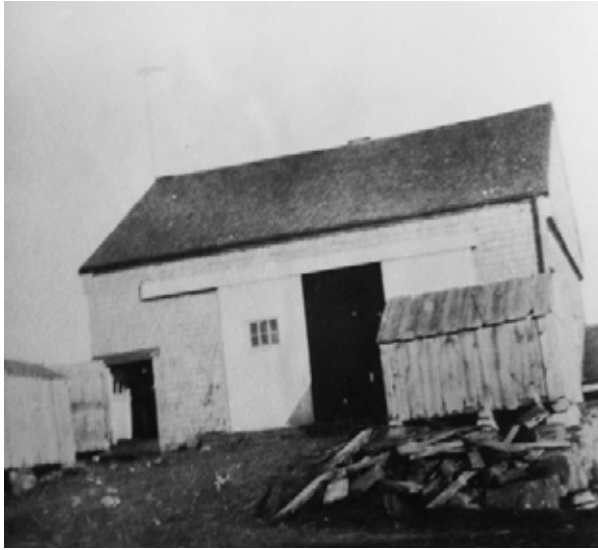
Figure 3.21: Photograph of 19th-century barn with shed. Unknown date. (Courtesy M. Bibeau) Compare with Figure 3.18.

modate everyone. The “S” next to the Barn may be a stable, or a shed. It is quite possibly a shed. There are two photographs of the barn: one with a shed in front of it (Figure 3.21) and one without (Figure 3.18). The dates for both of the photos are unknown. There is also a shed next to the Waite-Kirby-Potter house currently. It is of newer construction; however there was an earlier shed on the same building footprint.

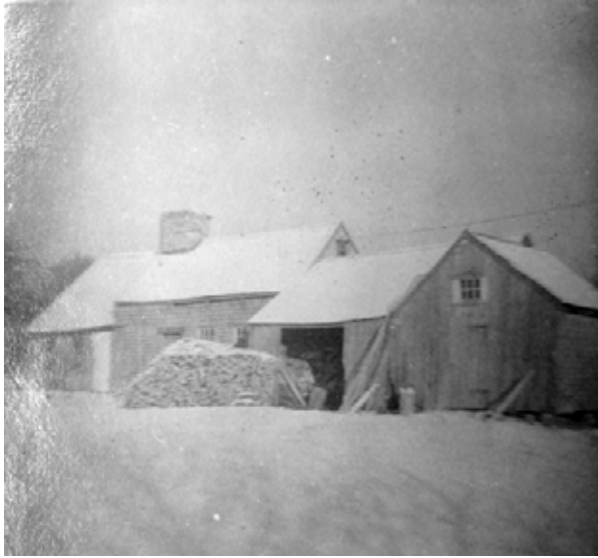
Figure 3.23: House, woodshed, and corn crib, c. 1930s.

Between 1930 and 1940 there was an increasing interest in the Waite-Kirby-Potter house as “the oldest house in town.” Muriel remarked that she remembered visitors coming through often to catch a glimpse, even though the property was, and is, privately owned. She recounted one particular incident where a pair of out-of-town visitors drove down their driveway with a camera. Muriel’s grandmother, Alice, had just finished hanging out the laundry, which stretched on a line from the newer house to the Waite-Kirby-Potter house. The laundry was obstructing a clean camera shot, but Alice, who was now well over 80, had spent quite some time hanging out the clothes. The out-of-town man then asked her if she could take down the clothes so he could get a good photograph. She replied with a resounding NO and told him to get off of her land! (Muriel Bibeau, personal communication 2009). During the 1930s, Muriel’s family went back and forth from the house to an apartment in Fall River, where Ephraim was working as a shipping clerk for an oil company called William C. Atwater & Co (Sampson and Murdoch 1939). During this period, Muriel’s grandmother Alice and great-grandmother lived on the family farm in the newer of the two houses along with Muriel, who moved in with them in 1943 (Figure 3.23). After Frank died, Alice sold off various small properties. Chickens were still kept; how-
