**Documentary Research and Archaeological
Investigations at the Waite-Kirby-Potter Site,
Westport, Massachusetts**

**Prepared for:
The Community Preservation Committee
Town of Westport
Westport, MA**

**Prepared by:
Katharine M. Johnson and Christa M. Beranek
With contributions by Kathryn A. Catlin and Laura W. Ng
Fiske Center for Archaeological Research
University of Massachusetts Boston**

Cultural Resource Management Study No. 37

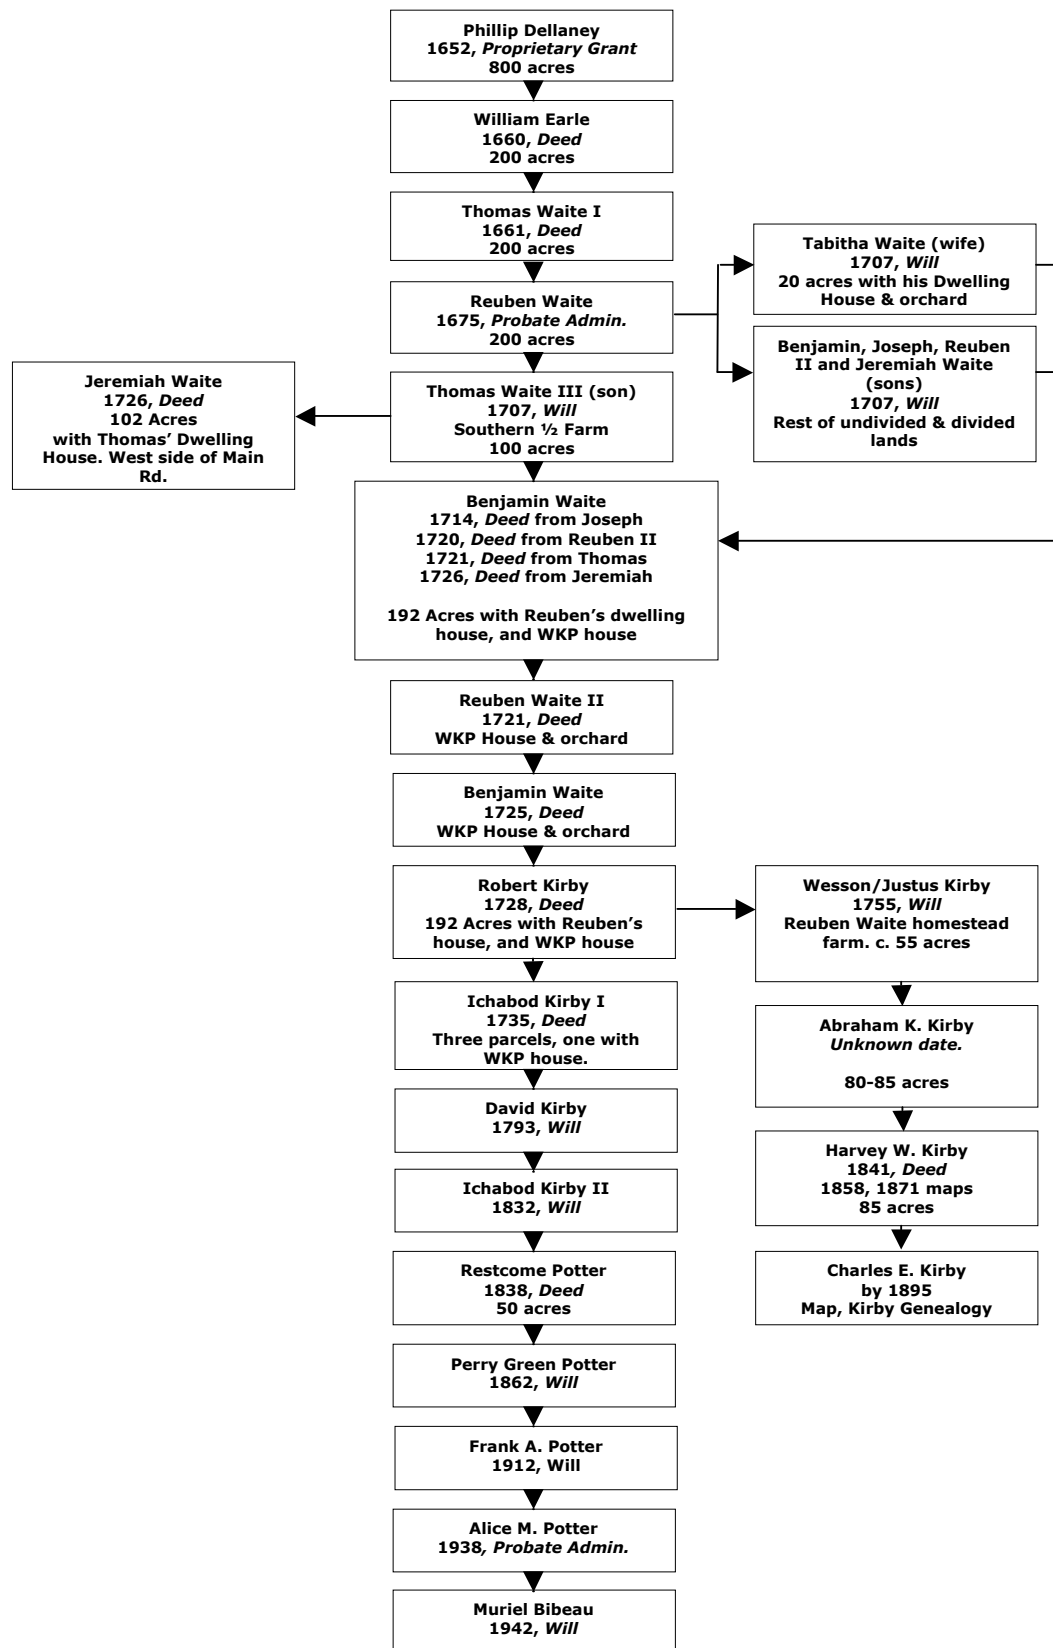
Figure 3.24: Anglo-American ownership and transmission of the Waite-Kirby-Potter parcel. Side branches show points at which other parts of the original 200 acre parcel were separated from the current parcel.

The following sections provide detailed family biographies of the Waites, Kirbys, and Potters in Westport as well as a complete chain of title with accompanying deeds and probate files quoted at length. A shorter summary of this chain of title precedes this detailed account (see also Figure 3.24 at the end of the chapter).

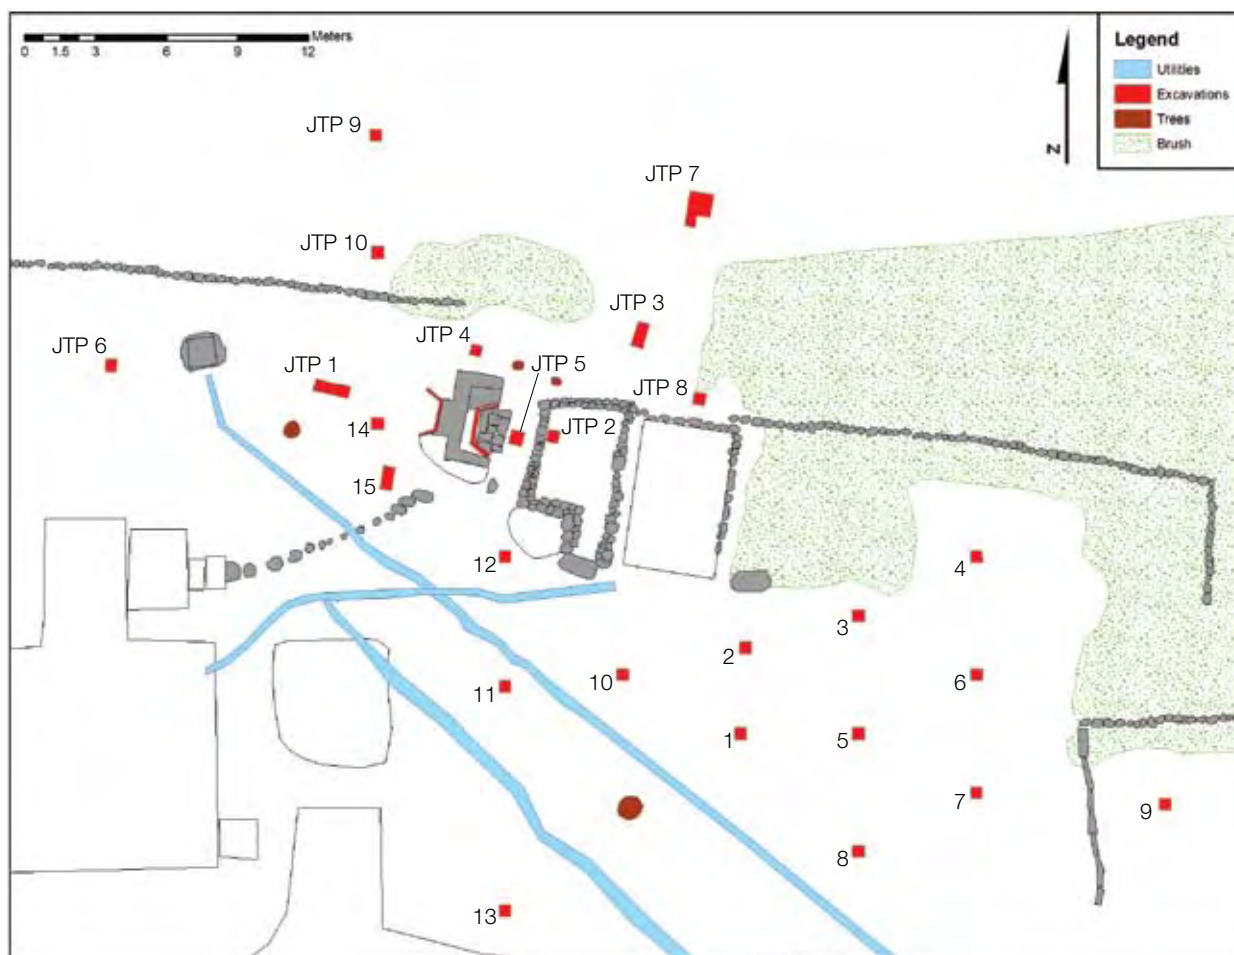
Figure 4.1: Locations of excavation areas.

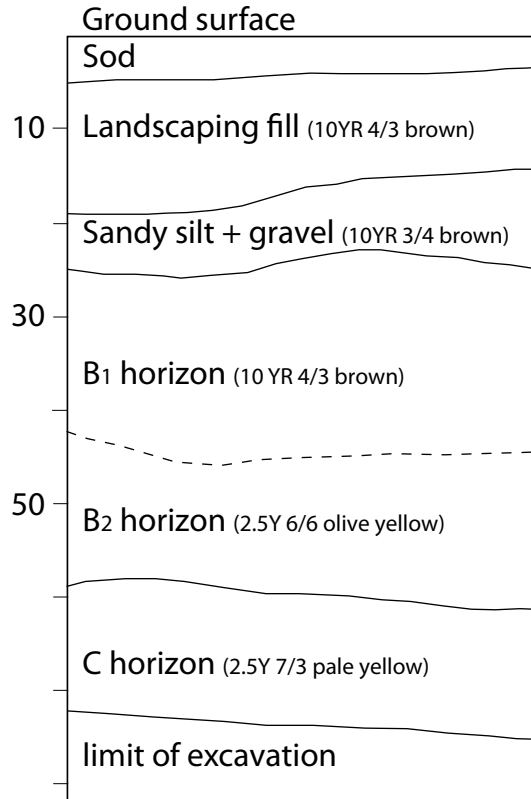
Figure 4.2: Representative profile of STPs in the front yard. The north wall of STP 2 is shown.

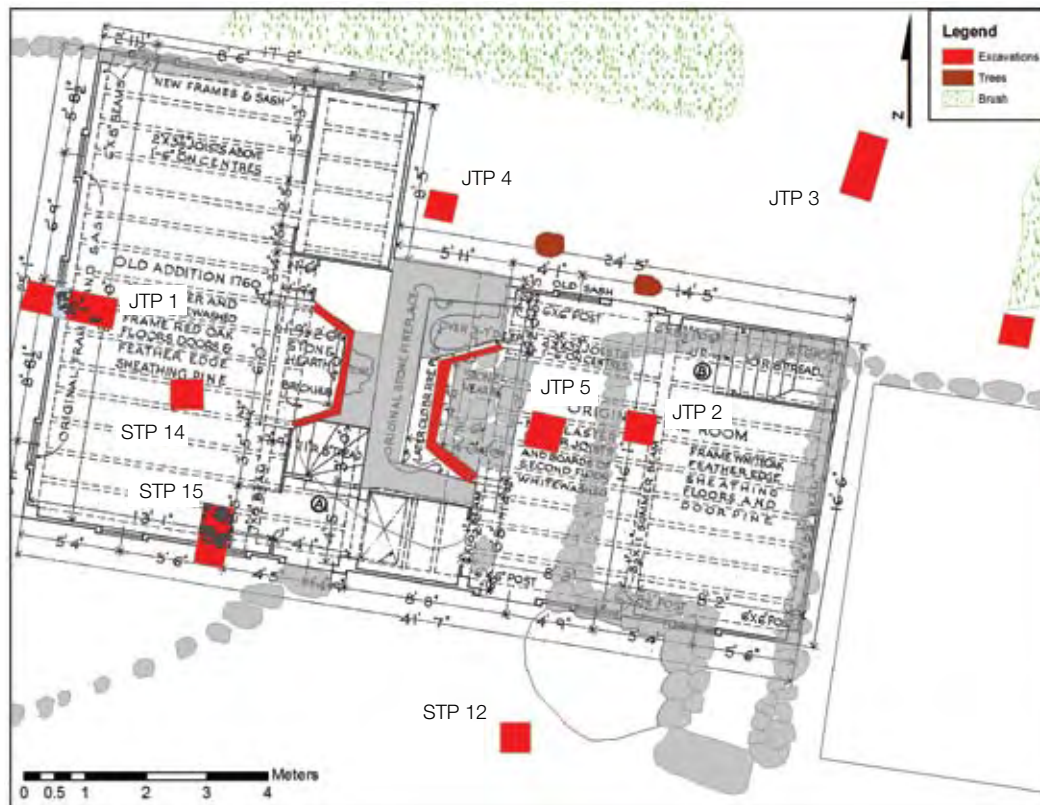
Figure 4.3: Plan of excavation areas near and inside the house with the HABS plan overlain.

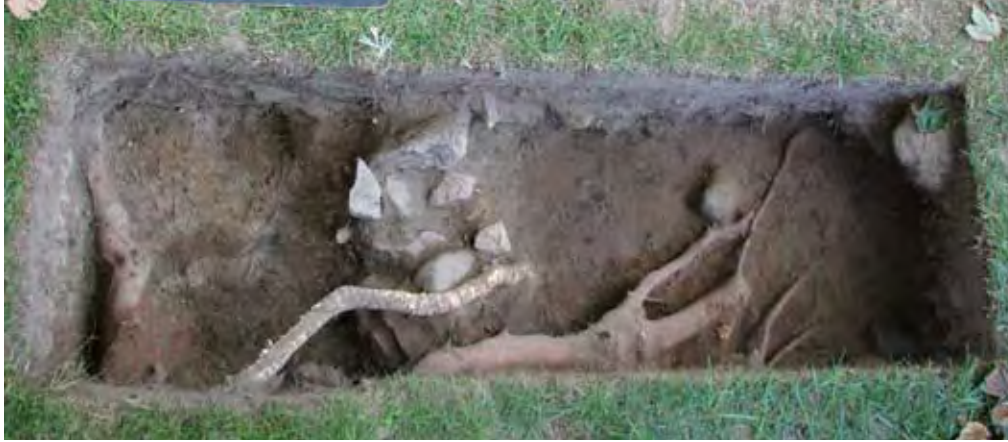
Figure 4.4: West sill support of the western addition in JTP 1, facing north.

JTP 1 was placed to investigate stones visible on the surface that Muriel Bibeau noted were most likely the western edge of the newer portion of the house (added between 1763 and 1793 based on documentary evidence, see Chapter 3). A 1.5 m × 50 cm unit was placed to straddle the possible wall (Figure 4.4). The unit was full of roots from a near by tree and the lower levels were also disturbed by a rodent burrow. The surface stones (Feature 1) did continue below ground; the construction appears to be very simple in that there is no cut, or any large stones. The feature is probably a sill support, rather than a foundation per se and consists purely of small 5-10 cm in diameter stones stacked on and next to one another a few centimeters above the yellowish brown subsoil. A 25 cm section of the stones was removed to examine the layer under the features. The stones rested directly on a thin (4-6 cm) layer of brown sandy silt mottled with black silt and dark yellowish brown silt which covered the whole unit and

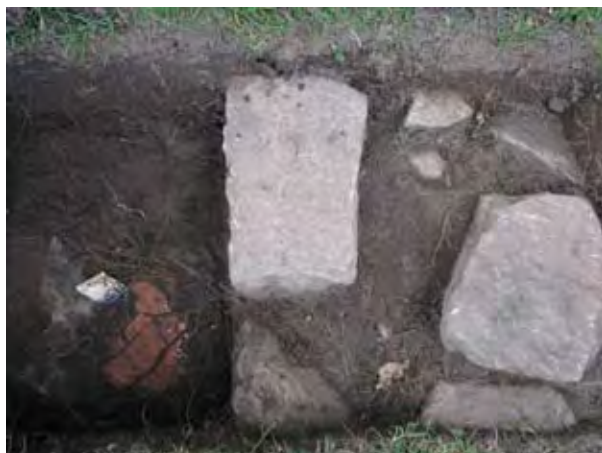
Figures 4.5: In situ ceramics against the exterior of the south foundation wall of the western addition, STP 15. North is to the right.

There was no cellar in this portion of the house, and it is likely that the addition consisted of a wooden sill joined to posts the rested on stone corner stone piers or set directly into the ground with smaller stones underneath the sills. This construction method would have protected the sills from rot and helped to seal the area underneath the floor from rodents. Immediately outside the sill support were the shallow remains of a post hole (Feature 2). This hole was 30 cm in diameter, but only a few centimeters of its fill remained.

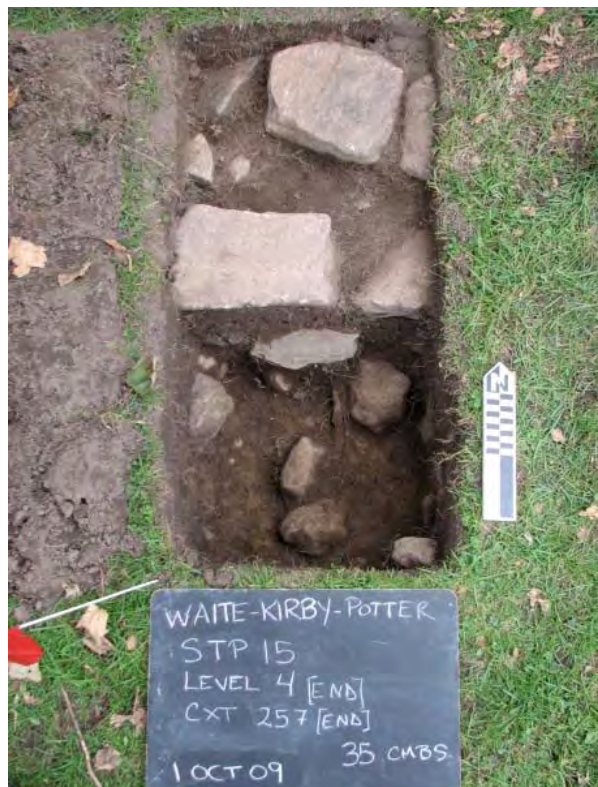
Figure 4.6: STP15 at the end of excavation.

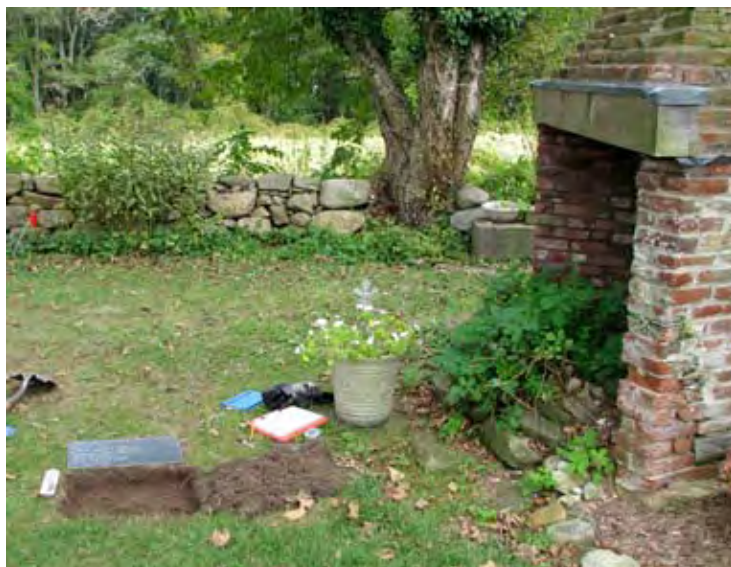
Figure 4.7: STP 14 inside the western addition, during excavation, facing north.

STP 14 was excavated directly west of the brick fireplace (Figure 4.7), in what would have been the interior of the western addition. Since there was no cellar in this part of the house, it was thought that perhaps there might be earlier deposits that had been capped by the 18th-century addition. Although no such deposit was found, the test pit was artifact-dense, likely from objects falling through cracks in the floorboards. The unit was excavated to the depth of 45 cmbs in three strata: topsoil (0-17 cm) which contained most of the artifacts, a mottled level containing charcoal flecks which might have been the old ground surface or the surface under the floorboards (17 to 27 cmbs), and a rapid transition to gravelly, yellowish brown subsoil (excavated to 45 cmbs). Again, most of the artifacts were architectural (nails, window glass, and construction materials). A silver plated spoon marked "Rogers Bros" of an inexpensive pattern manufactured between 1879 and 1915 and

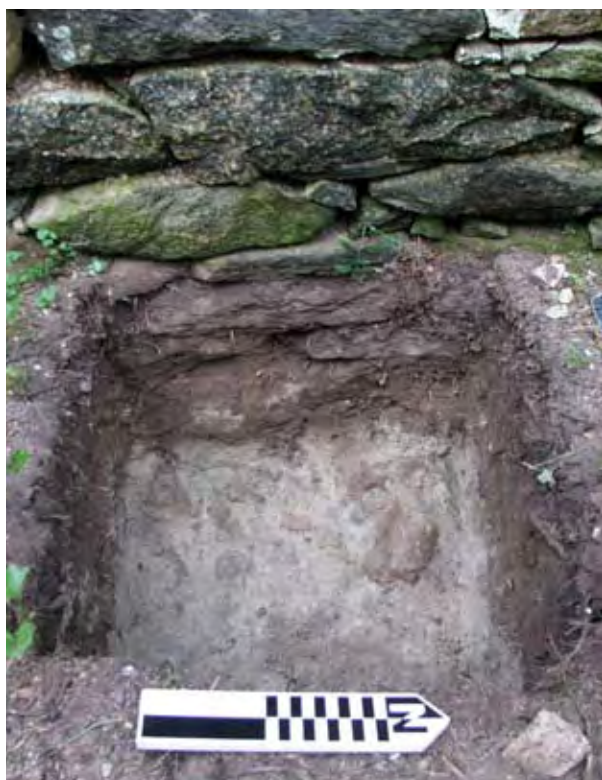
Figure 4.8: JTP 2 at the end of the cultural layers.

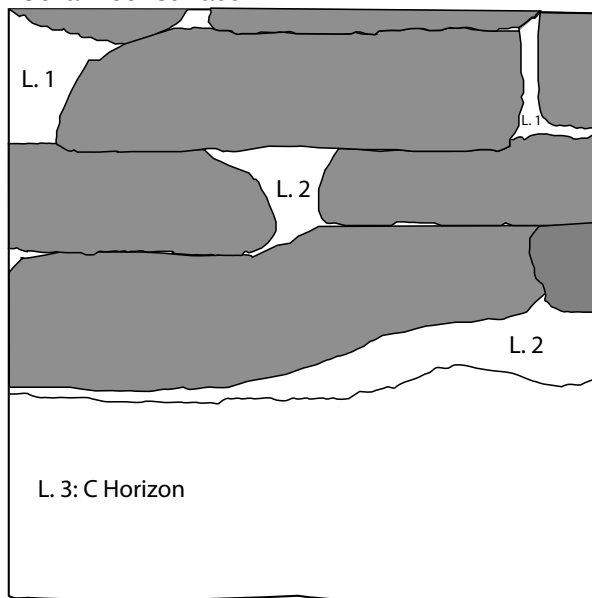
Figure 4.9: West profile of JTP 2 showing cellar wall construction and stratigraphy of the cellar floor.

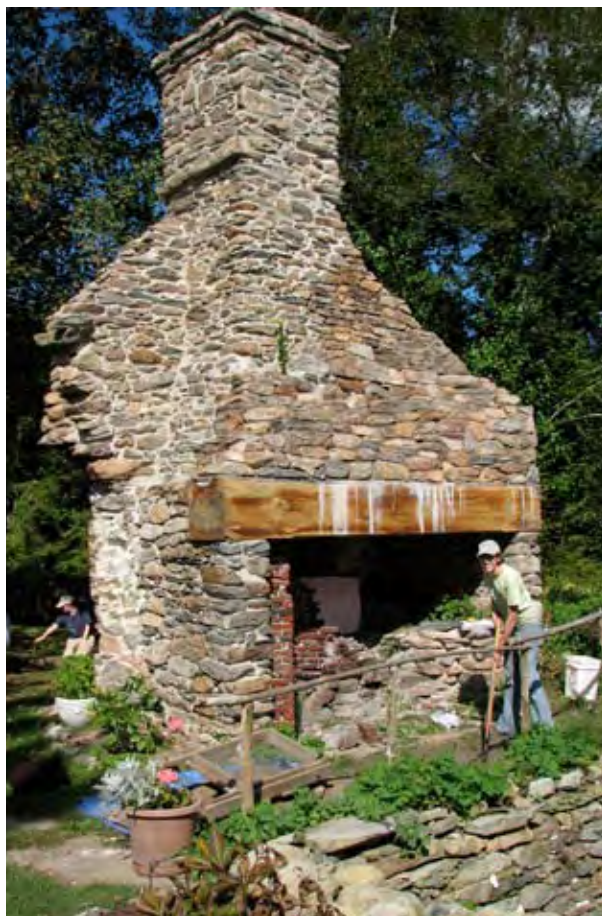
Figure 4.10: Excavation of JTP 5 in progress, facing northwest.

JTP 5 was excavated just to the west of the cellar hole in what would have been the interior of the stone end house. The unit was located between the cellar and the hearth stones of the stone fireplace (Figure 4.10). Although no distinct living surface was found, the top layer which extended to 25 cm below surface had a large amount of architectural debris including bricks marked “B B Co.” Mottling with the 10YR 5/6 yellowish brown subsoil began at approximately 35 cm below surface. Artifacts continued into the subsoil, and this is most likely due to the heavily bioturbated strata by roots and large glacial boulders. The eastern side of the test pit revealed stacked stones, which may be the western side of the cellar wall. This suggests that the hole for the cellar was dug first, and then lined with stones.

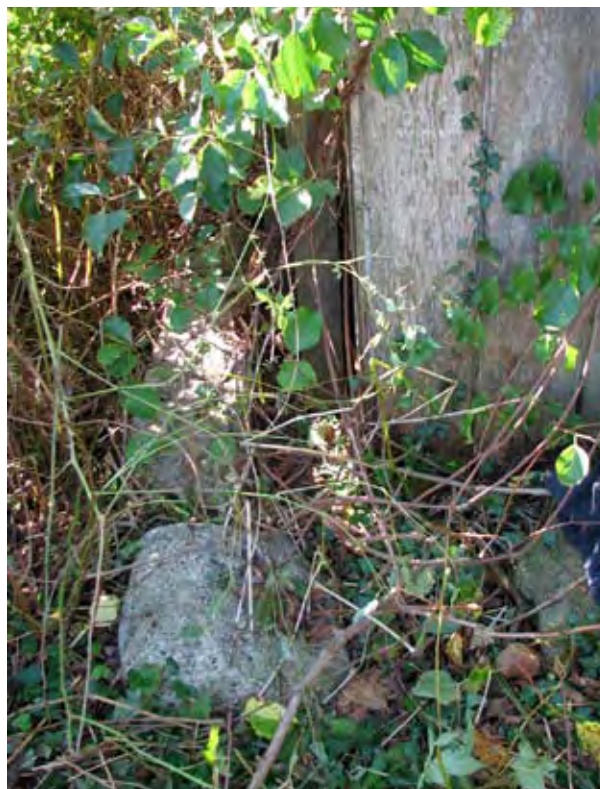
Figure 4.11: Foundation stones for previous shed just outside the northwest corner of the modern shed.

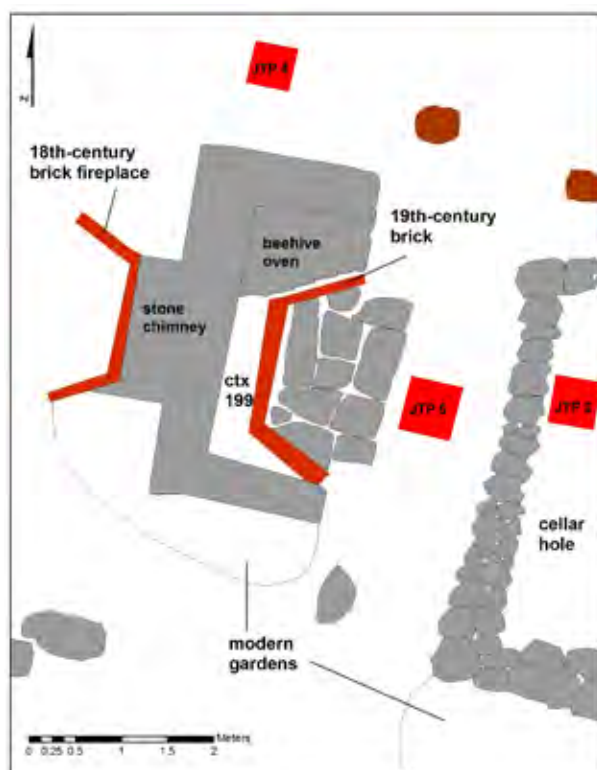
Figure 4.12: Plan of the chimney complex, showing elements from different time periods. North is to the top.

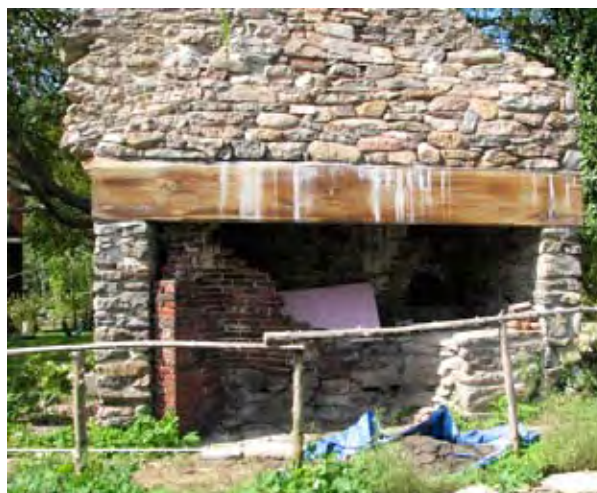
Figure 4.13: The current condition of the east side of the stone chimney with restored stonework and lintel and decaying later brick firebox, facing west.

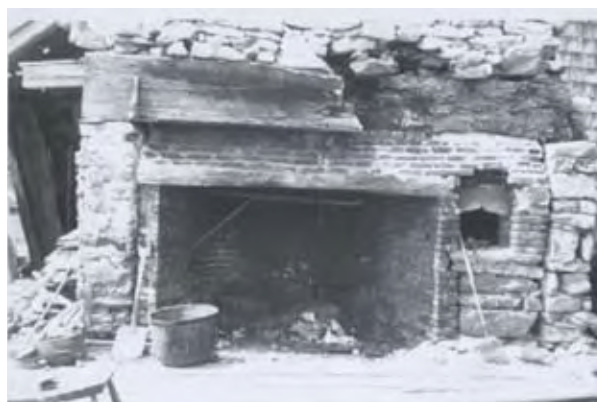
Figure 4.14: Historical photograph of the stone chimney, facing west, with intact smaller brick firebox and bake oven, date unknown, but post 1954. Courtesy of Muriel Bibeau.

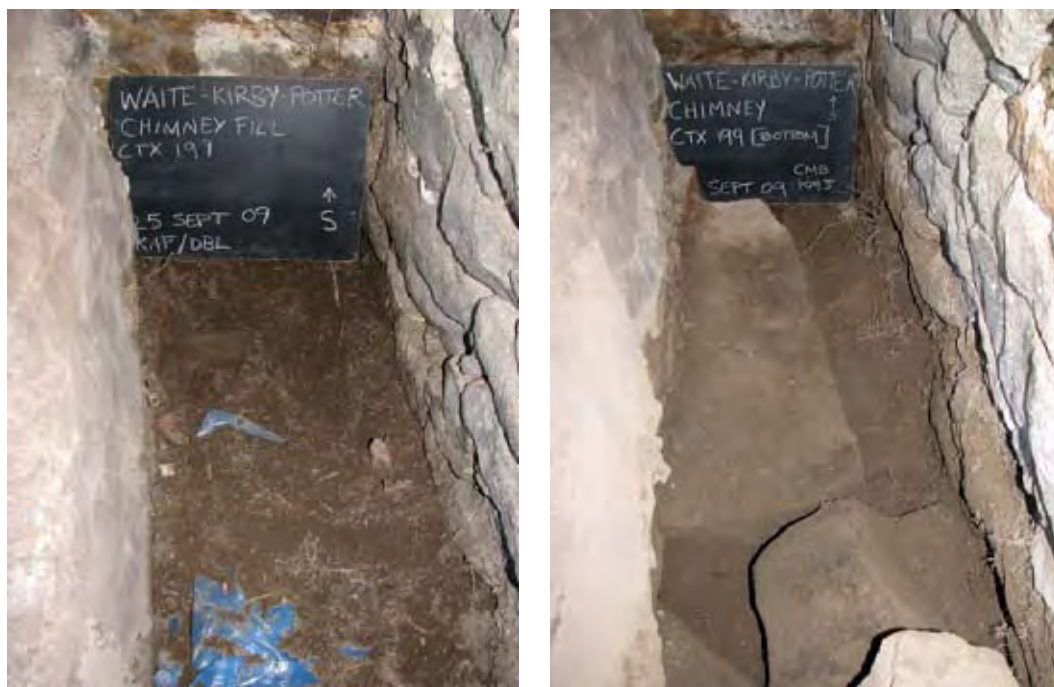
Figure 4.15: Context 199 inside the chimney at the beginning and end of excavation. The opening photograph shows the blue tarp left during the chimney restoration.

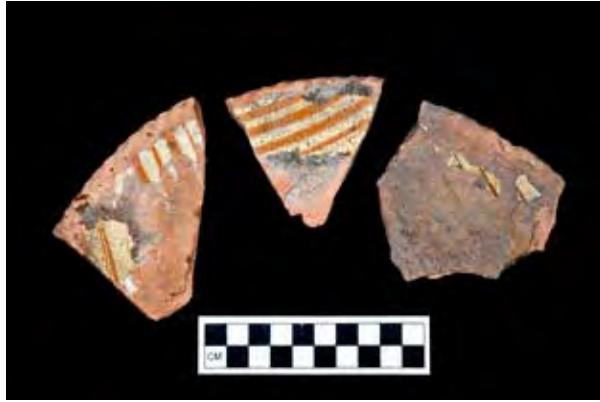
Figure 4.16: Vessel 17, redware plate with white slip decoration.

Twenty-six individual ceramic vessels were identified from contexts 0 and 199. Among these were seven coarse red earthenware vessels: a red and yellow slip-trailed plate with crimped edges (Vessel 17, Figure 4.16), two plain glazed bowls (Vessels 21 and 22, Figure 4.17), an interior-glazed pot (Vessel 23), a black manganese-glazed bowl (Vessel 18), a green-glazed bottle with a ribbed neck (Vessel 19, Figure 4.18), and one very unusual slip-trailed vessel with a glazed spout at its base (Vessel 20, Figure 4.19). Red earthenware (or redware) was produced locally by New England potters and was the most common ceramic material for utilitarian kitchen ceramics as well as some more refined mugs, bowls, and tea pots in the 17th through early 19th centuries.

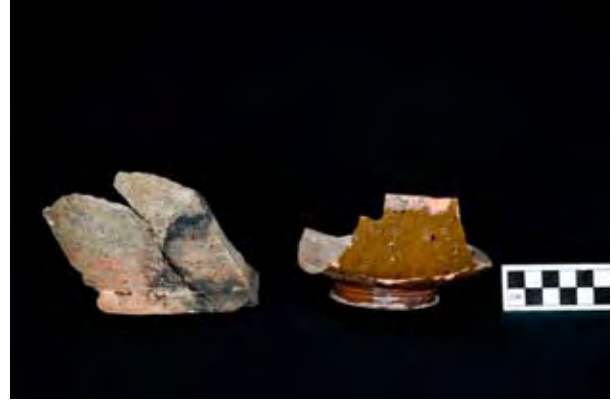
Figure 4.17: Vessels 21 and 22, glazed redware bowls.

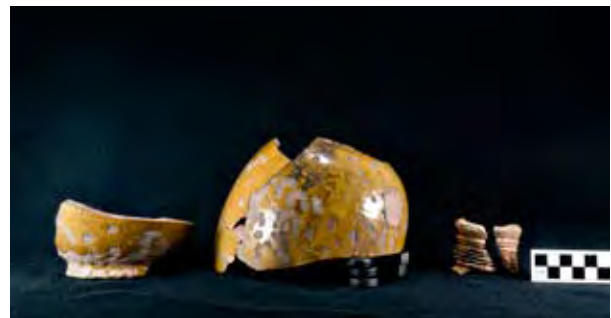
Figure 4.18: Vessel 19, a glazed redware bottle.

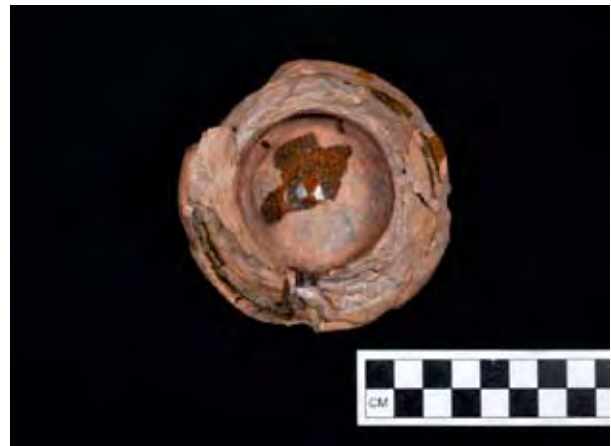
Figure 4.19: Vessel 20, a redware vessel with a spout near the base, possibly a posset pot.

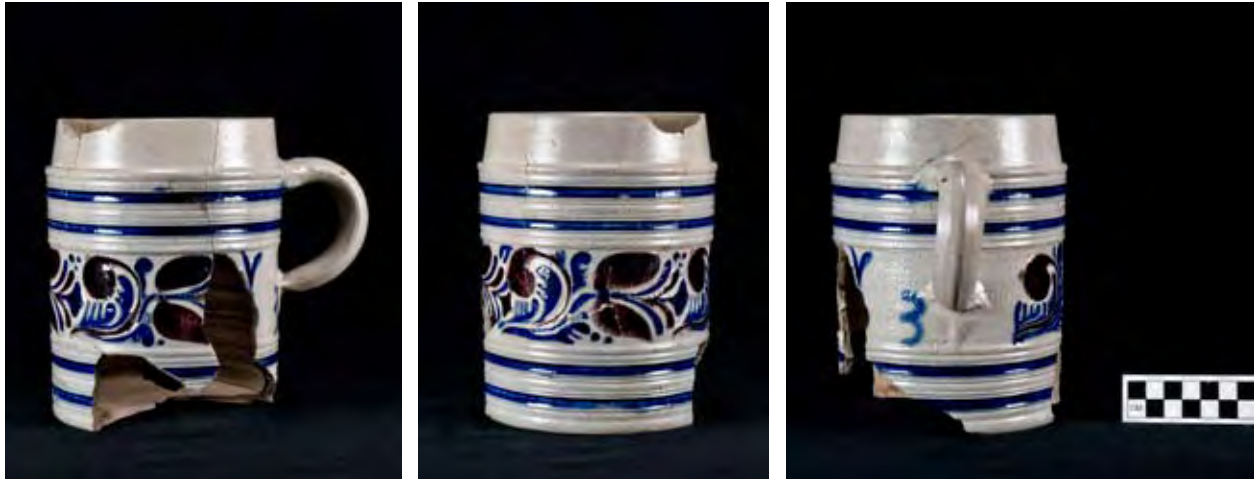
Figure 4.20: Vessel 1, a Rhenish stoneware mug, possibly late 17th or early 18th century. Purple (manganese) decoration is more common on vessels produced between 1670 and 1710.

Stoneware included a nearly-complete Rhenish sprig-molded blue and purple tankard (Vessel 1, Figure 4.20) with the number “3” on the side (indicating that it held 2 quarts of liquid (Nöel Hume 1969: 282)), an engine-turned red salt-glazed lid, probably to a butter churn (Vessel 16, Figure 4.21), a white salt-glazed saucer (Vessel 2), and two individual American pots or crocks with Albany slip (Vessels 24 and 25).

The earliest date of manufacture for the assemblage is 1650 (the Rhenish stoneware tankard, Vessel 1). The tankard had probably been curated for many decades prior to its breakage and disposal in the chimney. The terminus post quem (TPQ) for the assemblage is 1842, based on the earliest known manufacture of white ironstone teapots (Vessel 12). The two whiteware plates (Vessels 3 and 14, one from each context) date to 1841, based on their unscalloped, impressed edge decoration (Miller et al. 2000). It is also worth noting that these three vessels do exhibit signs of burning, indicating that they were deposited while the chimney was still in use. The whiteware plate from Context 0 (Vessel 14) might come from a different area of the site altogether.

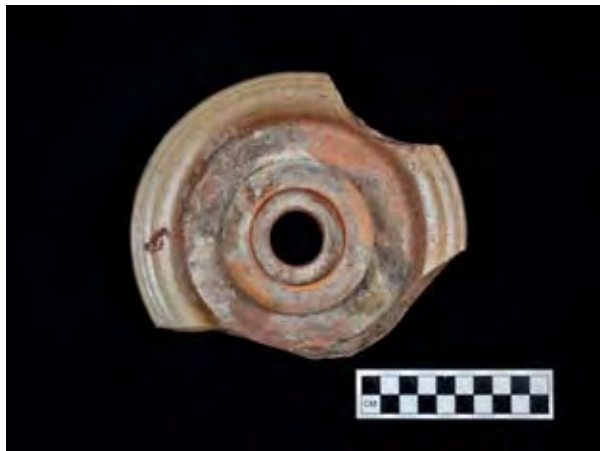
Figure 4.21: Vessel 16, the lid to a butter churn or crock.

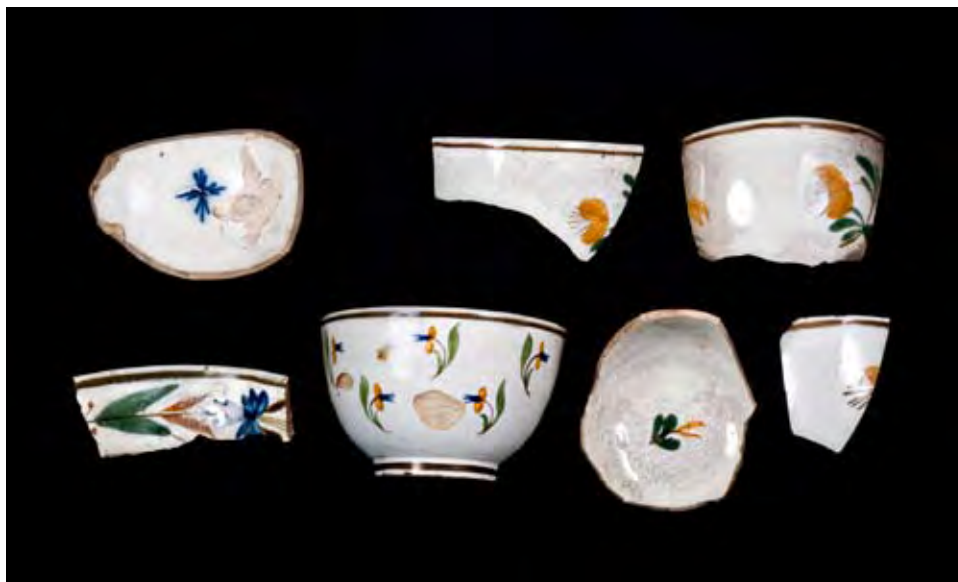
Figure 4.22: Pearlware tea cups and a saucer.

The 10 pearlware vessels included six teacups and a saucer (Figure 4.22): three polychrome

teacups and one saucer (Vessels 4, 5, 6, and 26), an underglaze blue teacup (Vessel 7), and two teacups represented only by their foot rims (Vessels 10 and 11, not pictured). All of these examples appear to be tea bowls, which have no handles. Vessel 26 is a polychrome painted saucer or bowl in a pattern similar to Vessel 4. Other pearlware (Figure

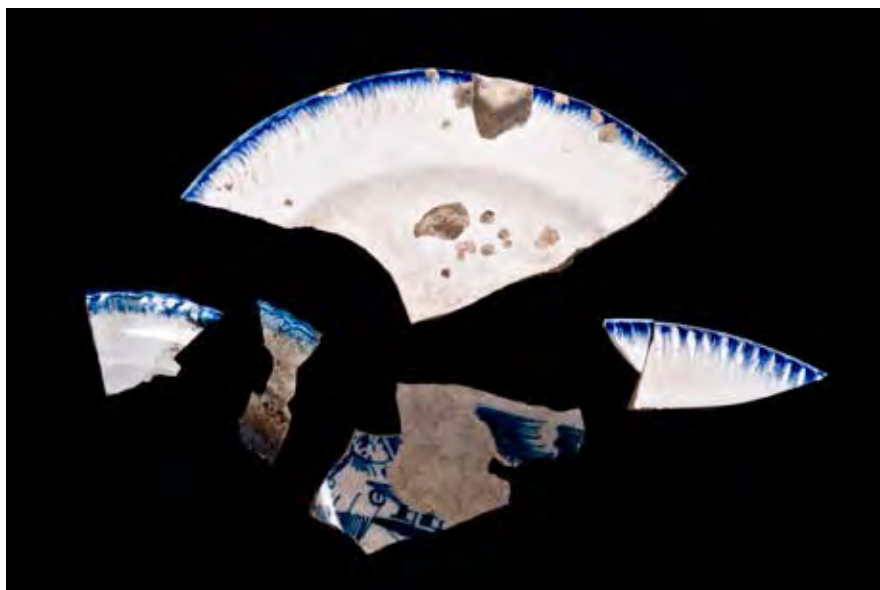
Figure 4.23: Edge decorated and painted pearlware and whiteware plates Left, vessel 9; top, vessel 14; right, vessel 3; bottom, vessel 8.

4.23) consisted of a blue shell-edged plate (Vessel 9), a hand-painted underglaze blue chinoiserie plate (Vessel 8), and the plain base and foot rim of a probable bowl (Vessel 13). The assemblage also contained two blue feather-edged whiteware plates (Vessels 3 and 14, Figure 4.23), an ironstone (white granite) teapot (Vessel 12), and a white-glazed sherd of unidentifiable refined earthenware (Vessel 15).

The chinoiserie plate is the earliest of these (Vessel 8). It is pearlware and not of Chinese origin, but is hand-painted rather than transfer-printed, dating it most probably to the late 18th century (Barker and Majewski 2006). The whiteware plates (Vessel 3 and 14) and ironstone teapot (Vessel 12) are the latest wares in the assemblage. The Rhenish stoneware tankard (Vessel 1) and white salt glazed

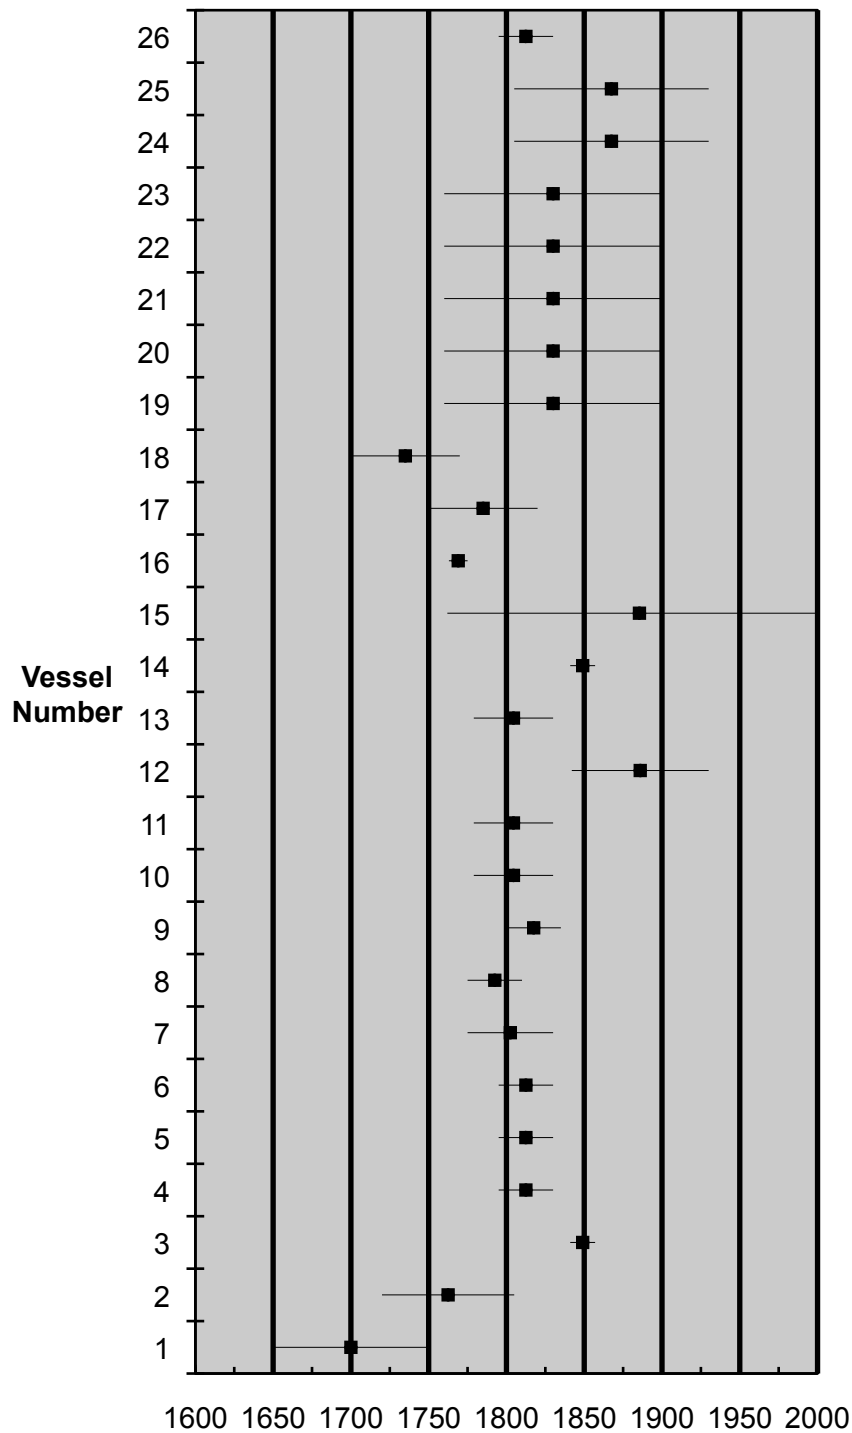
Figure 4.24: Production date ranges for vessels from contexts 0 and 199.

The ceramics in contexts 199 and 0 span a wide range of dates. Mean production dates for most vessels fall in the first half of the 19th century, but there are earlier and later outliers (Figure 4.24). The earliest pieces may have been heirlooms, unique examples of older wares that were still in use. The latest pieces help us to determine the date at which the deposit was formed; the

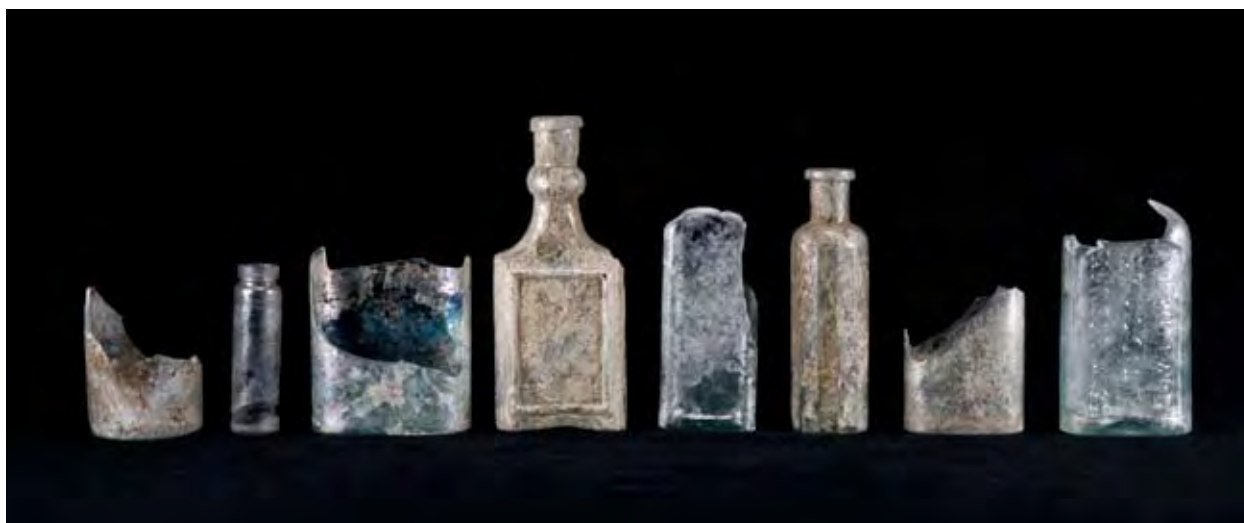
Figure 4.25: Glass bottles from contexts 0 and 199. From left to right, vessels 40, 35, 2, 1, 42, 3, 4, and 41.

One of the most distinctive bottles from context 199 is Vessel 1 (Figure 4.25, fourth from left). It is an almost completely intact medicine bottle with a patent finish, recessed panels on all four sides, is rectangular in style with four chamfered

sides, and contains a pontil mark on the base. This is one of the few bottles where its shape can tell us the contents it held. The ball neck, patent lip, and recessed paneling tell us that it most likely held a medicinal syrup (Fike 1984: 13). Syrups were sometimes taken to soothe throats (SHA 2009). The date of this bottle is unknown.

Other interesting types of medicine containers can be found in context 0. Three colorless vials (Vessels 35-37; see Figure 4.25) were collected by Anne Baker, and they appear to be homeopathic medicine vials which usually held liquid medicines and pills (Jones and Sullivan 1985: 73). These vials do not have a neck, just a patent finish and a cylindrical body. A cork was probably put in the bore to contain the medicine. Another interesting medicine bottle is Vessel 41, a plate-mold druggist bottle. The bottle is almost intact and only missing the neck and finish. It is embossed with the words, “A.L. WILLARD / DRUGGIST / TAUNTON MASS.” This company is not referenced in the Fike book (1984) or in William Hunt’s embossed medicine bottle database (2009), but the fact that it was plate-molded indicates that this bottle has a post-1867 date since plate-molds were not patented in the U.S. until 1867 (Jones and Sullivan 1985: 48-49). Another interesting type of medicine bottle from context 0 is vessel 40 because it is datable. It is small in size, has a round base, contains a pontil mark and a push-up.

Two bottles (Vessel 2 from context 199 and Vessel 38 from context 0) show evidence of re-use to hold blue laundry dye. Both contain traces of a blue film on the interior (visible on Vessel 2 in Figure 4.25). Another fragment (record no. 9 from

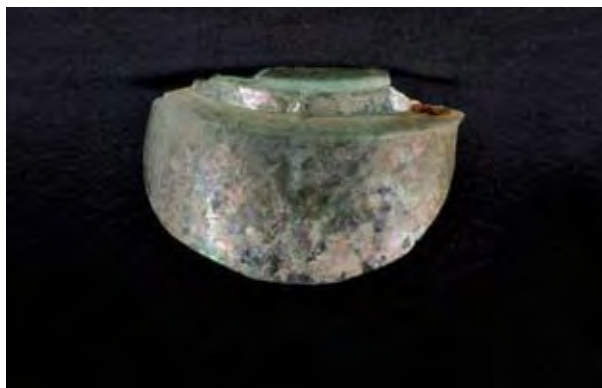
Figure 4.26: Vessel 27, the rim of a Mason's fruit jar.

Context 199 contains one Mason fruit jar (Vessel 27) that mends with a fragment with context 0. This vessel was identified as a fruit jar because of the thread finish, the wide mouth, and an upper body that slopes inward (Figure 4.26). This sloping body was a typical shape for a fruit jar in the last third of the nineteenth century (SHA 2009). Several additional embossed fragments from context 199 and one embossed fragment from context 0 have fragments of the embossing which was common fruit jars. These mason jars would read, "MASON'S / PATENT / NOV. 20TH / 1858." Mason's fruit jars helped preserved foods and "freed farm families from having to rely on pickle barrels, root cellars, and smoke houses to get through the winter" (Hinson 2009). The fact that the jars read 1858 does not mean they were all manufactured and used in 1858. The embossing with the "Nov. 20th 1858" date actually increased in the 1870s and 1880s because John Mason's patents on his product expired. The same embossing continued to be produced on machine-made fruit jars in the early twentieth-century (SHA 2009). Therefore, all we can say about the date the fruit jar fragments is that the earliest it can possibly date to is 1858.

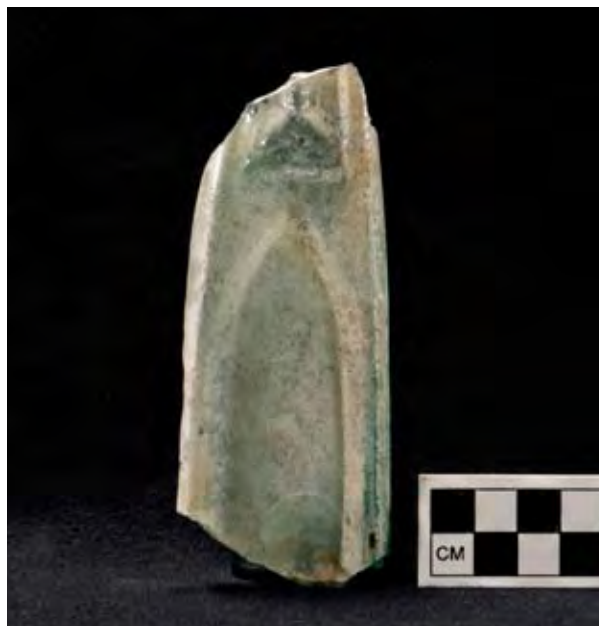
Figure 4.27: Vessel 39 from context 0, a condiment bottle.

Vessel 39 from context 0 is another interesting food-related object even though we cannot verify that it came from the chimney deposit (Figure

4.27). It is a partial fragment of four-sided Gothic or Cathedral style pepper sauce bottle. These bottles held pepper sauces, but they might have also been manufactured to hold other types of sauces, condiments such as ketchup, or syrups (SHA 2009). Vessel 39 has an indented arched panel on each of the four sides and this is characteristic of Gothic pepper sauce bottles. This style originated in the mid-nineteenth century during the "Gothic Revival" period in America as an attempt to attract consumers by adding gothic characteristics to their bottles (SHA 2009). Since vessel 5 is square in cross-section, the bottle can be dated to between the late 1840s and the 1890s (SHA 2009). Without the base and a pontil mark, it is not possible to determine a more precise date.

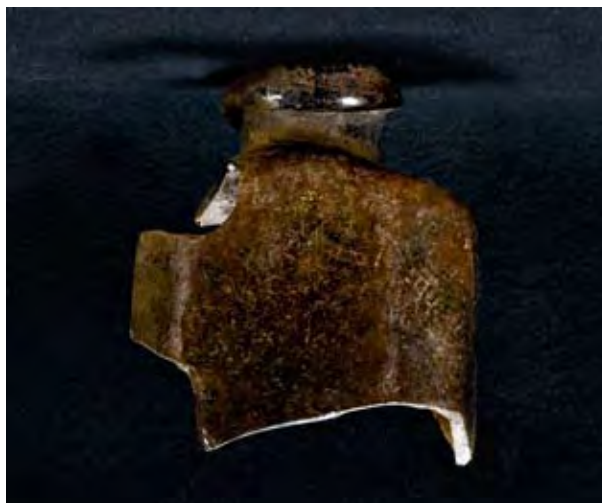
Figure 4.28: Vessel 10, the neck of a rectangular bottle.

Vessel 10 from context 199 is an olive case bottle shoulder fragment and as an intact bottle, would have held liquor, wine, or possibly oil (Figure 4.28). A case bottle is "a bottle with a square cross-section, widening from base to shoulder, with a short neck and indented base, and usually dark green glass" (Jones & Sullivan 1985: 72). The square cross-section enabled it to fit easily into a compartmented crate, box, or case and made packaging more efficient than round bottles. This

vessel is impossible to date from a shoulder fragment. The pitted, orange-peel that is visible on its surface indicates that this was blown in a full-sized mold (Jones and Sullivan 1985: 15). Vessel 38, a large aqua bottle, may also have been a beverage bottle for mineral water or another beverage, based on its large size. It has a few embossed letters, but not enough to identify a manufacturer.

On Vessel 10, there are also use-wear marks visible as yellow scratches. This indicates that the bottle was probably re-used for many years and possibly shows a pattern of recycling if the people who discarded this case bottle are the same ones who discarded the bottles with bluing. Also, since most of the glass objects, except for one complete bottle, were found broken, it shows that the household valued their glass bottles and reused them until they broke.

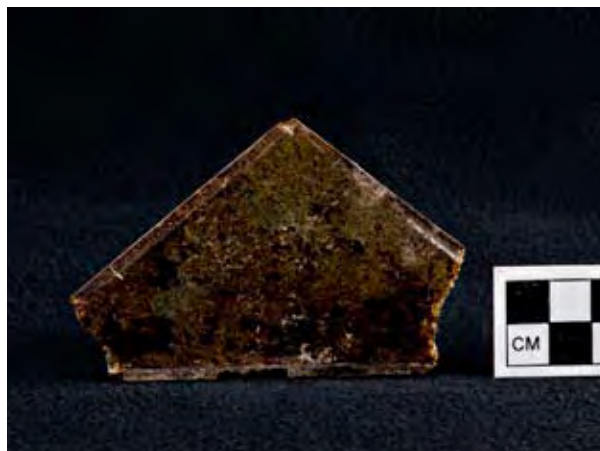
Figure 4.29: Triangular window glass pane from context 199.

The fragments from a triangular pane of window glass from context 199 are an important find because they come from casement windows, probably those original to the house when it was built. On the most complete piece (Figure 4.29), the angle measurements at the corners are 40 degrees (at two corners) and 100 degrees. Two edges measure 10 cm and the longest is 16 cm. Another pane represented only by a corner of a diamond or triangle has an angle of 65 degrees. Both window panes are brown and very weathered, but they most likely were originally aqua in color. This type of small, cut, window pane glass dates to the seventeenth and early eighteenth centuries (Jones and Sullivan 1985: 172). The lighter colored patination on the edges of these window panes indicates the area where the lead coming held it in the casement (Jones and Sullivan 1985: 172). Other types of window glass, such the square-cut ones found in context 199 and 0 come from later in the 18th century but cannot be dated any more specifically.

Window panes have long lives as artifacts; they can last fifty years before breaking so they are often the oldest artifacts on a site (Jones and Sullivan 1985: 172). In this case, the fragments of diamond and triangular panes are older than any of the other glass in the chimney deposit. They were probably original to the house and suggest that one or more of the old casement style windows may have existed on the house until the chimney alterations were made in the second half of the 19th century.

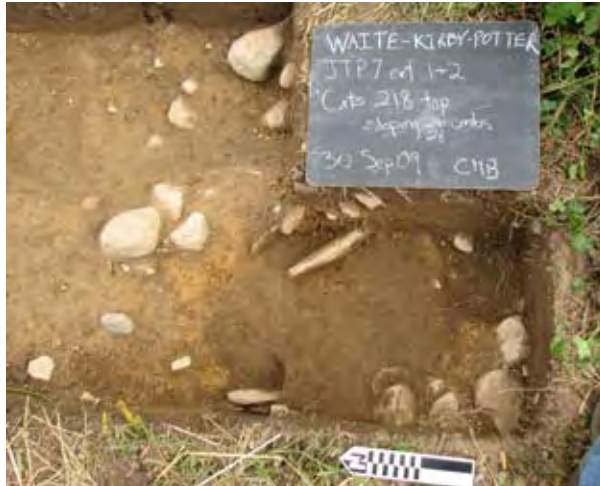
Figure 4.30: JTP 7 showing the top of one post hole feature. Note the vertical granite spalls in the hole, presumable to help hold the post upright.

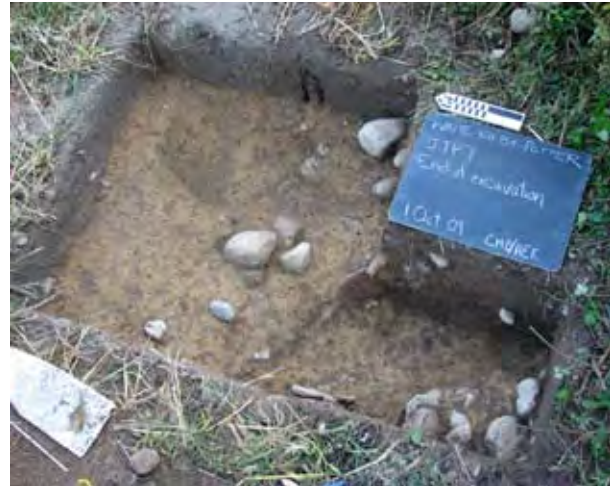
Figure 4.31: JTP 7 at the end of excavation. One excavated posthole is visible in the northeast of the unit, another in the southwest, while the edge of a third post hole is just visible in the southeast corner of the extension.

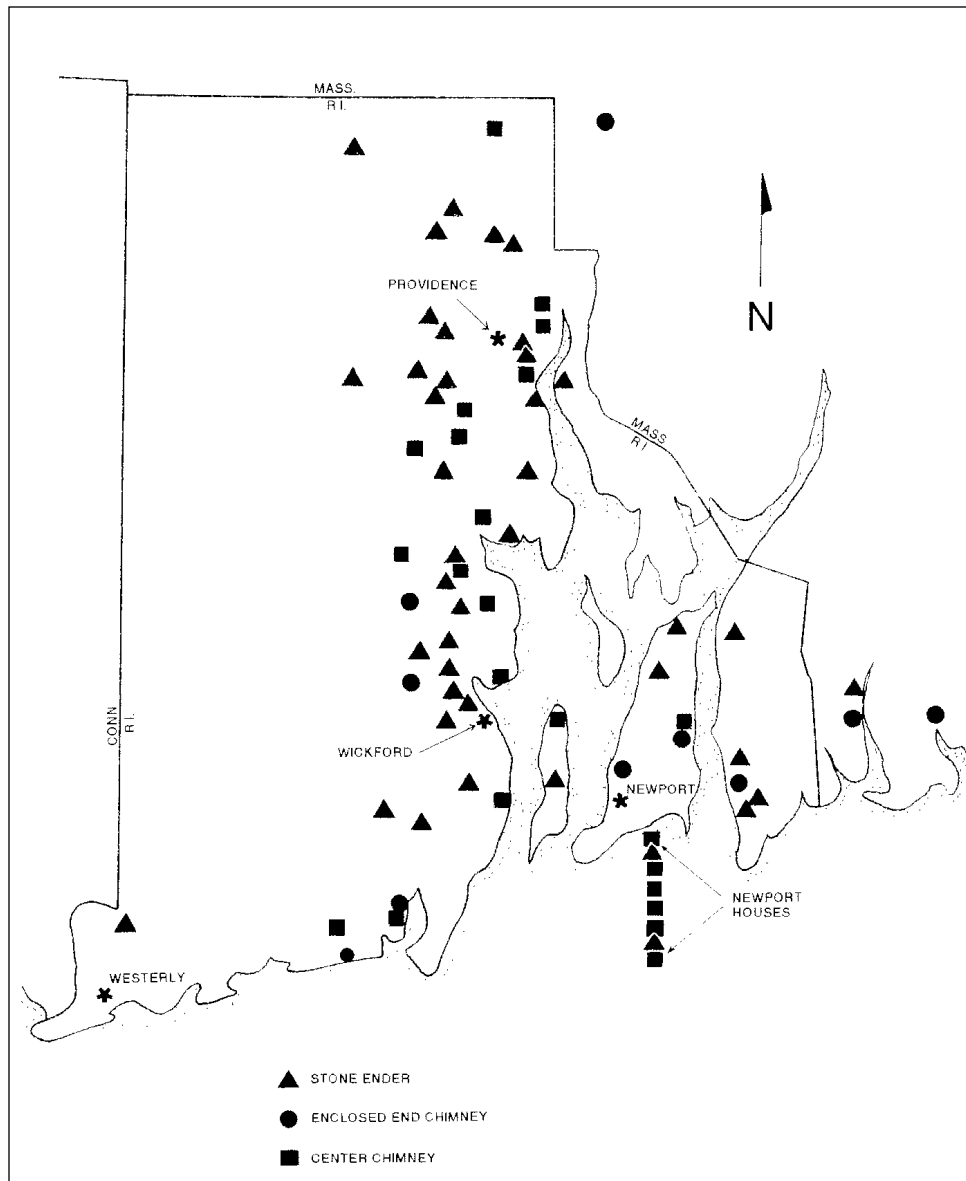
Figure 5.1: Distribution of stone end houses in the Narragansett Basin (Stachiw 2001b: 22).

ragansett Basin which includes Westport (Stachiw 2001a). Most examples can be found in Rhode Island (Figure 5.1), and the Waite-Kirby-Potter house is a rare example of the type in Massachusetts. In stone end houses, one of the gable ends, as the name implies, is constructed of stone with an integral stone chimney, while the rest of the house is framed. The stone end is left exposed, while the sides are sometimes encased by the house's framing. Construction of stone end houses continued into the 18th century, as can be seen by the example of the Bliss House in Newport (con-
