**Documentary Research and Archaeological
Investigations at the Waite-Kirby-Potter Site,
Westport, Massachusetts**

**Prepared for:
The Community Preservation Committee
Town of Westport
Westport, MA**

**Prepared by:
Katharine M. Johnson and Christa M. Beranek
With contributions by Kathryn A. Catlin and Laura W. Ng
Fiske Center for Archaeological Research
University of Massachusetts Boston**

Cultural Resource Management Study No. 37

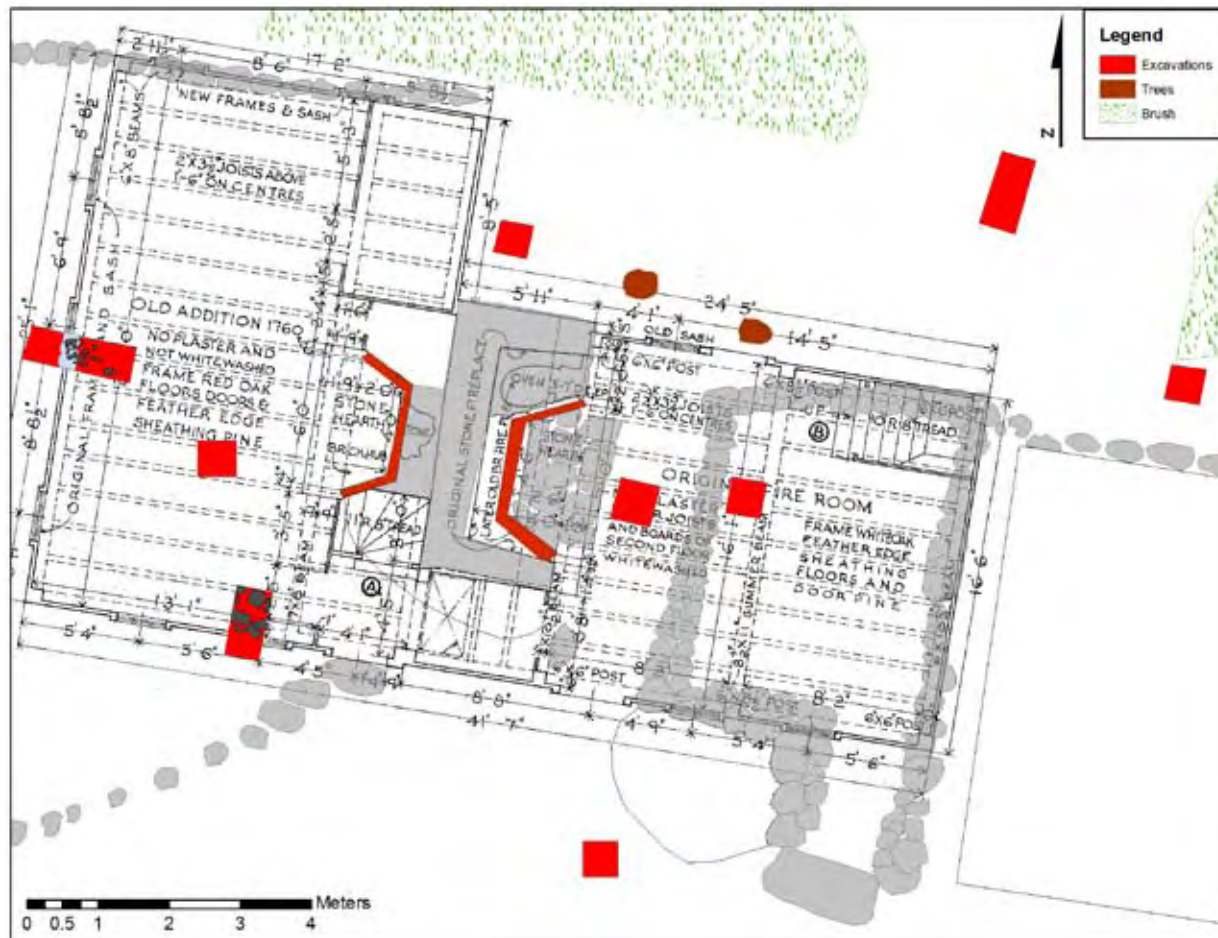
Figure 5.2: The HABS plan of the Waite-Kirby-Potter house superimposed on the map of the cellar hole.

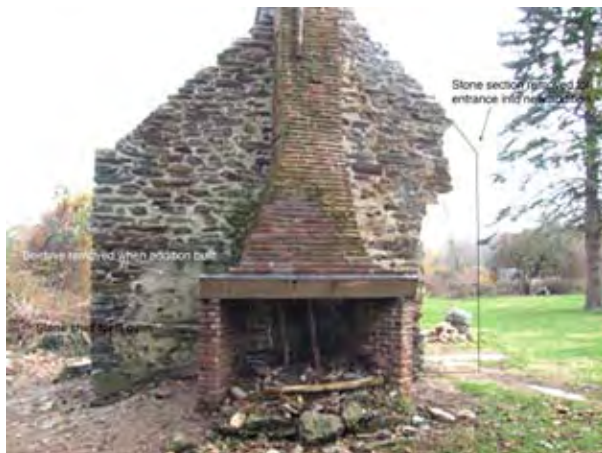
Figure 5.3: Anne Baker's annotated photograph of the west side of the stone chimney showing evidence of the original beehive oven (Courtesy of Anne Baker, 2009).

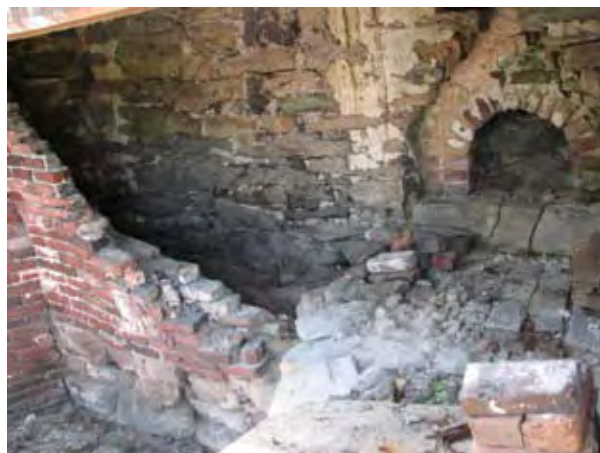
Figure 5.4: The opening for the original bake oven behind the later brick firebox insert in the east hearth.
