### Seeing Red: Characterizing Historic Bricks at Sylvester Manor, Long Island, NY 1652-1735

SEEING RED: CHARACTERIZING HISTORIC BRICKS AT SYLVESTER MANOR,  
SHELTER ISLAND, NEW YORK 1652-1735

December 2014

Historical Archaeology Program

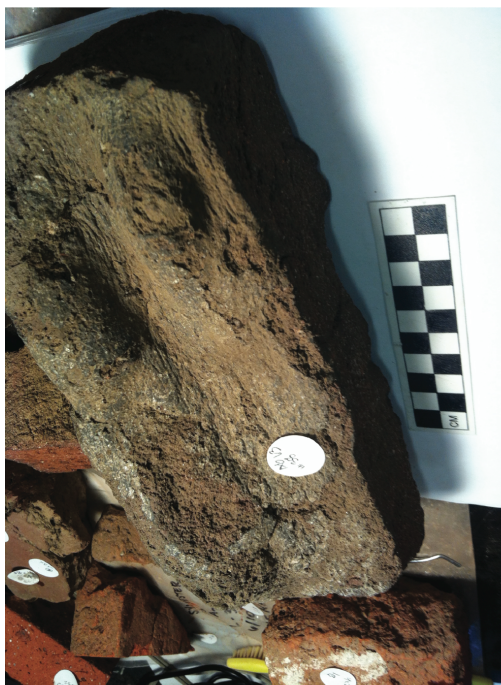
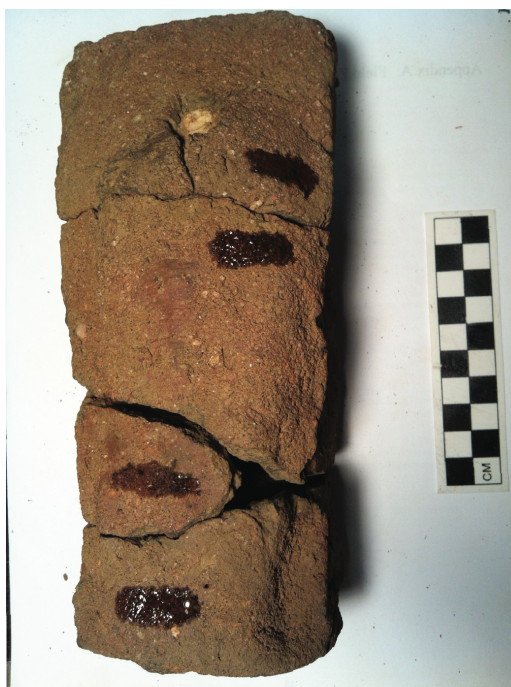
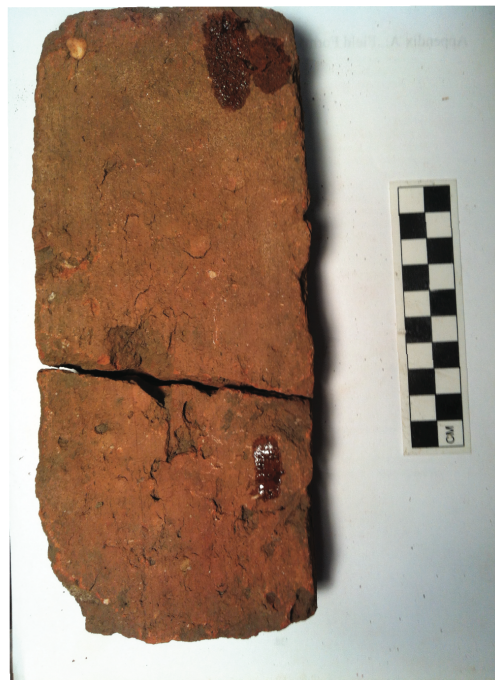
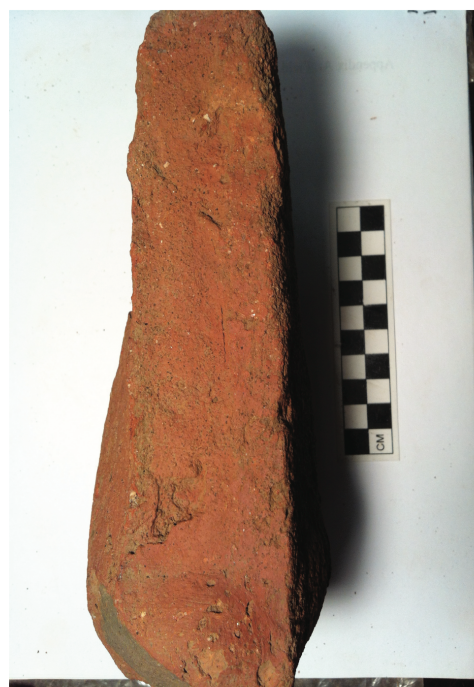
Fig. 2a) Presentation of the four whole bats recovered from the A-Block. Clockwise from top left: #38, wasted, bloated 1B brick, A6; #68 1A brick, crossmended within F.218; #1 bloated 1A type brick, A1; #63 1B brick, broken and cross-mended, E2

c) The Sylvester Manor bricks appear as weathered spall, rubble and bats in various conditions: the industrial “palette” is very wide (figures 2a-c). As with other structural materials and facings, this reflects different architectural “rhythms” of repair, maintenance and re-purposing that create distinctive taphonomic patterns for building materials and structural decay on archaeological sites (Leech 2005; Antonelli, Cancelliere and Lazzarini 2002; Bolvin 2000; Hinks 1997).

mended (fig. 2a). Additionally, four bat samples were identified from adjacent areas of the South Lawn for comparative purposes, bringing the total bat sample to 71. No other bats were identified in the south lawn, and no bats were sampled outside the south lawn. Yellow brick was also recorded for the A-Block units, yielding a total of 27 bats.

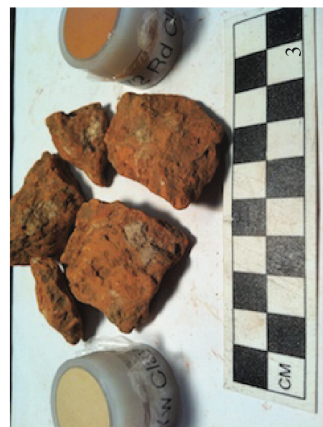
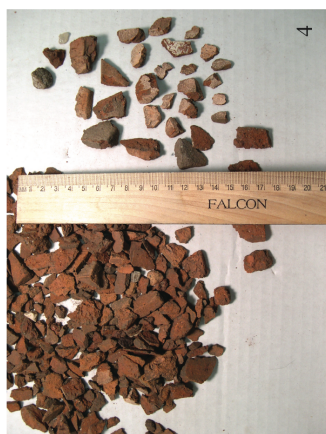
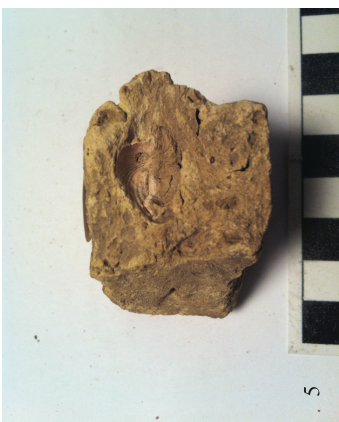
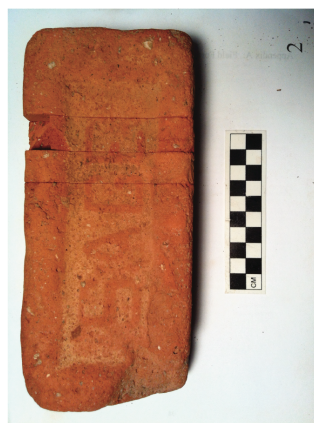
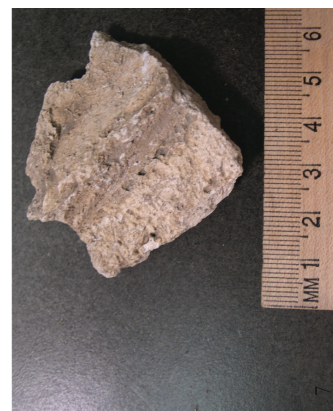
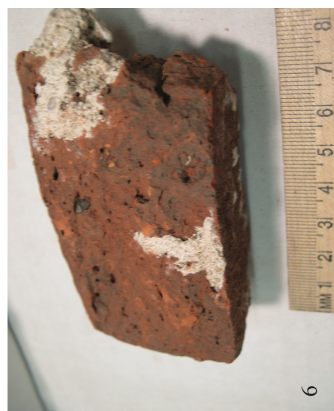
Fig. 2b) Details of Sylvester Manor brick rubble and debris. Clockwise from bottom left:

- 1) Brick recovered from current Manor House (#72)
- 2) Brick bearing 'SAGE' mark from 19th brickyard at Greenport, recovered in surf (#74)
- 3) Underfired rubble incorporating the two base clays identified visually (CTX 1872)
- 4) Example of diagnostic (right) vs. undiagnostic (left) rubble (CTX 119)
- 5) Yellow brick rubble with incorporated shell fragment (CTX 106)
- 6) Brick fragment with mortar traces, possibly used as bricklaying tool (CTX 143)
- 7) Plaster fragment bearing contours reflecting brick facing (CTX 2032)

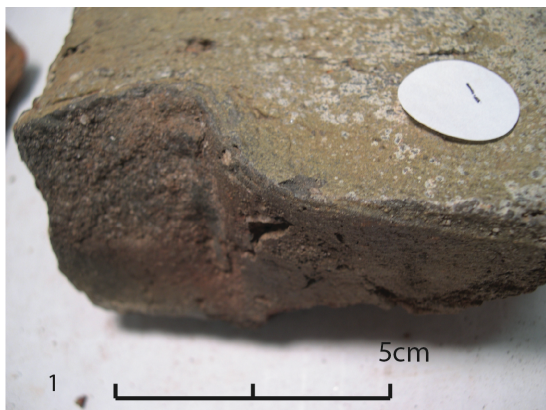
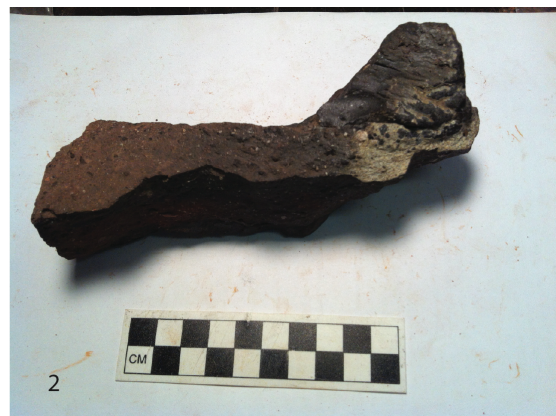
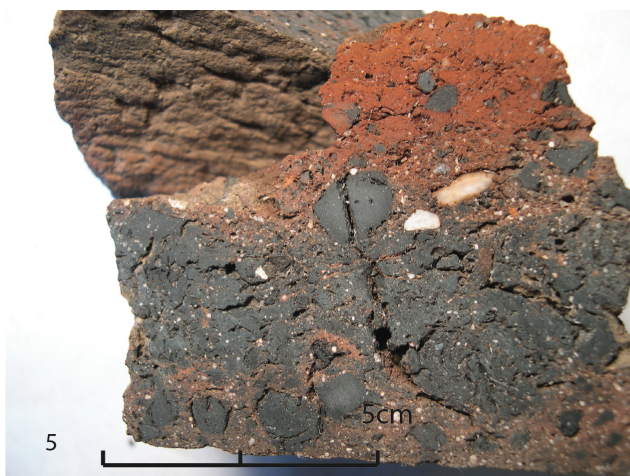
Fig. 2c) Details of brick features mentioned in text.  
Clockwise from top left:

2) Broken, fused debris, 1B subgroup CTX 169

5) Internal appearance of oxidized clay (red) and with components of carbon/iron rich clay (black), recorded as "burned" brick (1C subgroup, #117)

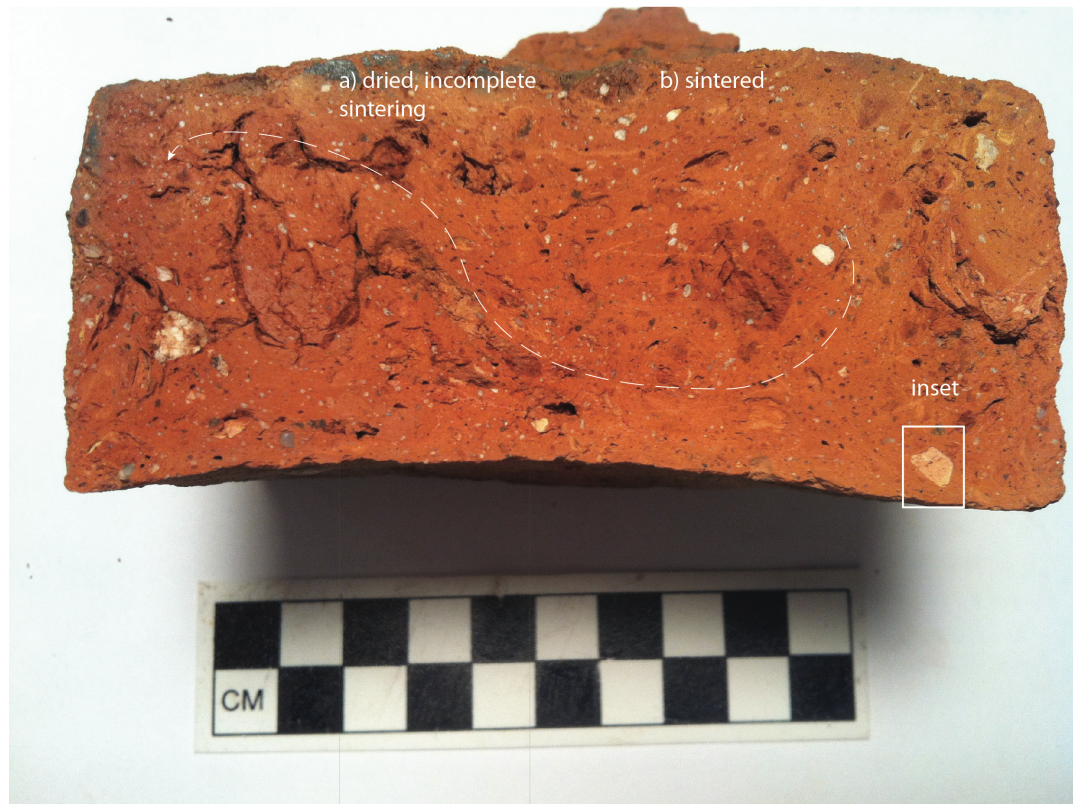
Fig. 5a) Group 1  
Type 1B Cross Section Profile Sample # 19 South Lawn Midden A3

Inclusions (% of coarse fraction)  
Quartz and Rock (as temper) 30%  
Grog or Dried Clay 5%  
Feldspars 20%  
Hornblende/Mica 5%  
Sand 30-35%  
Limestone or marl <10%

Voids/Pores: closed, tunnel, pocket, burn-outs  
Surface Strike: Length

The 1B subgroup contains 21 bats, 21% of the total sample. It consists of flat, hard bricks with sanded reverse faces and smoothed sides, struck length-wise (figs. 5a-b). Their small thermal mass and highly plastic body caused a wide range of temperature effects and marbling due to gaseous movement through the fabric in a highly variable firing atmosphere. It is a counterpart to the extensive vitrification and sintered (solid-state particle fusing) phases observed in Type 1A, though a more diverse range of inclusions can be identified since the fine fraction is not extensively deformed and obscured by air pockets (figures 6a-b). These bricks are unequally vitrified and sintered with extensive continuous glassy vitrification on exposed surfaces and porous interiors. Reduced and oxidized colors are often layered or marbled especially where vitrification and heat exposure was unequal in some cases showing capillary organic extraction (Rice 2005). The fine fraction is generally a dark red with a clean, well-sorted quartz sand and a bi-modal crushed quartz component which consists of rough, highly angular pieces. Associated rubble is usually vitrified: flat, sharp and quite hard and the rubble retains edge features very well. 1B bricks can also show the black coring common to handmade

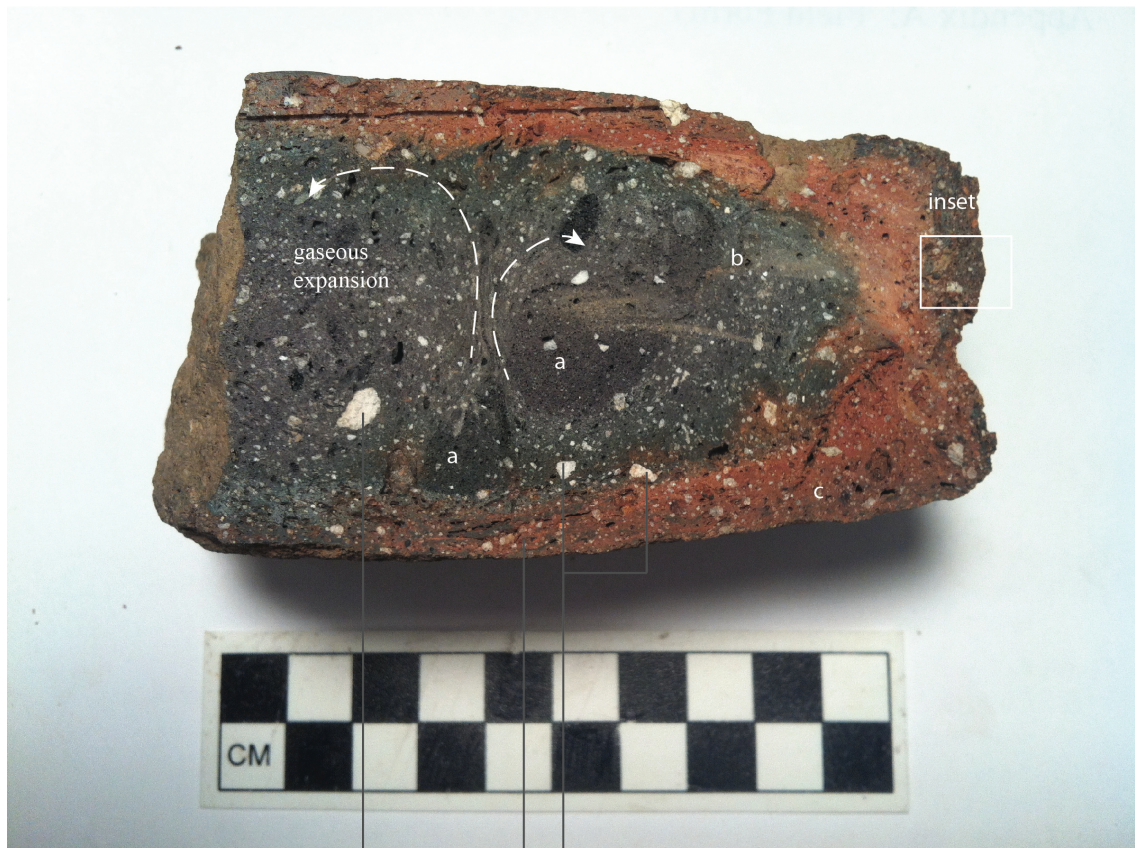
Fig. 5b) Group 1, Reduction Core  
Subgroup 1B Cross Section Profile Sample #3 South Lawn Midden A1

Inclusions (% of coarse fraction)  
Quartz and Rocks (as temper) 40%  
Grog or Dried Clay 10%  
Feldspars 20%  
Hornblende/Mica (as sand)  
Sand 30%

Voids/Pores: closed, tunnel , carbon burnouts  
Surface Strike: Length  
Coarse:Fine:Void ratio 40:50:10

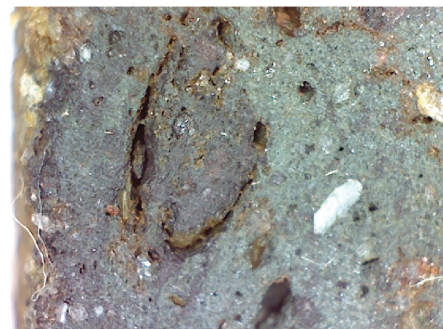
Detail of #3 vitrifying exterior incorporating sintered nodule, width of field 8mm

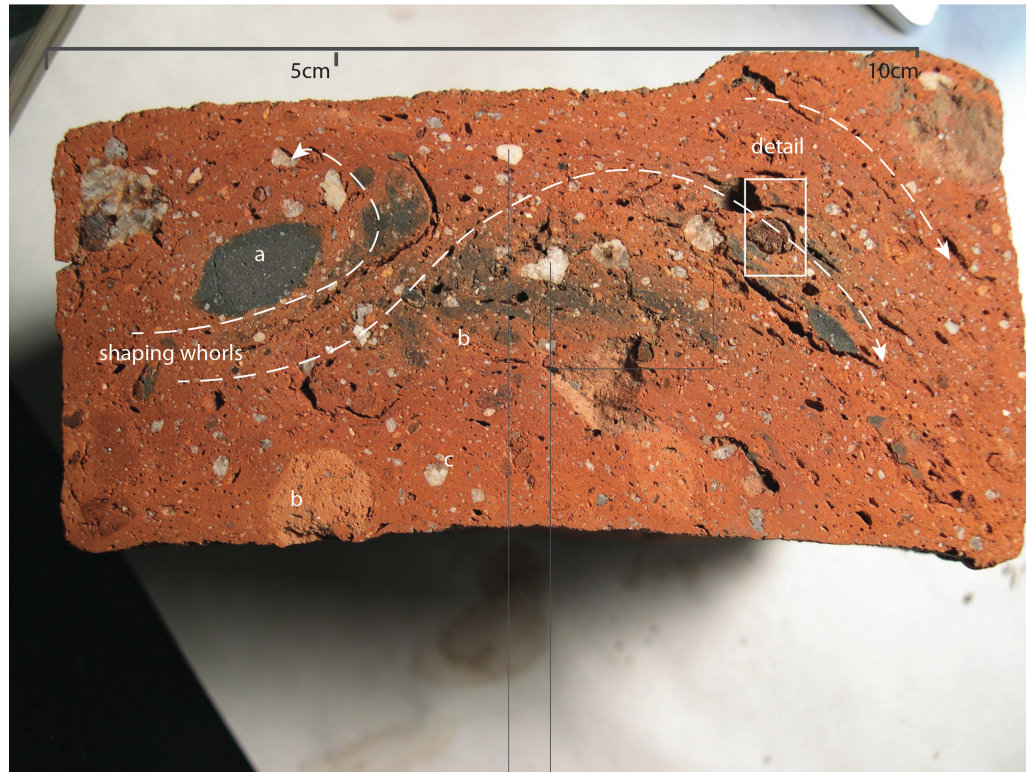
Fig. 6a Group 1  
Subgroup 1C Cross Section Profile Sample #43 South Lawn Midden A4

Inclusions (% of coarse fraction)  
Quartz and Rock (as temper) 30%  
Grog or Nodules 5%  
Feldspars 20%  
Hornblende/Mica 15%  
Sand 30%

Areas: a) reduced nodules, b) underfired, c) oxidized

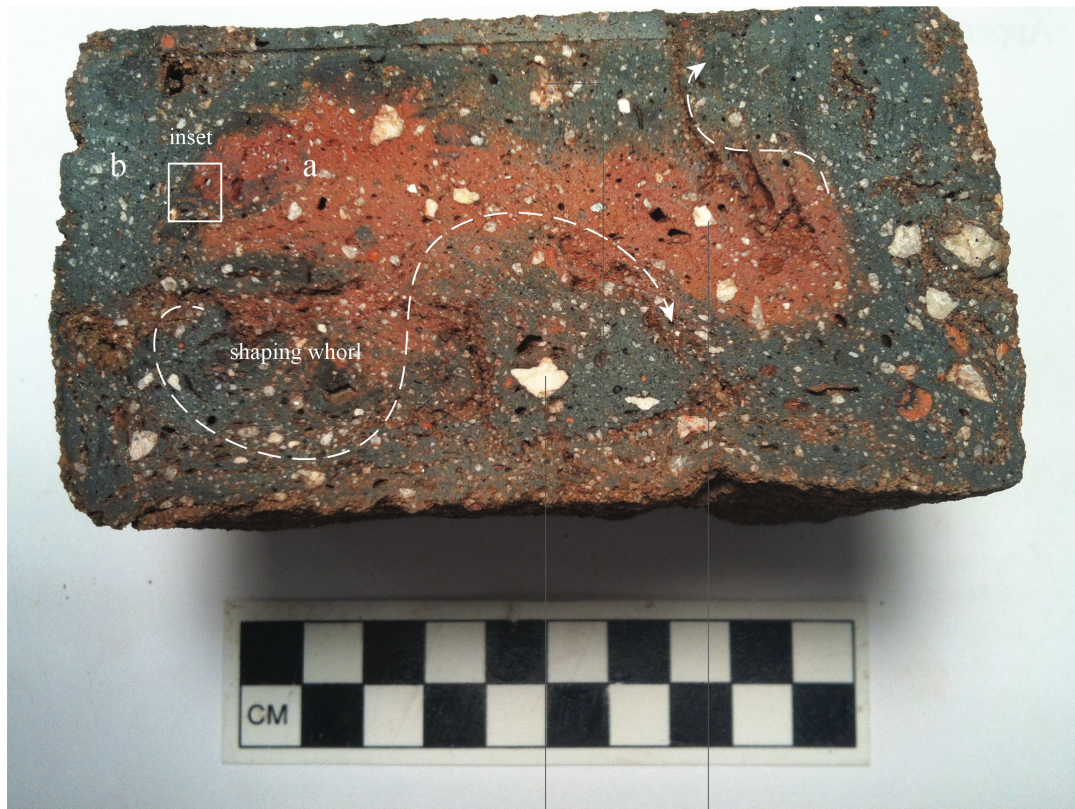
Fig. 6b) Group 1  
Subgroup 1C Cross Section Profile Sample #55 South Lawn Midden A9

Inclusions (% of coarse fraction)  
Quartz and Rocks (as temper) 40%  
Grog or Dried Clay 5%  
Feldspars 20%  
Hornblende/Mica 5%  
Sand 30%

Areas: a) oxidized core, b) reduction, vitrification of of sintered exterior

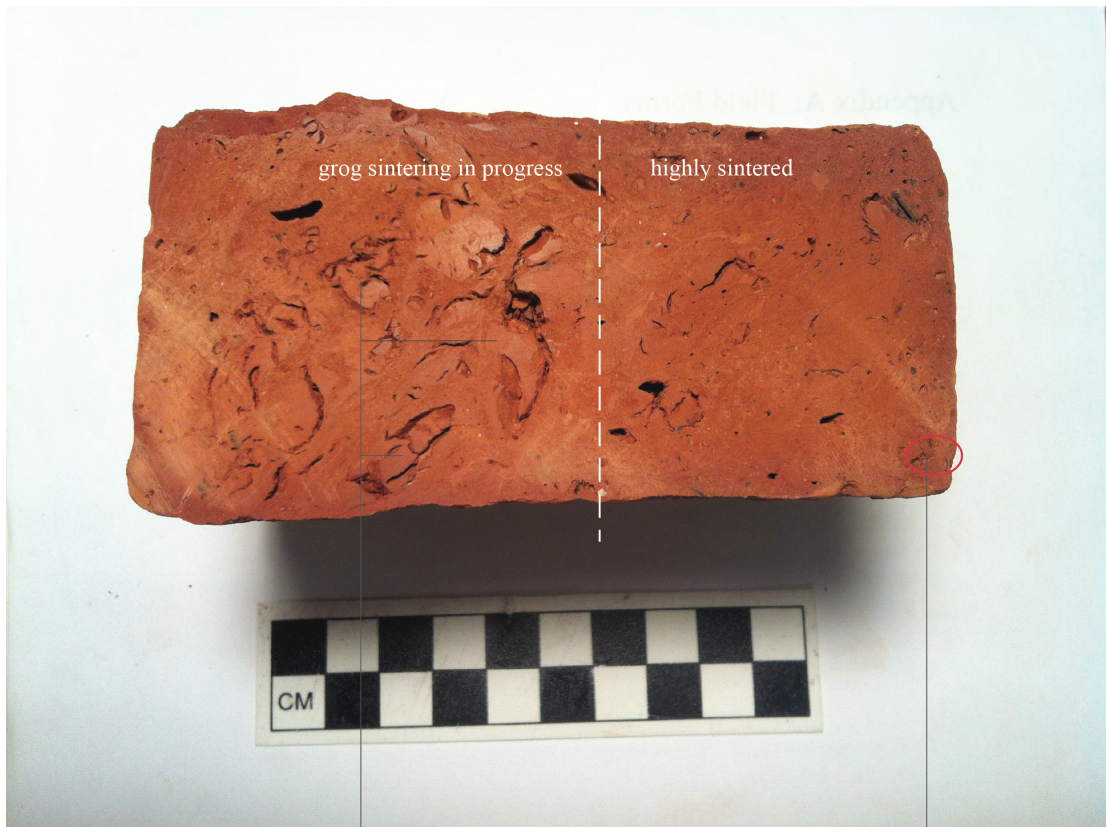
Fig. 7a) Group 2  
Cross Section Profile Sample #21 South Lawn Midden A4

Group 2 bricks total 13 bats, or 13% of the total sample. The key characteristics for these bricks are a smooth, well-fused fabric with consistent exterior shaping and dimensions (figure 7a). The clays used for this brick were likely very finely ground or separated by flotation (“elutriated”) to create evenly sized particles and remove debris. As a result the fabric is visually homogenous. Subtle color changes within the fabric are not caused by defective firing conditions, rather they show mixed clay sources of similar consistency but slightly different tempers. Incorporated clay fragments in the fabrics can show marbling from previous exposure, but are usually visually identical with the base fabric once they have sintered, and so can be termed an aplastic grog. As the ceramic fires and sinters, these inclusions become visually indistinct or lost altogether, which

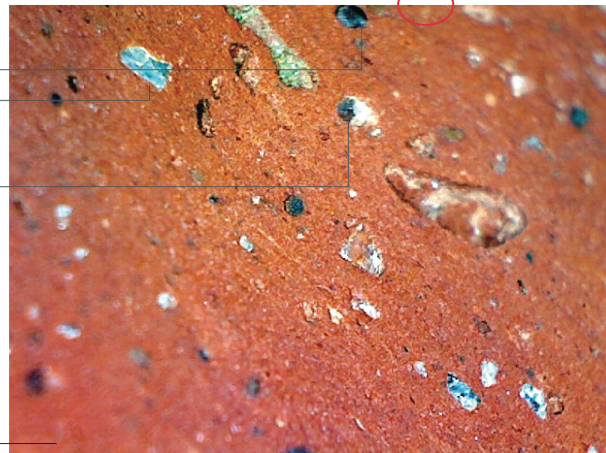
Detail of #21, microscopic coarse fraction,  
field of width 1cm

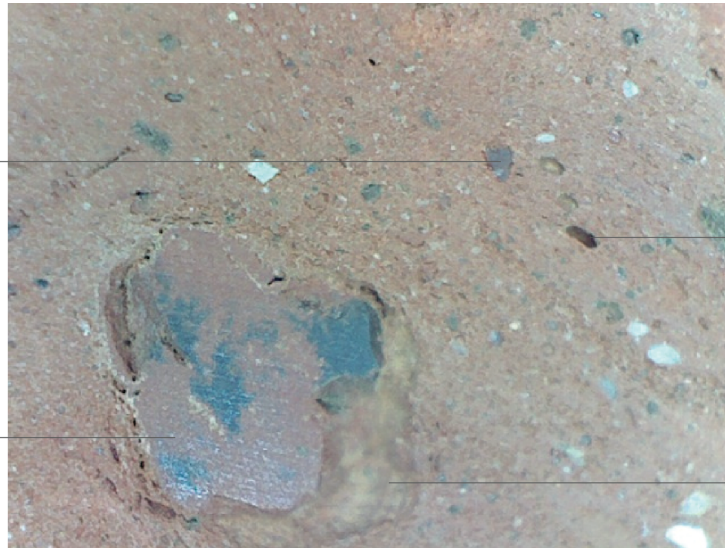
Fig. 7b) #4 Group 2: Detail of aplastic clay nodule (previously fired grog). The marbling of this inclusion demonstrates a distinct particle embedded in the surrounding brick fabric. A shrinkage rim with associated void shows the sintering temperature did not exceed previous firing temperature. Field of width 2cm.

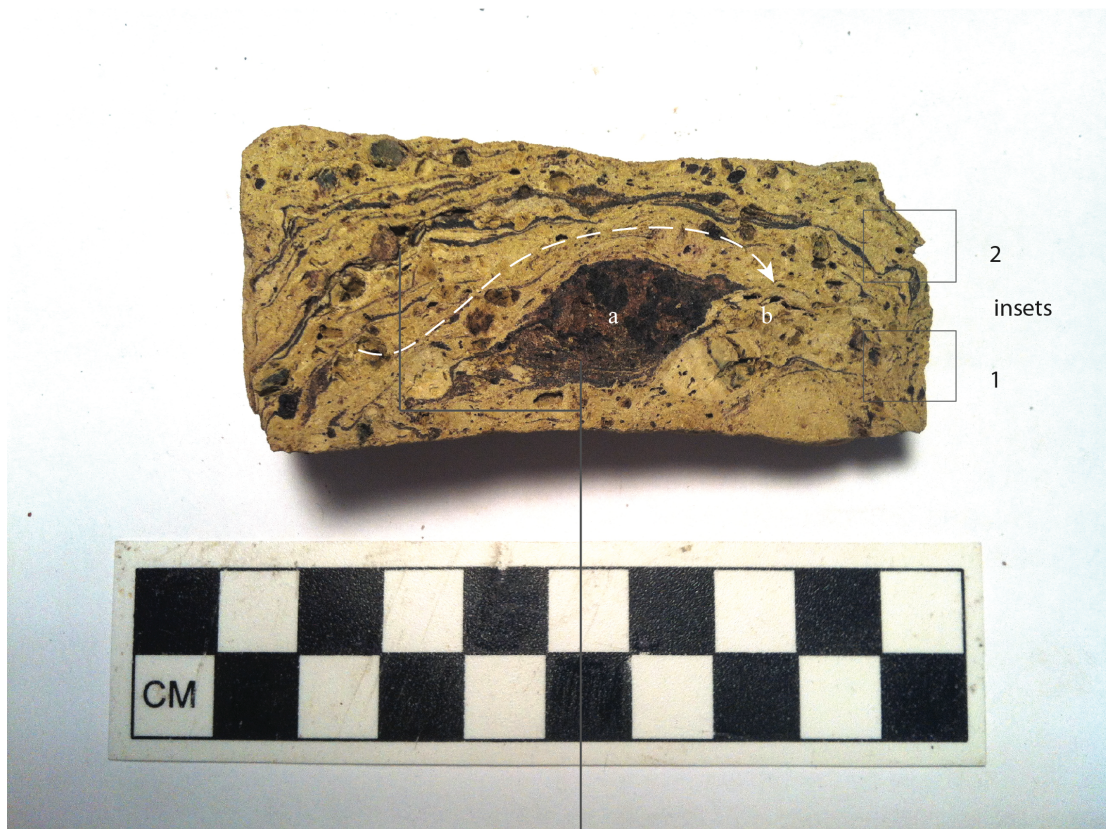
Fig. 8a) Group Yellow  
Cross Section Profile Sample #84 (Y13) South Lawn Midden A6

Unlike the red bricks, the yellow bricks in the A -Block appear to constitute a single fabric. They are easily distinguished by their range of yellowish, buff cream colors. 27 bats are in this group, 28% of the total sample. There is no indication of severe internal combustion or bloating and the best examples are quite hard and are resonant when struck together (figure 8a). They are fairly porous and slightly friable due to high proportion of sand in the fabric, however. Mechanical deformations are common, particularly slumping and pinching. They are made from a soft mixture of clays and sands with distinct components that appear either as dark or red nodules, marbles and

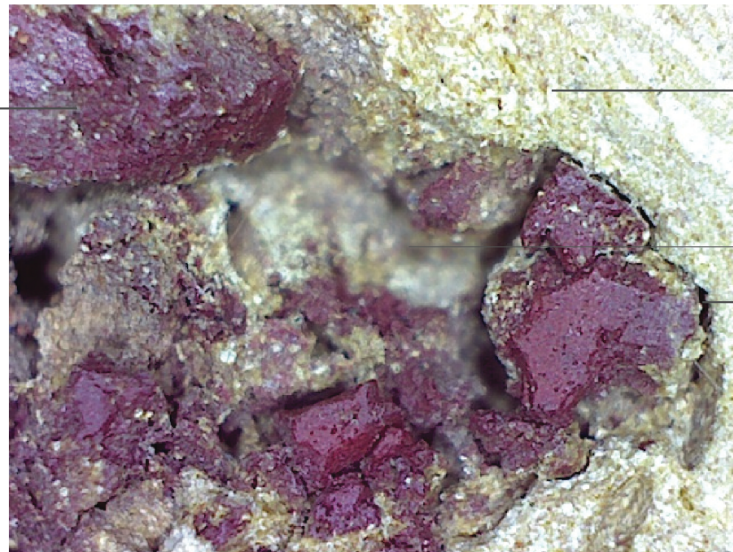
Fig. 8f) #114, 1B fabric cross-section: Detail of sintering clay nodule in sand heavy brick phase with developing shrinkage crack. This clay component appears rounded where the oxidized true grog is angular. These nodules incorporate fluxes but no temper and sinter readily. Width of field 1cm.

Incorporated  
clay fraction
