### Archaeological Investigation of the Drive Circle and West Hyphen at Gore Place Waltham, Massachusetts

**Archaeological Investigation of the  
Drive Circle and West Hyphen at Gore Place  
Waltham, Massachusetts**

**Cultural Resource Management Study No. 74**

**April 2016**

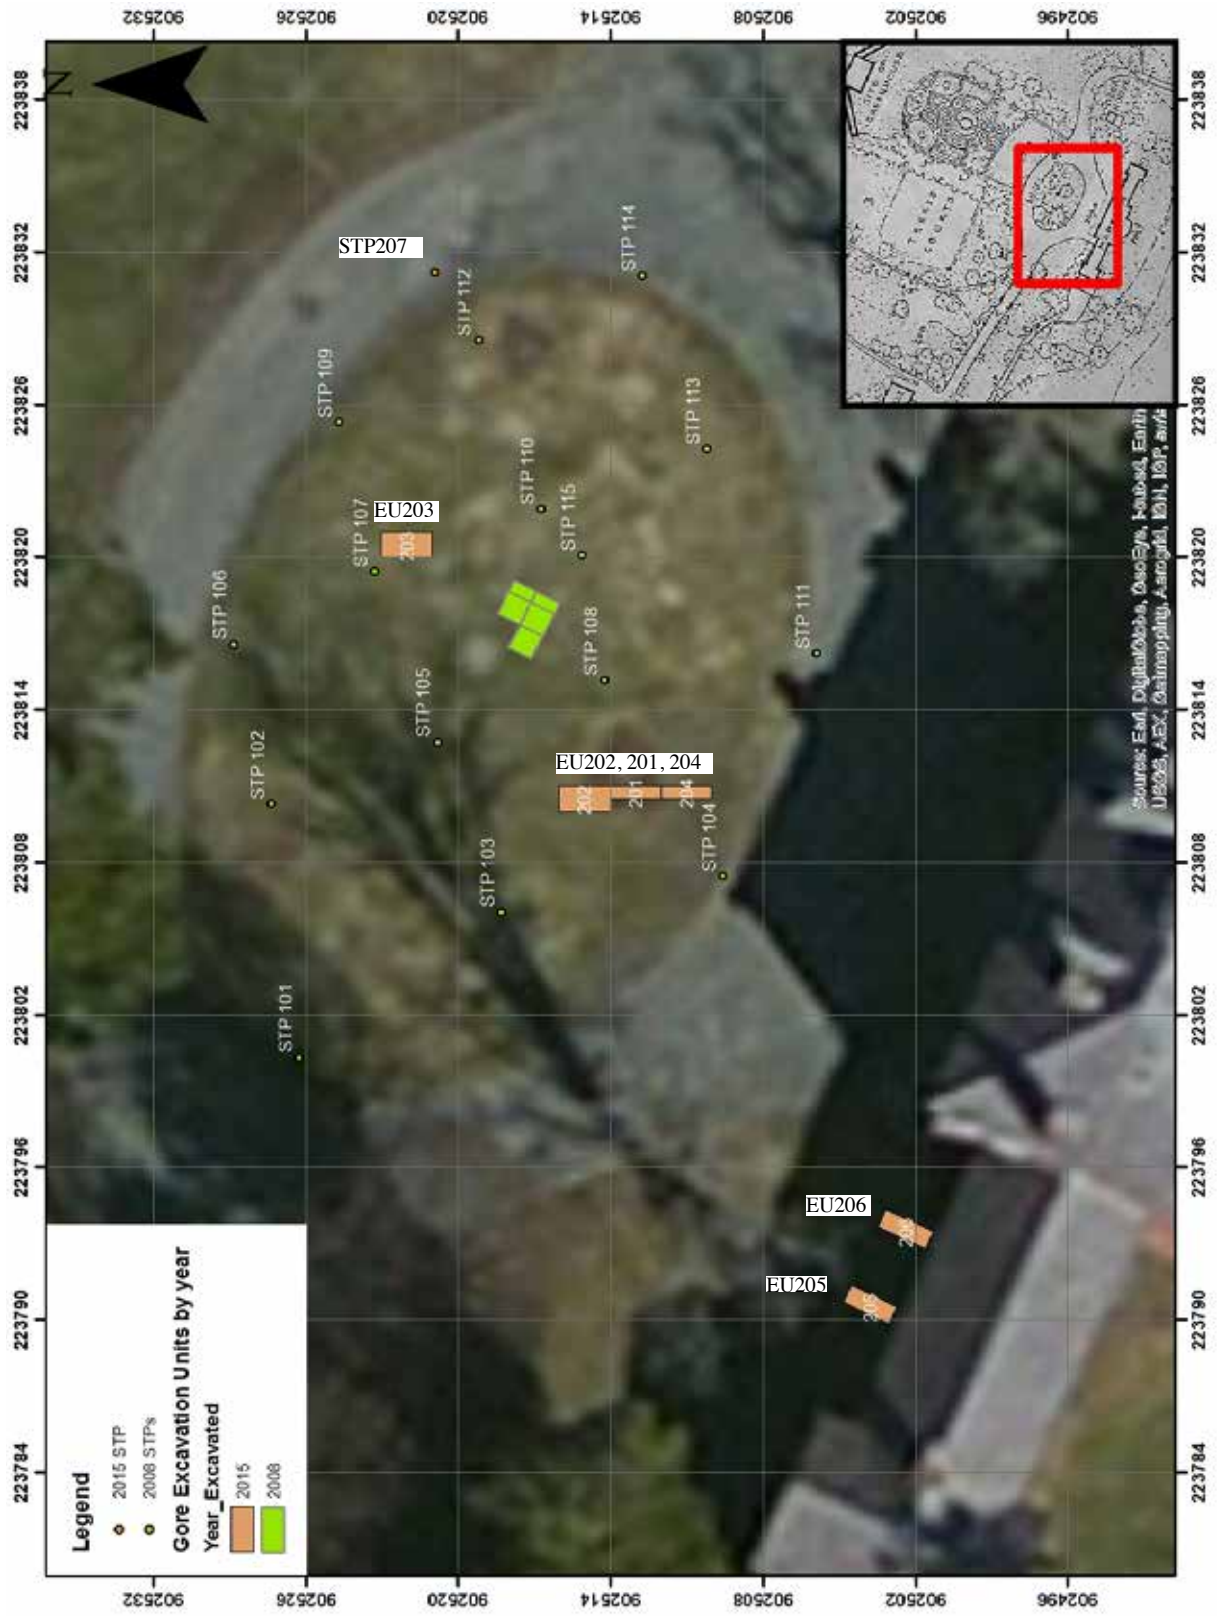
Figure 5. Detail of excavation unit locations (2008 and 2015) in the drive circle and against the west hyphen. The margins show the Massachusetts State Plane grid in meters.

Gore Place is currently interested in understanding and potentially reconstructing the landscape features to the north of the 1806 mansion house. The 2015 fieldwork focused on the drive circle and a possible cellar access against the west hyphen of the house (Fig. 5). The Gore Place Society contacted the Fiske Center for Archaeological Research at the University of Massachusetts Boston, for the purpose of conducting an archaeological survey of these areas to test features previously

In 2008, the Fiske Center conducted a GPR survey of the grassy oval in the driveway north of the mansion (which had not been surveyed by RSI), followed by test pits across the oval and excavation units focused on the well (see Fig. 5; Smith, Beranek, and Steinberg 2010). We located a path that ran from the well towards the house, and in our initial interpretation identified a possible square enclosure from the GPR slices (Fig. 9). The GPR results also suggested that the grassy area surrounding the well may have had a straighter edge facing the house, rather than the oval configuration seen today.

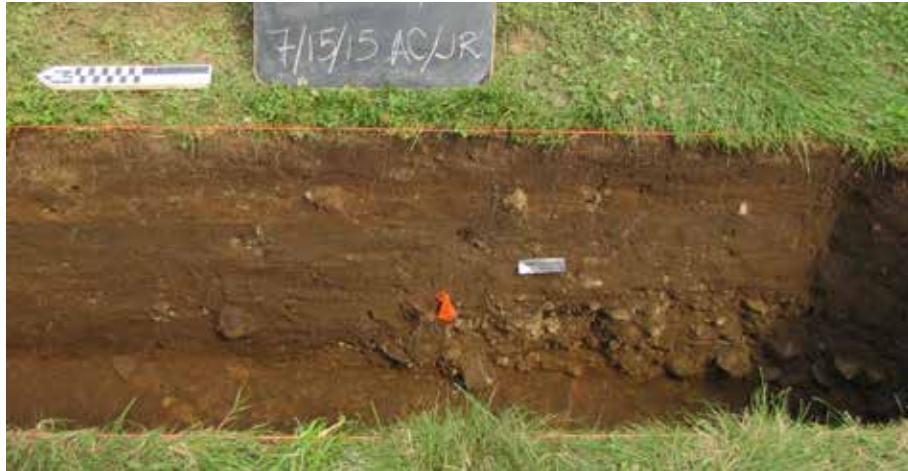
Figure 15. Photograph of the gravel driveway in the east wall profile of EU204.

In the southern third of the unit, a gravel surface with 10YR 5/2 very dark grayish brown sandy silt was revealed (Fig. 15). The gravel surface (context 1123) was sorted, with larger cobbles located at the bottom of the layer. No artifacts were recovered in context 1123. The layer was approximately 10-25 cm in depth and has been interpreted as the Gore-era driveway. At approximately 55 cm below surface, context 1123 gave way to a mixed gravel and 10YR 4/4 dark yellow brown silty sand fill that was given the designation context 1129. The mixed fill is believed to possibly be the "Gore Fill" seen elsewhere in excavations on the property. No artifacts were recovered

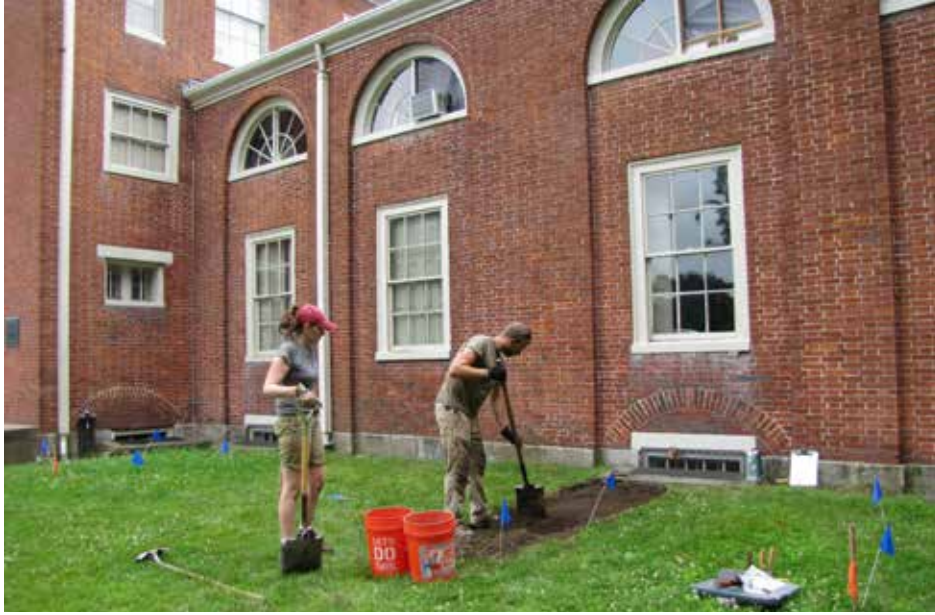
Figure 23. Starting excavation of EU205. Note that the unit abuts the window well of a cellar window with an arch in the brickwork above the window. The architects have interpreted the arch as evidence that this window and another cellar window to the east (left in the photograph) were once doorways. EU206, not yet excavated in this photograph, is located under the middle of the three large first floor windows.

EU205 was purposely placed against the third window well to the west of the north entrance (Fig. 23). The unit was located adjacent to the arched window to determine if the arch, which was different from several of the surrounding windows, indicated its use as a cellar entrance during previous periods of mansion occupation. It was also placed in order to determine if any cellar ramp or entrance features were still intact. EU206 was placed between the second and third windows to the west of the north entrance in order to investigate an unknown GPR reflector, and see if the reflector was part of an intact ramp leading to the cellar. This unit was located below a first floor window that architectural analysis suggested had once been a door.

Two of the basement windows have arches in the brickwork above them, which the architects have said indicate that they used to be cellar doorways (Fig. 23). In EUs 205 and 206, we encountered a buried ground surface at roughly 120 cm (47 inches) below the modern surface. In parts of EU 206, there was a thin clay cap on top of the buried topsoil, similar to the clay that capped the road between the carriage house and the greenhouse (uncovered in the excavations in the fall of 2008). There were also wheel ruts in EU 206 (Fig. 27). The fact that the buried ground surface is relatively level and at the same depth in both units suggests that these two former doorways were not accessed by two separate ramps or sets of stairs. Rather, the whole area in front of this hyphen seems to have been exposed, with access not unlike what now exists at the west end of the house – a ground surface door with low clearance that you enter and step down to the cellar floor (Fig. 39). The absolute elevation of the top of the buried ground surface is 16.45 masl, only 45 cm (18 inches) lower than the top of the cobble driveway in EU204 (at 16.90 masl) (see Table 4). The current cellar floor of the room nearest to EU 205 is roughly 80 cm (32 inches) below the top of the buried ground surface outside.

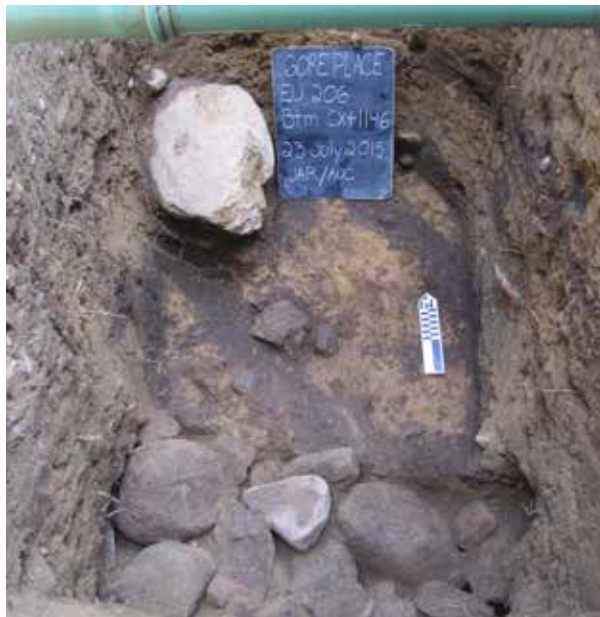
Figure 27. Dark features in the floor of EU206 interpreted as wheel ruts. The rocks in the lower part of the image are the fill of the later French drain.

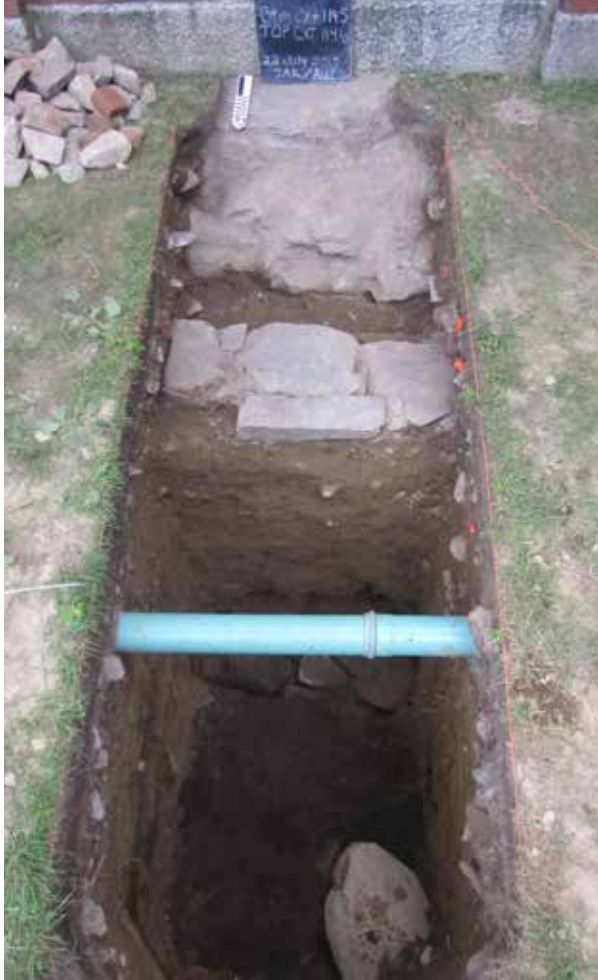
Figure 28. Door footer in EU206, north of a later concrete cap placed for foundation repair.

Chronologically, the next event that took place and was visible in the archaeological record was the construction and later abandonment of an old doorstep in the southern portion of the unit. Constructed out of green-gray slate, a single stone course was uncovered approximately 35cm below surface that extended east-west across the unit (Fig. 28). For stability reasons, the stones were left in situ and the soil underneath them was not excavated. Above the stones was a thin buried ground

EU 206 also uncovered a footing that corresponds to a former first floor entrance (Fig. 26). The footing was above the fill that raised the ground surface in front of the west hyphen, but below the architectural destruction debris that covered the area. This suggests that this first floor door existed for a period of time after the west hyphen cellar entrances fell out of use and before a major architectural renovation (so in use some time between ca. 1817 and 1880). The architectural reports propose an 1880-1900 renovation of the west wing on the first floor, including rebuilding a chimney (Mesick et al 2001), so this may correspond to the demolition debris that covers the area in front of the west hyphen. The presence of a late 19th-century bottle base in this deposit supports this interpretation.

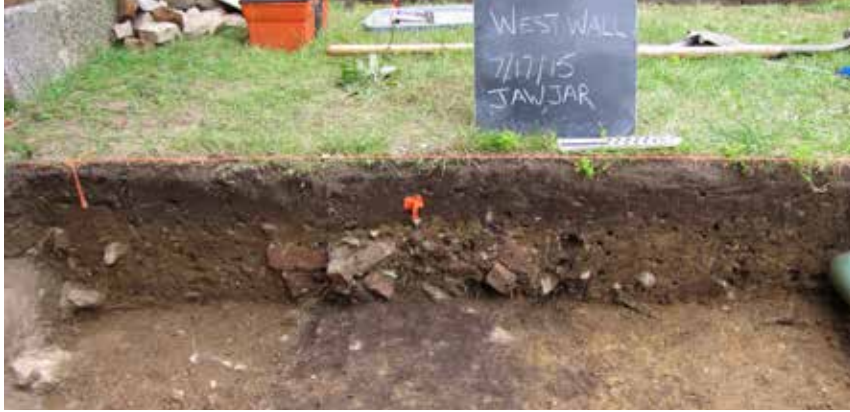
Figure 30. West wall of EU206 showing the small preserved remnant of the demolition layer (center), cut through on the south (left) by a trench to repair the foundation and on the north (right) by a trench to place a French drain.

The next stratigraphically visible alternation to the landscape seen in the units consisted of two separate events: the creation of a trench for a French drain, and the cut and filling of a builder’s trench for structural repairs to the house foundation (EU206) and window well (EU205). These events cut through the rubble/demolition layers (Fig. 30). The fill for the French drain was designated context 1132 in EU 205 and context 1138 in EU206. In both units the soil was noted as yellow brown with dark gray brown/black mottling. The trench was oriented east-west roughly parallel to the house and was approximately 50 cm wide. The cuts for the drain trench were vertical and straight sided, suggesting the use of mechanical equipment for its construction. At just under 1.3 m below surface, the trench gave way to voids in both units. The voids were later attributed to rodent burrows. Underneath the voids, large stones were piled within the trench to allow water to drain away from the structure (Figs. 31 and 32). Artifact density was generally low in the trench given its depth, with recovered artifacts including architectural debris, pearlware, nails, and bottle glass.

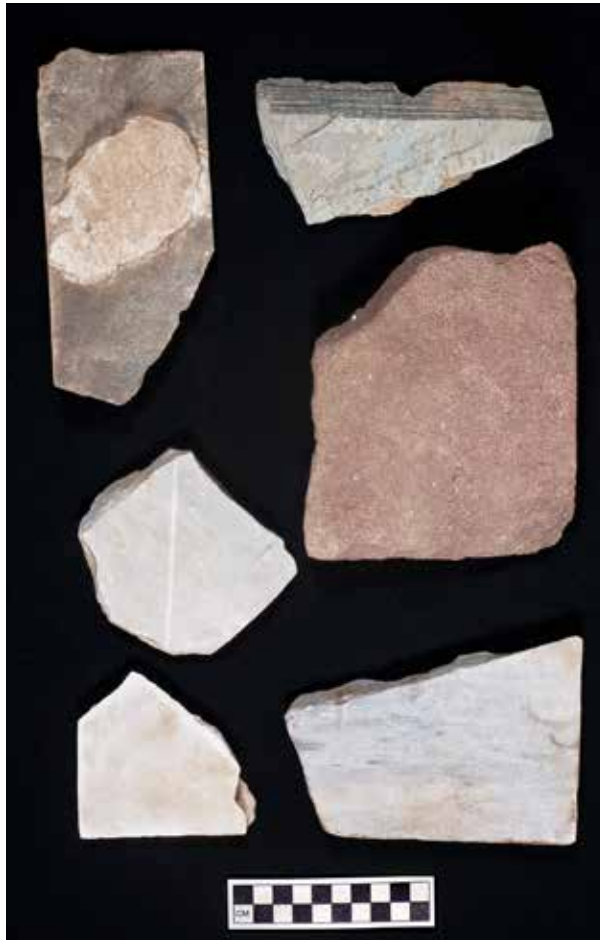
Figure 34. A sample of the architectural materials from contexts 1135 and 1136; top: gray slate with mortar, pale greenish slate; middle: red sandstone; bottom: three marble tile fragments, including one with an incised line.

We did not save all of this material, but did retain samples of each of the types represented. The layer of demolition debris beneath the topsoil in EUs 205 and 206 contained predominantly broken bricks, but also roofing slate, marble chips, and tin-glazed tile fragments. The volume of architectural rubble suggests a major episode of renovation involving a section of brick wall, duct or chimney that also affected some of the floor, as evidenced by the pieces of marble and slate flooring material. The amount of roofing slate indicates roof repair at the same time. The deposit in EU206 was relatively uniform, but the demolition debris in EU205 seemed to be composed of several dumping episodes, each containing a slightly different mixture and proportion of materials indicating repairs to different parts of the house. The least common material is the red sandstone, the single example of which is pictured in Figure 34. This material makes up the mansion's north porch.

Larger fragments of marble and slate floor tiles (Fig. 34) were also found in context 1136 in EU206, the trench cut for foundation repair. As one of the later features in this unit, the inclusion of flooring material could come from a later period of renovation, or it could have been re-deposited from the demolition debris that they had to cut through to access and repair the foundation. The dark gray roofing slate with a nail hole (Fig. 36) is from the French drain deposit in EU206 so could also be re-deposited from the demolition debris or incorporated later when the French drain was excavated.

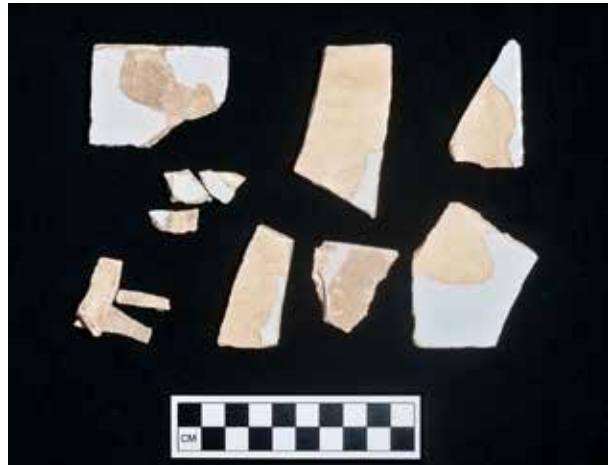
Figure 35. A sample of the tin glazed tile fragments from contexts 1120 and 1125.

The tile fragments recovered during the 2015 excavation (Fig. 35) were concentrated in the topsoil and demolition debris of EU205, with a smaller number found in EU206. They were relatively infrequent compared to the volume of material such as brick and slate that comprised the demolition deposit. Like those recovered by Smith, none of the tiles we found had mortar on them, suggesting they might have been discarded

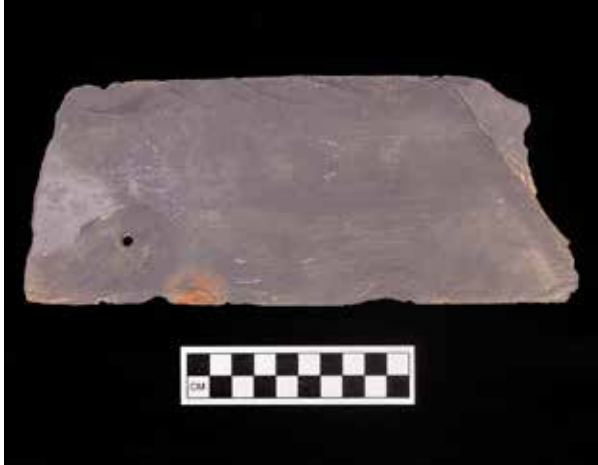
Figure 36. Gray roofing slate with a nail hole from the fill of the French drain in EU206.

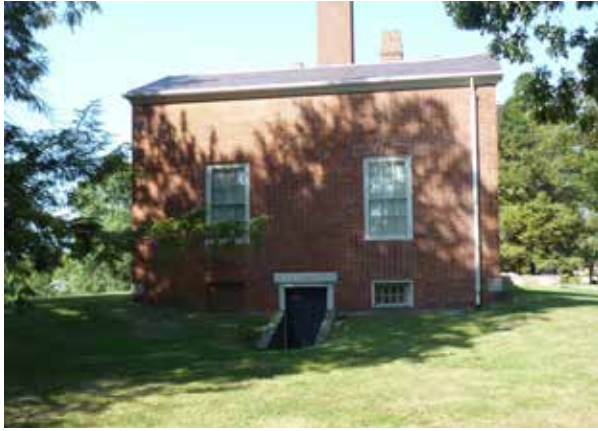
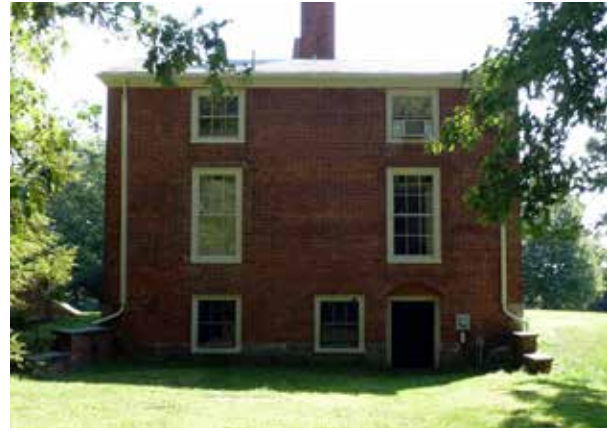
Figure 39. East (left) and west (right) ends of the mansion showing two different ways that cellar entrances are configured today. Note the courses of stone visible below the brick on the west end.

dow well, not out the house's foundation. The east and west ends of the house have some of the cellar story exposed, and they offer two different possibly appearances for the front of the west hyphen (Fig. 39). The existence of the cellar entrances also raises the question about symmetry between the east and west hyphens. If the west was exposed and the east was not, the house would not have appeared so symmetrical from the north side as it does today.
