# Data Recovery Excavations of the Carriage House, Greenhouse, and Greenhouse/Carriage House Well at Gore Place, Waltham, Massachusetts

**Data Recovery Excavations of the Carriage House,  
Greenhouse, and Greenhouse/Carriage House Well at  
Gore Place, Waltham, Massachusetts**

**Prepared by:  
Christa M. Beranek, J.N. Leith Smith, and John M. Steinberg  
With contributions by Michelle G. Styger, Heidi Krofft, and Rita A. DeForest  
Fiske Center for Archaeological Research  
University of Massachusetts Boston**

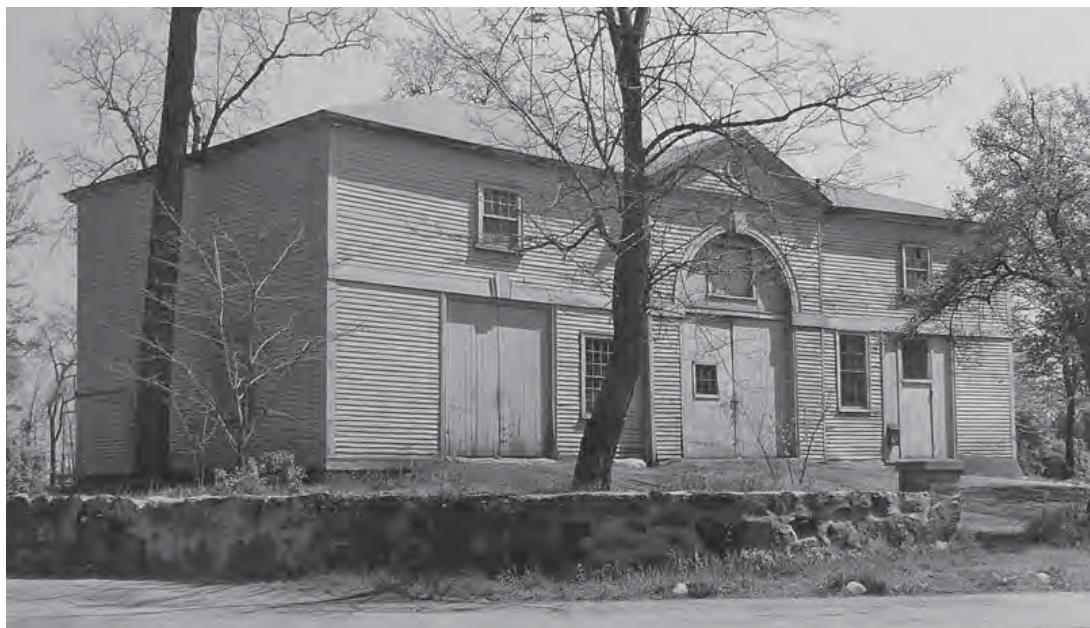
Figure 2.1. Carriage house as it appeared ca. 1937.

The carriage house, also known as the coach house or coach barn, is a large, two-story structure that was originally located on the north side of Gore's entrance drive adjacent to Gore Street (former Cross Road; Figure 2.1). It was built around 1793 of timber frame construction finished with clapboards and relatively high style Federal period detailing. It is one of a small number of such barns to survive intact from the late 18th century in New England and played an important role in the management of the estate. Its construction date is based on its similarity to the carriage barn at the nearby Theodore Lyman estate (The Vale) known to have been built at that time and designed by the accomplished architect, Samuel McIntyre of Salem, Massachusetts. The Gore carriage house measures approximately 70 × 40 ft, and according to Historic American Buildings Survey (HABS) records was set on a full, dry-laid fieldstone (rubble) foundation. The first floor consists of three bays, each with its own access door (Figure 2.2). At present, the western bay or coach room features plastered walls and ceiling with horizontal plank wainscoting. The central bay is formed by wood plank and stud partitions, while the east bay contains a harness or tack room and seven horse stalls. The stalls are constructed of match-board paneling with curved arches and numbered keystones that may have been installed in the mid 19th century. The second floor follows an open plan and is accessed via a wide staircase at the central rear of the building. The cellar was present under the entire structure and was accessed via a ramp and exterior opening in the east foundation wall. The ramp was protected from the weather by a shed addition that is clearly depicted on the Greene estate plan, and the ghosted image of its roofline was documented by the HABS drawings.

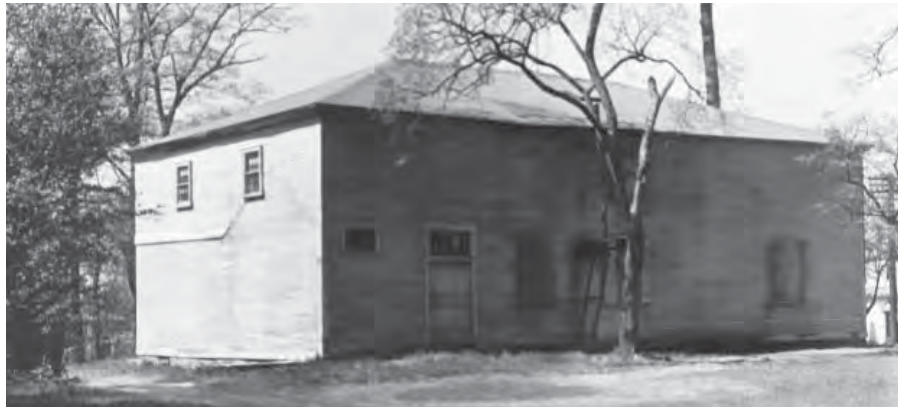
Figure 2.6. A) Detail of the east side of the carriage house; B) photograph showing the ghost image of the roofline (HABS 1936).

When the estate came under the ownership of the Gore Place Society in 1935, repairs were made to the roof of the building as a result of a second floor fire, but the cause of the fire is unknown. In the same year, the carriage house was documented along with the mansion house by HABS. This work provided detailed drawings as well as photographs of the exterior and some interior spaces. Particularly noteworthy was the depiction of the east carriage house foundation wall, ramp, and wooden cellar door (Figures 2.6 and 2.7). Dimen-

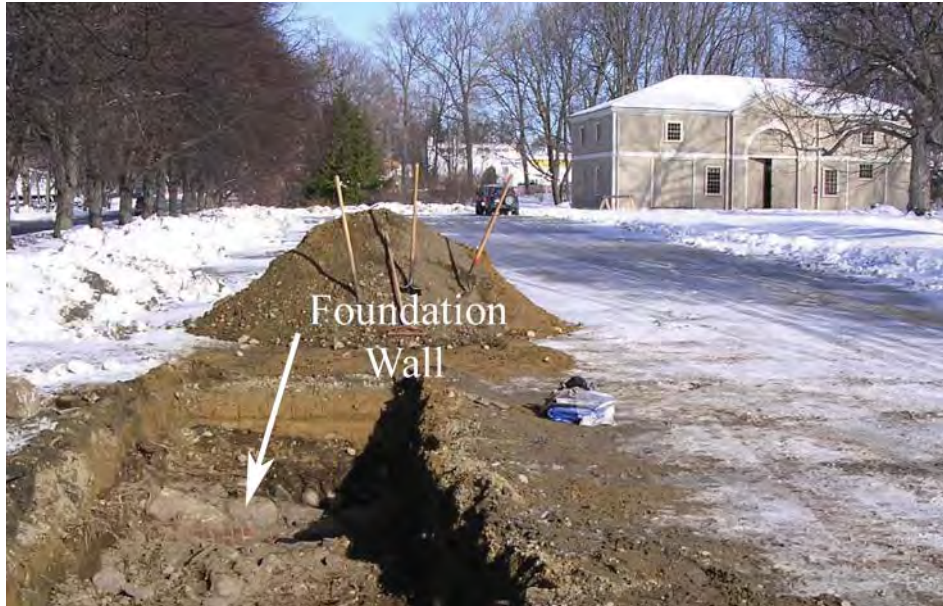
Figure 2.12. Excavation trench and north wall location in 2004 (facing north).

the north side of the foundation wall at an elevation between 70 cm (27.5 in) and 100 cm (39 in) below the parking lot surface (Figure 2.12). After the wall's location was recorded the excavation trench was backfilled.

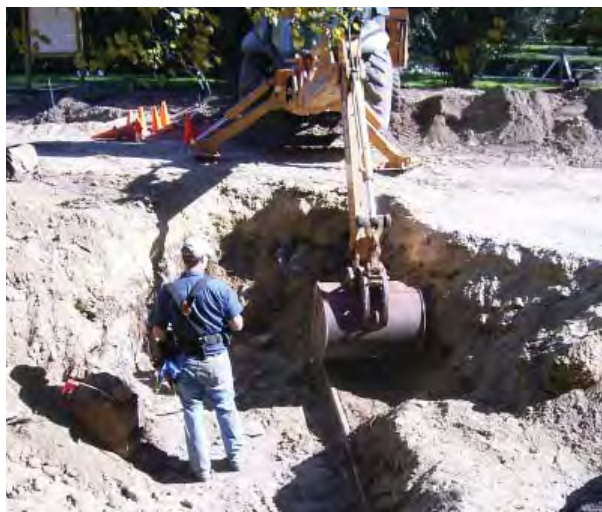
Figure 2.15. Backhoe removing fill from carriage house cellar, facing east.

The backhoe was repositioned to the east side of the excavation area to carefully remove remaining cellar fill and to expand the area eastward in hopes of encountering the east foundation wall (Figure 2.15). As soil fill was mechanically removed from west to east just inside the north foundation wall, a split granite post containing an iron pintle was revealed adjacent to the wall. It was immediately recognized that this was a support for the cellar door. Excavation in the area had to be ceased at that point in order to maintain a safe passage for cars to enter the rear portion of the parking lot. Thus, none of the ramp or ramp walls were exposed.

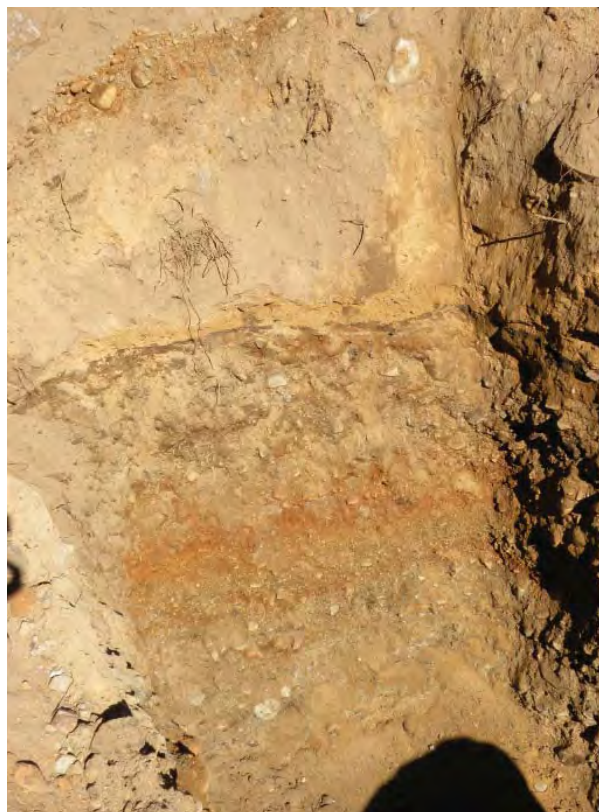
Figure 2.16. East wall profile of Test Trench 1.

and rounded gravel and stones were found instead. Interpreting this to represent possible feature fill, this trench (Test Trench 1) was expanded to 1.2 m in width and 2.5 m long, and was mechanically excavated to a depth of 2 m. This revealed four episodes of sand and gravel fill (Figure 2.16). Given this unexpected finding, the backhoe was repositioned immediately westward to open up a larger area to search for a possible feature border and for a buried ground surface if one still remained intact. Removal of the parking lot fill to a depth of 30 cm bs showed sandy gravel to be present across the entire area. A single trench (Test Trench 2) was extended northward to search for a border of the sand and gravel fill. Excavation proceeded to a depth of 40 cm and the trench was extended 17.5 m north of the rear carriage house foundation wall. Parking lot gravel, yellow sand bedding and sandy gravel fill was present for the entire length of the trench to a depth of 40 cm bs. Archaeological testing in this portion of the parking lot in 2004 showed parking lot gravel and sand bedding to range in depth between 35 and 50 cm.

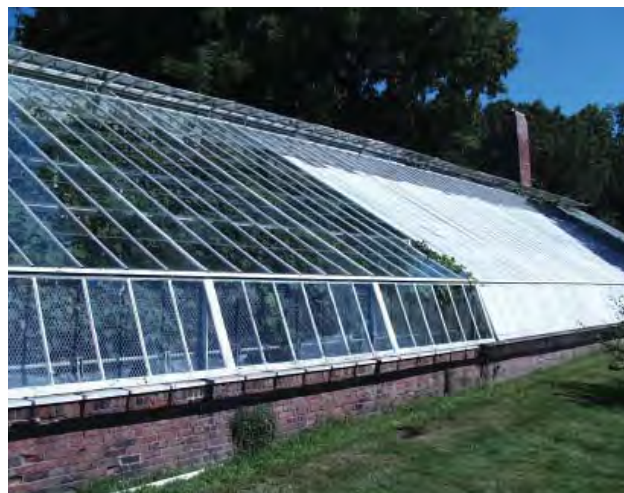
Figure 3.5. A) Profile of a greenhouse with a substantial back wall and short front knee wall from Diderot's *Encyclopédie*; B) Detail of greenhouse at the Vale using this construction method.

The second type, introduced near the end of the 18th century (Pogue 2009) was designed to take more advantage of the sun's energy and had a substantial back wall and a sloped roof and front constructed mostly of glass, resting on a shorter and less substantial knee-wall in front, sometimes called a lean-to style greenhouse (Figure 3.5). Examples of this type were built at the Lyman Estate in Waltham, Massachusetts, and Oatlands Plantation in Virginia. M'Mahon suggests that the piers between the sashes be made of wood to let in more light and that a half to a third of the roof be glazed, the rest roofed in slate (1806: 80).

On the interior, plants could either be planted in built-in beds (as they are in the late 18th-century Lyman greenhouse) or placed in pots on tiered shelves (Loudon 1825: 12) as illustrated in Figure 3.5. A third option was to have a sunken section of the floor, known as a "bark pit" (Figure 3.6). The pit was filled with pieces of bark and plant pots were set into the bark medium so that the decaying bark could provide a moist heat (M'Mahon 1857: 104-109). Jacob Farwell's *Farm Journal* notes that on occasion he hauled loads of oak and cherry tree bark (April 5, 1823); he does not specify whether this is for a bark bed, other aspects of soil preparation, or another purpose, such as tanning hides (possible since Farwell also mention leaching pits, likely also for tanning). On two occasions, he specifically states that he was getting the bark "for Mr. Gore" (March 4, 1823; June 22, 1824).

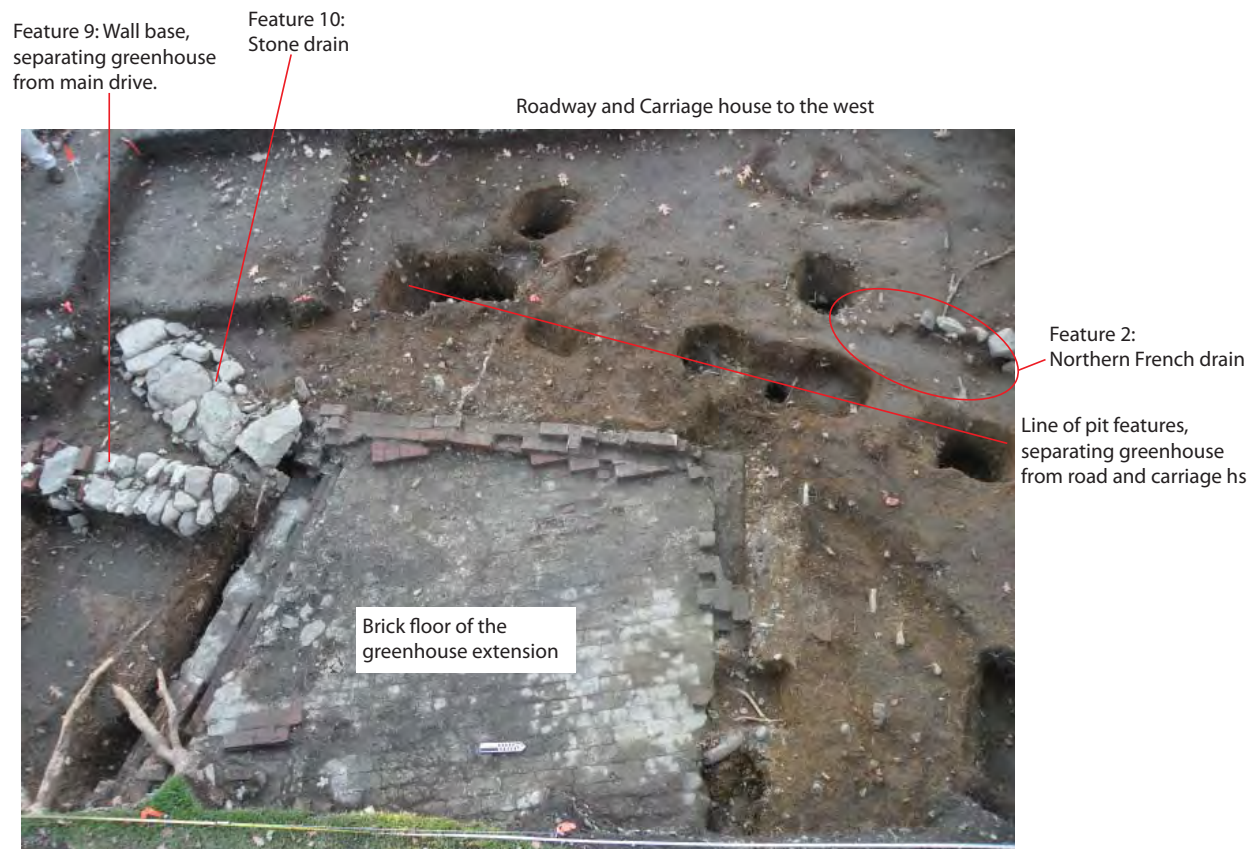
Figure 4.2. The greenhouse area at the end of the 2008 excavation, facing west.

The excavation uncovered a roughly  $3 \times 3$  meter trapezoidal brick floor, interpreted as the greenhouse extension depicted on the 1834 Lyman map (Figure 4.2). This floor was surrounded by a prepared ground surface and a number of features that seem to have been contemporary with the operation of the greenhouse, including a roadbed that passed between the greenhouse and the carriage house. A row of large post holes separated

The northern French drain ran roughly north-south through unit N582 E735 into units N580 E733 and E735 (see Figures 4.2 and 4.11). It was located between the edge of the roadway and the line of postholes that delimited the greenhouse area, placing it outside the greenhouse area. It is not clear what it was intended to drain, but it may have carried away water that ran off the roadway, since the edge of the roadway sloped down to the east. The west side and south end of the feature had been disturbed and cut away by later activity associated with the destruction of the greenhouse (see below). The drain cut through layers that had built up over the old ground surface, burying Feature 3, the clay pathway. Therefore, the drain is later than Feature 3, and later than the construction of the greenhouse. The drain was a sloping trench, up to 50 cm deep and 90 cm wide in the north, with a relatively flat bottom that had been lined in places with the same kind of marine clay used on the road bed (described above) and around the Drive Circle well. Its width at the south end cannot be determined because the feature was cut through by later activity at the site. The feature was filled with some large cobbles at the bottom, whole planting pots, large bones, sheets of window glass, and large metal tools including three shovel

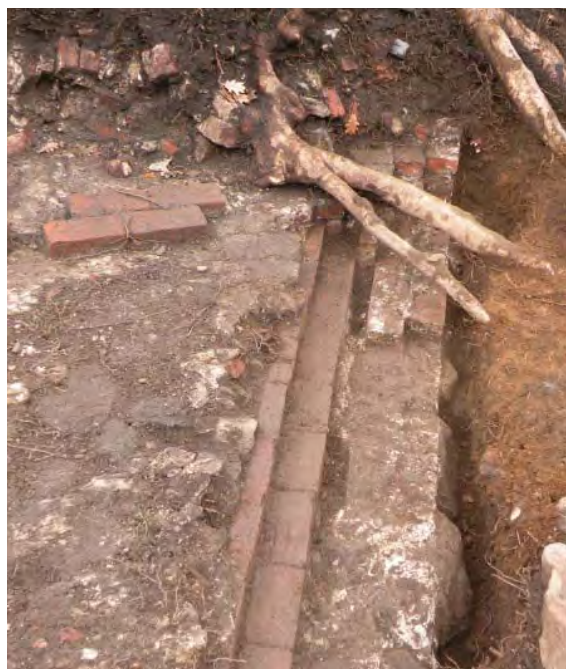
Figure 4.3 Brick channel at the south edge of the greenhouse extension floor, facing east. The fieldstone base of the south wall and the narrow builder's trench are visible at the right.

of the floor (Figure 4.4). The lowest course rested on a bed of mortared stone rubble which extended just slightly beyond the bricks. The mortar on the exterior of the bricks was very rough, suggesting that these courses were below the ground level while the building was in use and were not visible. The southern wall, on the other hand, was built of bricks set in mortar on a fieldstone foundation (see Figure 4.3).

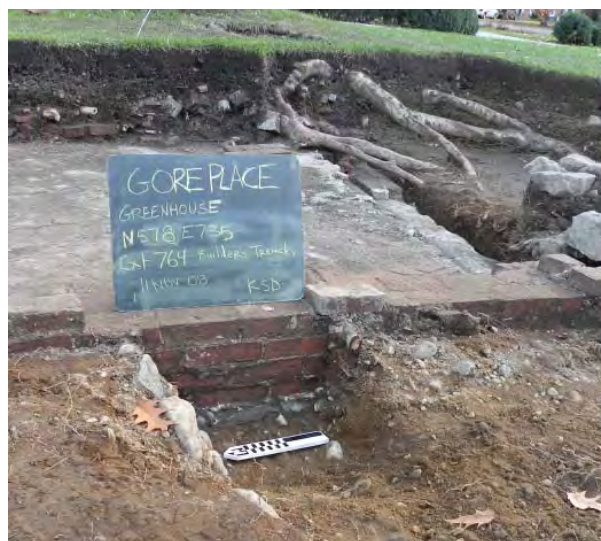
Figure 4.4. West edge of the greenhouse, exterior. Note unfinished mortart joints, as these would have been below grade and not visible.

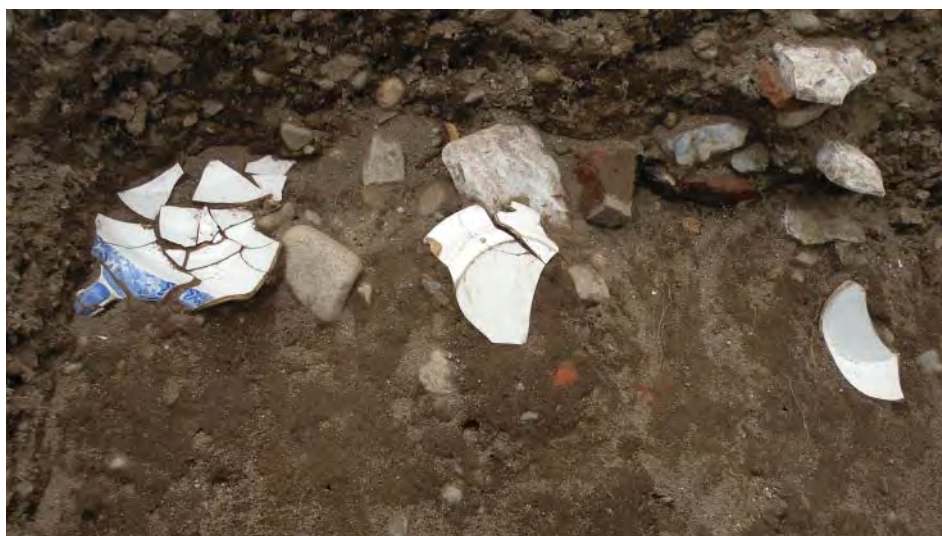
Figure 4.8. The artifact cluster (ext 650) at the upper surface of the deposit over the roadway (ext 686); pearlware pitcher, creamware plate, and marble floor tile fragments. North is to the top.

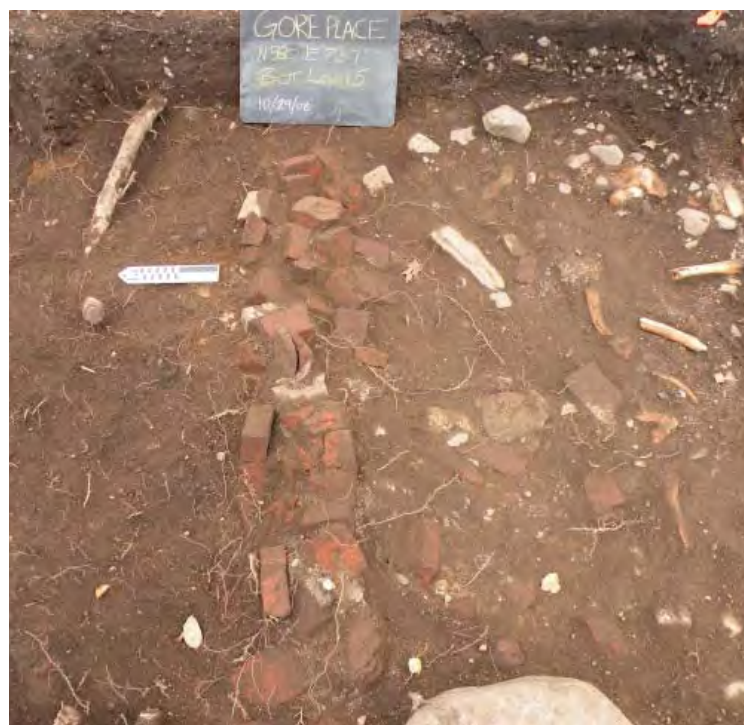
Figure 4.17. The top of the rubble deposits over the greenhouse extension floor. The line of broken bricks (Feature 11) marks the north edge of the floor. Compare the relatively clean deposit outside the greenhouse (Feature 6, left) with the brick, rubble, and bone laden deposit over the floor (right).

low in most places. Along the north wall, a distinct deposit of broken bricks (Feature 11, contexts 680, 745) was left along the line where the wall had once been (Figure 4.17). There was a similar deposit of rubble (Feature 17, context 701, 708) along the west wall boundary. The deposits that covered the brick floor of the greenhouse extension were varied and contained different types of rubble and artifacts (Table 4.7). Some were broad, covering most of the interior area, and others seemed to represent individual bucket loads of fill. There were also large pieces of bone throughout these deposits. The faunal collection is analyzed in Chapter 5. Immediately on top of the brick floor of the extension were dense deposits of coal (Figure 4.18).

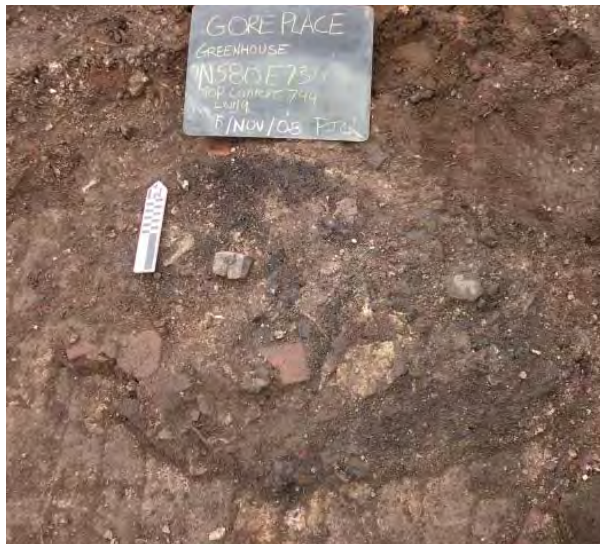
Figure 4.18. Coal deposits immediately on top of the greenhouse extension floor.

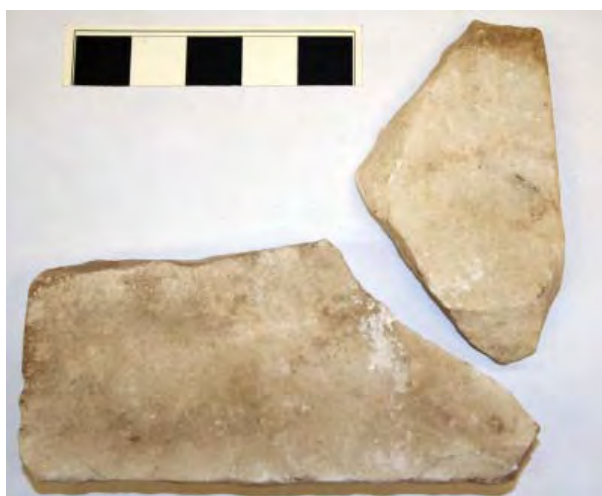
Figure 5.2. Fragments of white marble floor tiles. Scale is in inches. Photograph by Heidi Krofft.

The floor of the greenhouse extension that was uncovered in 2008 was paved in brick. Pieces of white marble tiles (and one piece of black slate tile) provide evidence that the floor of the main body of the greenhouse, however, was paved with marble (Figure 5.2) and possibly some slate. Additionally, pieces of mortar with brick and stone rubble aggregate were found with marble tile impressions. This may have been an attempt to lift the floor above ground level as suggested by the historical literature. The difference between the brick floor of the extension and the marble tile believed to have been used in the main body of the greenhouse underscores the difference between the functional work and storage space and the more formal or display oriented main space.

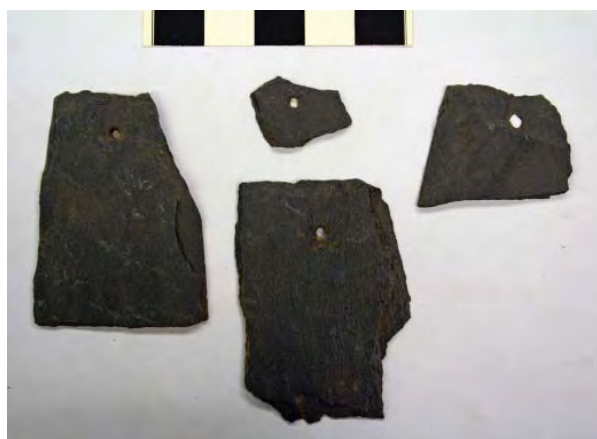
Figure 5.3. Roofing slate with nail holes. Photograph by Heidi Krofft.

The greenhouse excavations yielded 128 slate fragments of various sizes. Historically, slate was used for both paving and as a roofing material and the fragments suggest that both were present in the greenhouse. Several of the larger fragments of slate possessed nail holes (Figure 5.3), suggesting

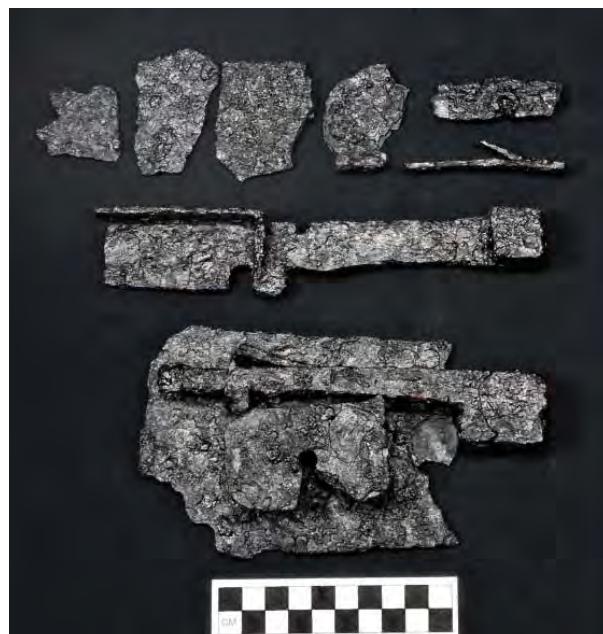
Figure 5.4. Rim and stock lock fragments.

A stock lock consisted of several iron parts creating the lock mechanism and attached to a wooden housing. Stock locks are mounted to the surface of the door and usually consist of only one bolt, the dead bolt. Although stock locks are not often found intact, according to Priess, their parts are distinctive and are not found on other types of locks (2000: 83). Three different parts of a stock lock were recovered: the lock bolt, the main ward,

With a rim lock, another surface-mounted lock, the components of the lock are fastened to an iron main plate with rims or sides to complete the housing. These locks were also attached to the surface of the door and often required keepers or a staple for the bolt to lock into. At the very minimum, a rim lock needed one bolt, a lock bolt or dead bolt, to function and was called a dead lock or a closet lock (Streeter 1974: 67). Often times, rim locks also had latch bolts and sometimes even another lock bolt. The rim lock from the greenhouse excavations is simple in its form and only has one bolt (Figure 5.4).

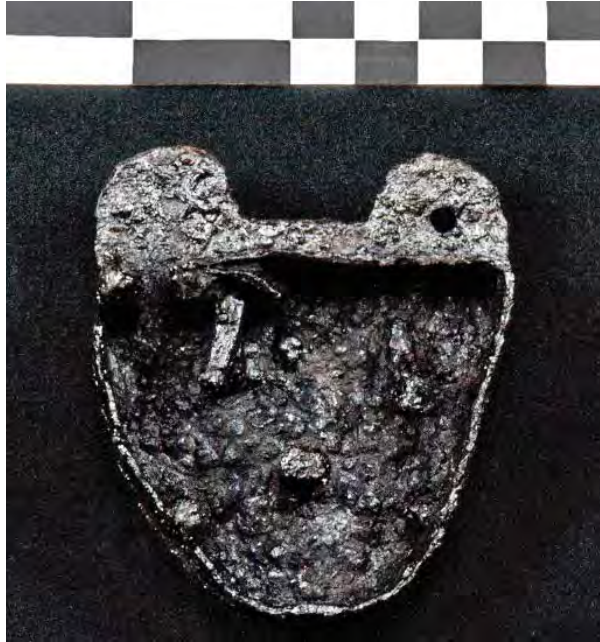
Figure 5.5. Padlock.

The padlock (Figure 5.5) is different from the stock lock and the rim lock in that it was portable. The padlock consists of a main housing enclosing the locking mechanism and a curved bow to secure the lock (Priess 2000: 79). The example from the greenhouse excavations is symmetrical with its widest dimension at the top of the lock. It has two lobes at the top to accommodate the bow. The lobe on the right has a hole where a pin would have passed through to attach the bow and to create a

pivot point. There is a void in the top of the housing where the opposite end of the bow would have been engaged in the mechanism to secure the lock closed. The general shape of the padlock dates it roughly to the 19th century (Priess 2000: 81). In addition, the presence of a pivoting brass keyhole cover also provides evidence for a date. According to Noël Hume, the brass keyhole covers were not used on iron padlocks until the 19th century with most of them dating after 1840 (1969: 251). Although the keyhole cover is not attached to the padlock, it was recovered from the same context and the two are likely associated with one another.

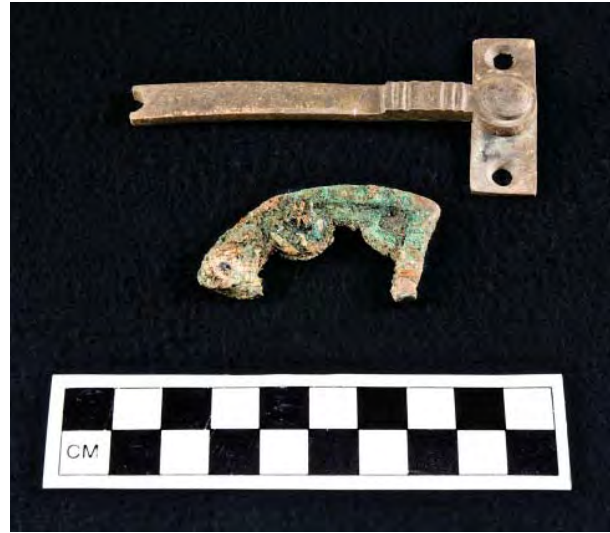
Figure 5.6 Copper alloy latch (top) and escutcheon (bottom) recovered during the 2005 excavations.

The 2004-05 survey of the greenhouse area also recovered some more decorative hardware that might also be from doors: a copper alloy latch and escutcheon (Figure 5.6). The latch came from an STP located on the north side of the greenhouse, and was probably discarded after it broke at the point where a small knob would have been

present to move it up or down. A second STP yielded a portion of a cast brass escutcheon. It is difficult to determine what type of hardware this fragment is from. It may be an attachment for a drop pull or the top end of a door handle. Regardless, it represents another example of the hardware potentially used in the greenhouse. The escutcheon in particular is one of the more ornamental pieces of hardware found on the greenhouse site. Therefore it is likely that it would have been used in a publicly visible space.

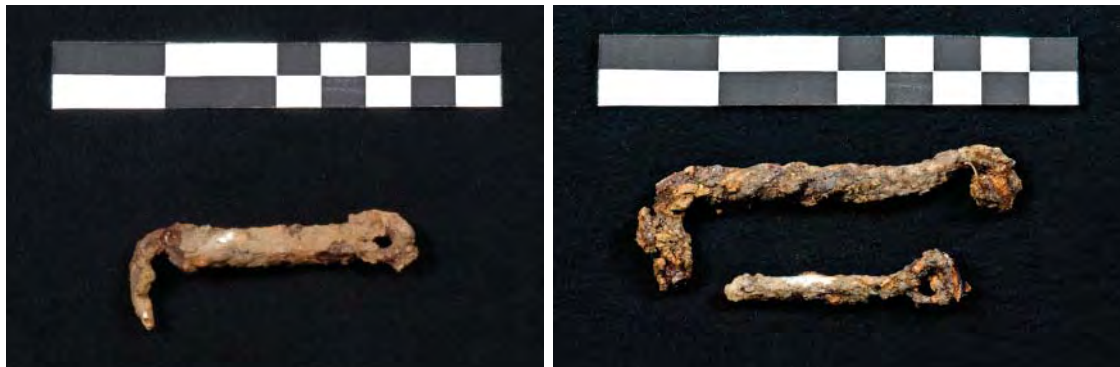
Figure 5.7. Two simple iron latches, context 614 and 714.

Hardware was also necessary to secure the shutters in a closed position. It is possible that the two latch hooks that were recovered from the excavation could have served this purpose (Figure 5.7). Although both of the latch hooks that were recovered were wrought iron they are in different styles. One of the latch hooks is plain and is about

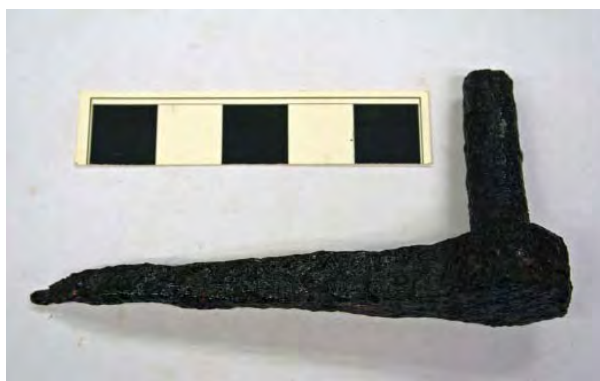
Figure 5.8. Iron pintle, context 669. Photograph by Heidi Krofft.

Overall, the excavations of the greenhouse area resulted in the recovery of at least six different hinges of three different types: strap hinge, H-type hinge, and snipe hinge. The strap hinge is represented by a wrought iron pintle (Figure 5.8). An iron strap would be attached to a shutter or door and had a joint that would fit over the pin of the pintle. The pintle would have been driven into the window frame or door frame or directly into the masonry work to fix the hinge in place.

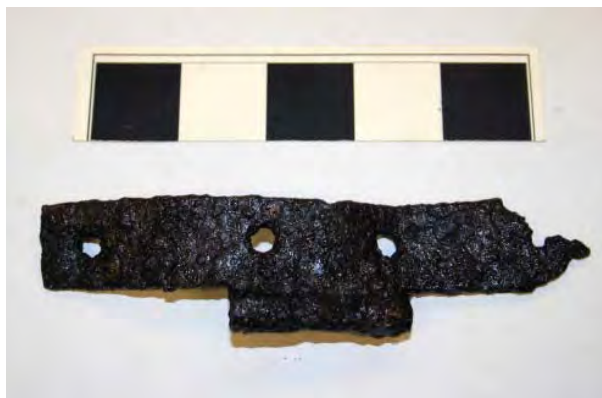
Figure 5.9. Strap from an H-hinge, context 669. Photograph by Heidi Krofft.

Fragments from at least five different H-type hinges were also recovered, none of them complete (Figure 5.9). These hinges are all made of iron and are hand wrought and represent two different sizes. The fragments provide evidence of at least two hinges of a similar size and may be a pair

of hinges from the same door or shutter. The straps measure about 16 cm (6.3 inches) long and about 2.2 cm (1 inch) wide. Both straps have four holes used to affix the hinge to a door or to a doorframe. Both of these examples are the side of the hinge with a single knuckle measuring about 4.9 cm (2 inches) tall. H-type hinges commonly had 3-part joints, so the associated strap would have had two knuckles that straddled this one (Priess 2000: 59). This center knuckle would have carried the weight of the door (Streeter 1973).

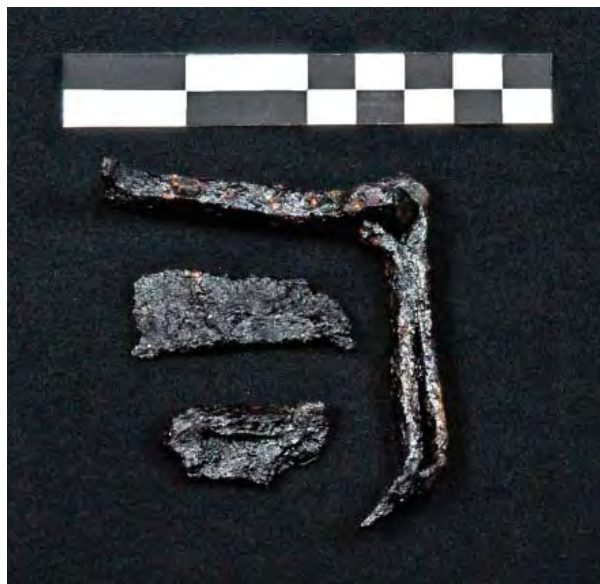
Figure 5.10. Snipe hinge, context 683.

The final type of hinge that was recovered is a snipe hinge. This consists of two eyes that are connected and form a pivoting point (Figure 5.10). These eyes would be driven into the door edge and the frame. One complete snipe hinge was recovered from the greenhouse excavations. This example shows evidence of clinching on the eye that was driven into the frame. Another snipe hinge was found during the 2005 survey. Only one eye from this hinge remains and due to the lack of clinching most likely represents the eye that was driven into the door. This type of hinge is much smaller than those previously discussed and it is unlikely that it would have held the weight of a full sized door or even a large shutter. It is more likely that this hinge would have been used for a small cabinet or compartment door. The presence of small cabinet or compartment doors indicates a need or desire to organize or separate tools in the workroom.

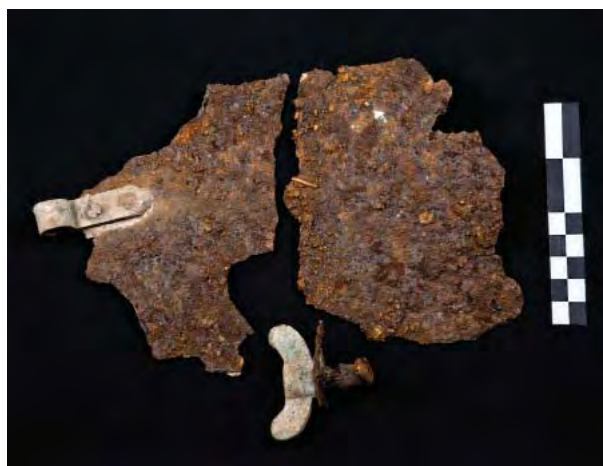
Figure 5.12. Possible furnace door fragments. Compare to the furnace door depicted in Figure 5.11.

Context	Unit Number	Level	Object	Material	Comments
651	N2580 E3733	3	sheet	iron	possible furnace door
651	N2580 E3733	3	sheet with brass fitting	iron and brass	possible furnace door (at least 26 cm tall)
651	N2580 E3733	3	wing nut latch?	brass and iron

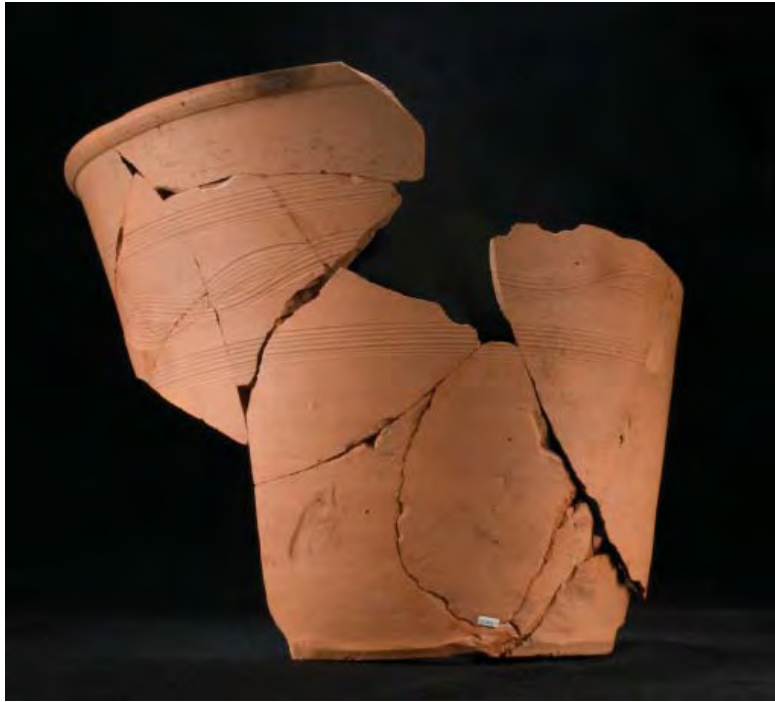
Figure 5.21. Detail of tooled decoration, vessel 39. Another style of tooling is visible on vessel 41 in Figure 5.18.

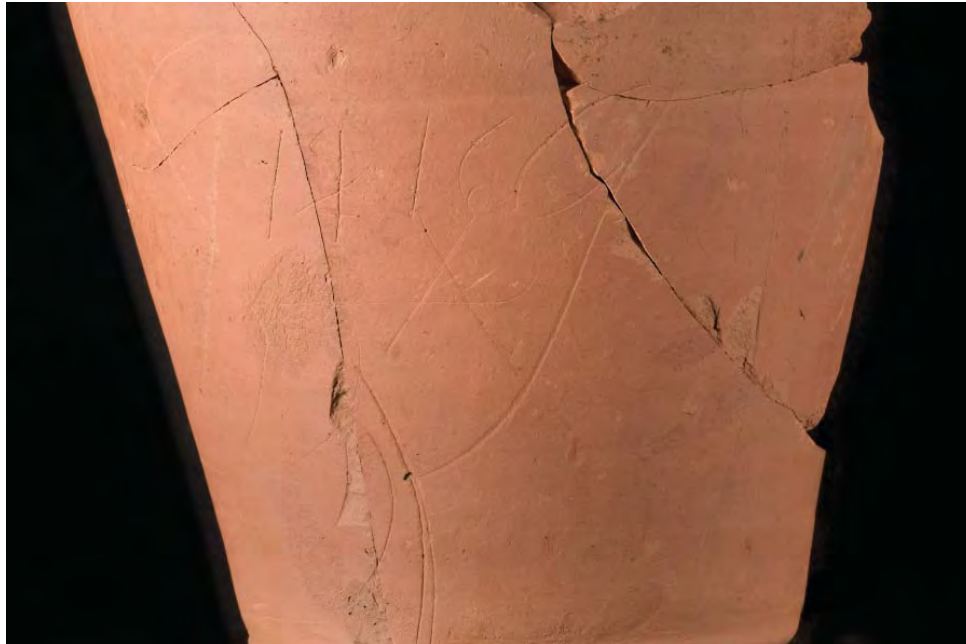
Figure 5.23. Scratched letters and numbers on vessel 35. The scratches include an X and a sequence which may read “1716g.”

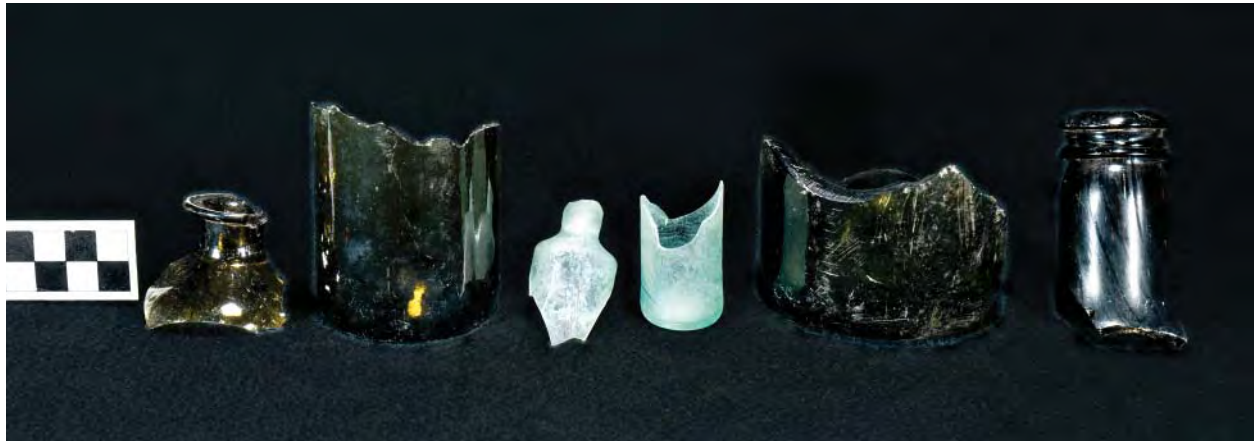
Figure 5.24. Glass bottle fragments from the northern French drain, Feature 2. These are the only large fragments of vessel glass recovered during the 2008 excavations.

Other than window glass, almost all of the glass from the greenhouse area is bottle glass, primarily necks and bases (Figure 5.24). There is one globe from a lamp represented, but no table glassware such as tumblers or stemware. Among the bottles are at least two small vials (base diameter = 2.5 cm) with flanged lips of the type that commonly held liquid medicines. Here,

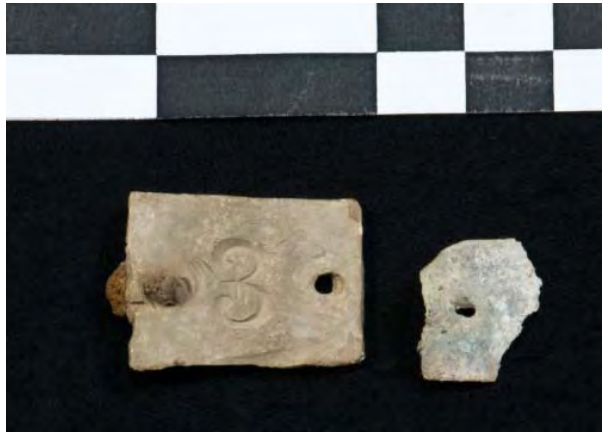
Figure 5.26. Lead tags from contexts 627 and 628.

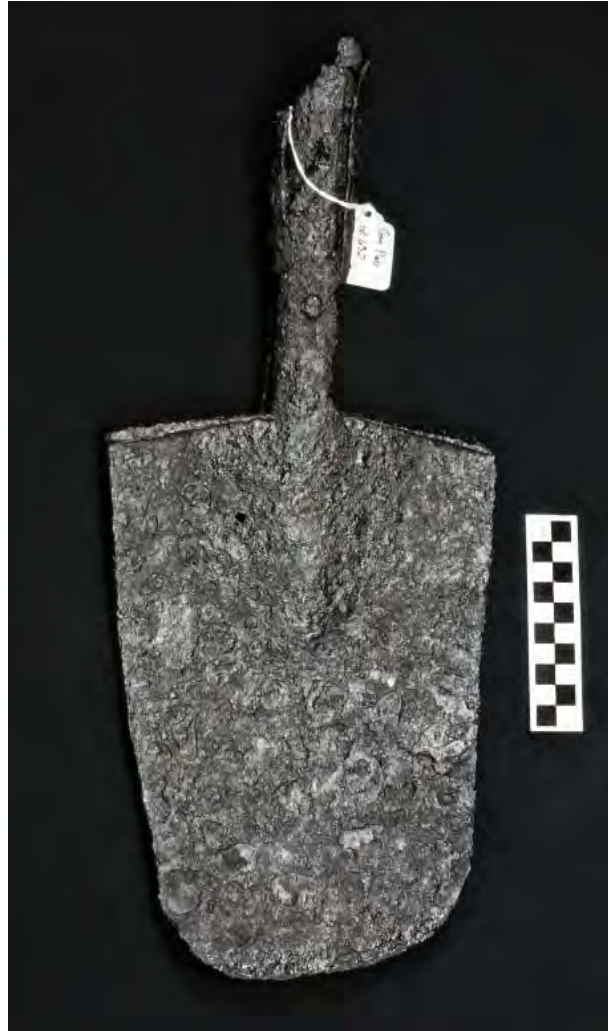
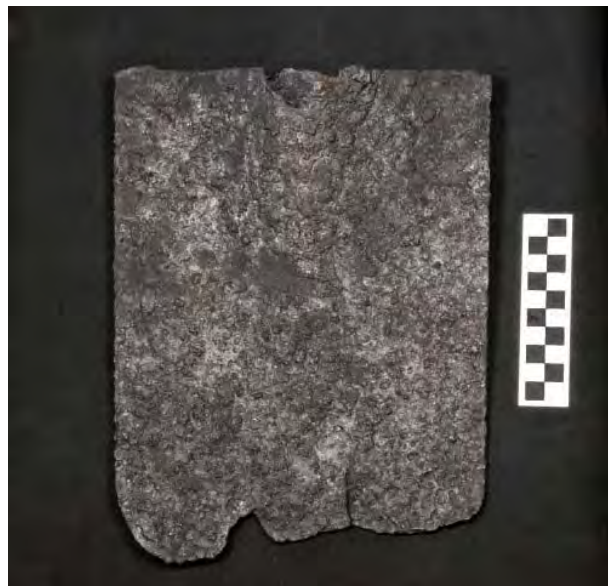
Figure 5.29. Iron spades from the northern French drain fill.

The fill of the northern French drain contained a number of large items, presumably placed there to promote drainage. In addition to several almost intact planting pots, there were three iron spades and a colander in the fill. These spades may not have been used in the greenhouse itself, but might have been used to turn soil or composting piles nearby. The greenhouse extension might have served as general purpose storage space for garden tools used in the area, though other general-purpose garden and farm tools such as hoes, rakes, and scythes were not found in the greenhouse area. Two of the spades were rectangular; one was rounded (Figure 5.29). The rounded example is the most complete and consists of two iron plates that are worked together for the blade of the spade, but which separate as they move towards the handle. The triangular iron plates that formed the top edge

of the shovel are intact, as is the beginning of the iron fitting that would have surrounded the wooden handle. The blade is 26 cm long and 19 cm wide at the top, tapering to a gently rounded point. Only the blades of the square spades survive. They are also both formed from two plates that separate near the handle. The top components are partially present on one example and missing on the other. Neither has a preserved handle attachment. These blades are 27 cm long, 21 cm wide at the top, and about 18 cm wide at the bottom.

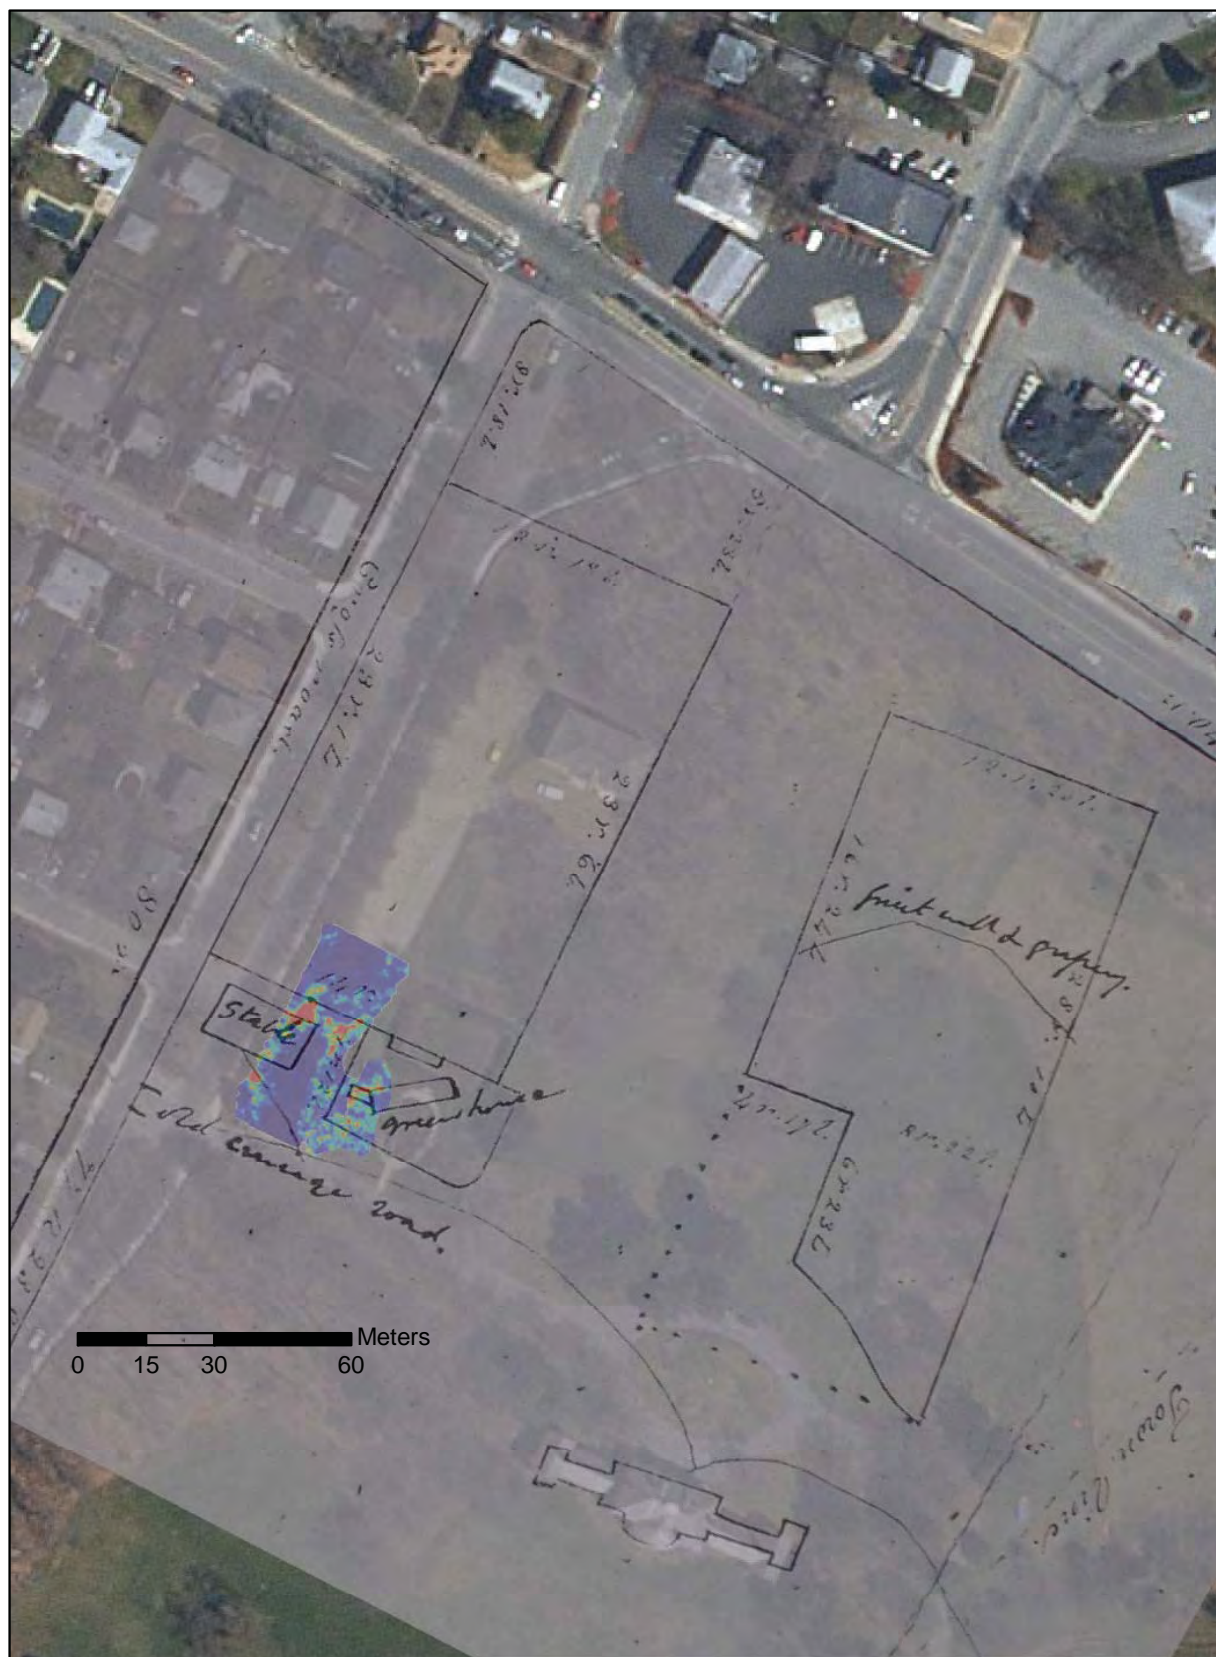
Figure 6.1. Property-wide georeference of the 1834 Lyman map. See Figure 2.3 for a detail.

While the 1834 Lyman map could be georeferenced to the whole property (Figure 6.1), with
